## EXAMINATION REPORT

**Purpose:** Dukane DK120 / BEA ULB examination

**Scope:** Accident investigation / AF447 event

**ULB Type:** P/N: DK120 S/N: ST24703

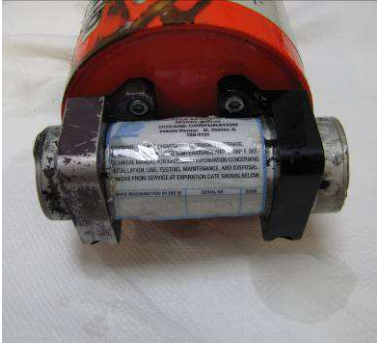
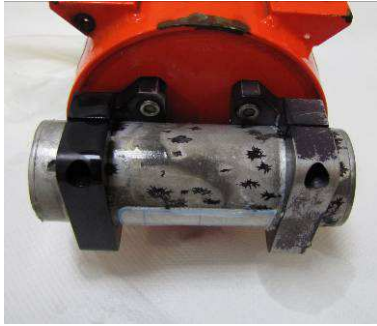
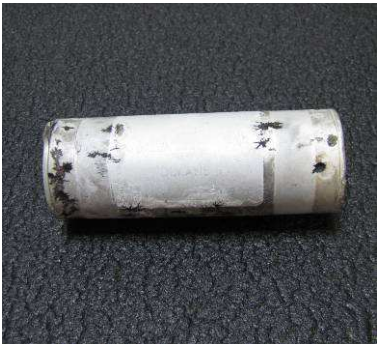
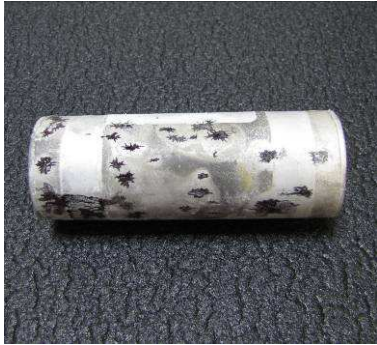
<p>Fasteners, screws and beacon body were brushed softly</p> <p>External corrosion points were present on the ULB body</p>
<p><b>STEP 2</b></p> <p><b>Battery compartment was opened</b></p>

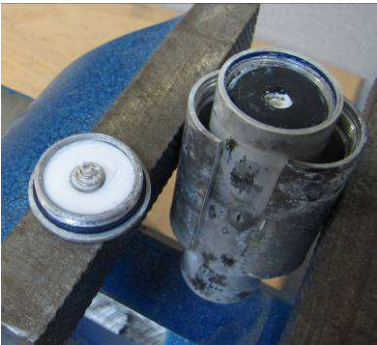
<p>bottom cap unscrewed</p>

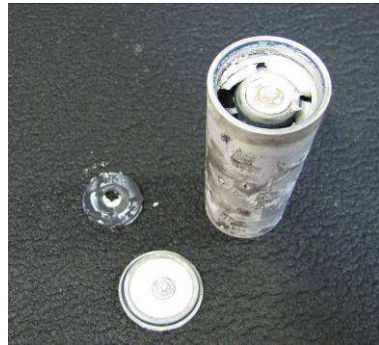
A doughy white deposit was present around the battery in the compartment

A sample was kept for analysis

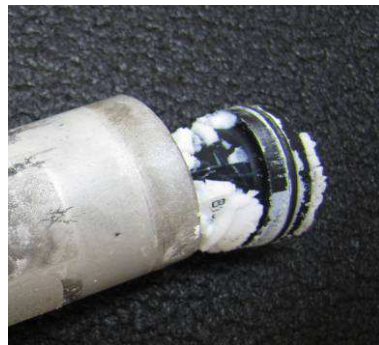
Battery guide removal  
(note white deposit)

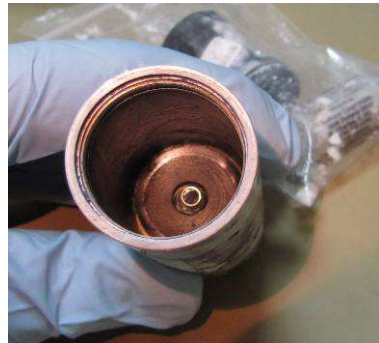
Neither noticeable internal damage nor corrosion inside the compartment observed

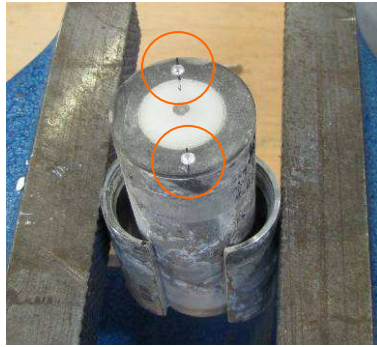
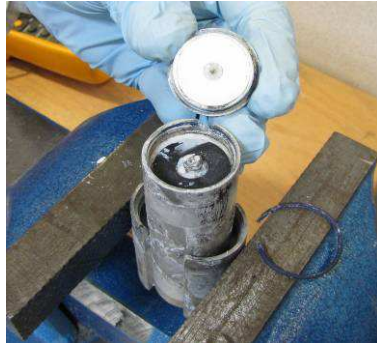
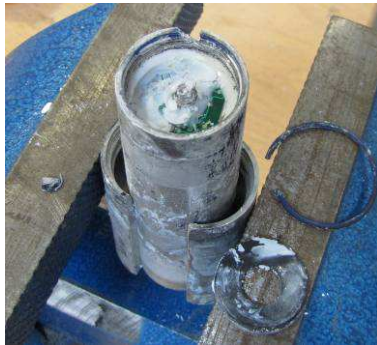
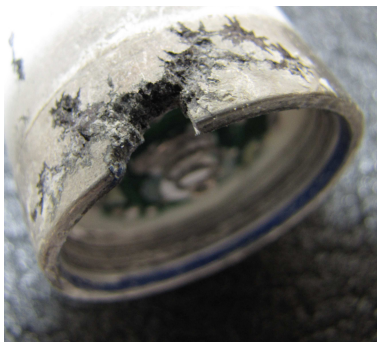
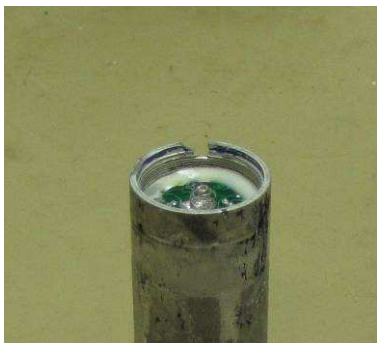
Shallow holes were made on the top cap in order to unscrew it with the special spanner

Top compartment was opened. Same white deposit as describe previously was present

Cap seal was accidentally cut during the opening operation

A little part of the upper side broke during the operation (located in a severely corroded area)

The visual examination of the top compartment revealed no corrosion inside, and no damage on the visible side of the electronic circuitry (board and components)

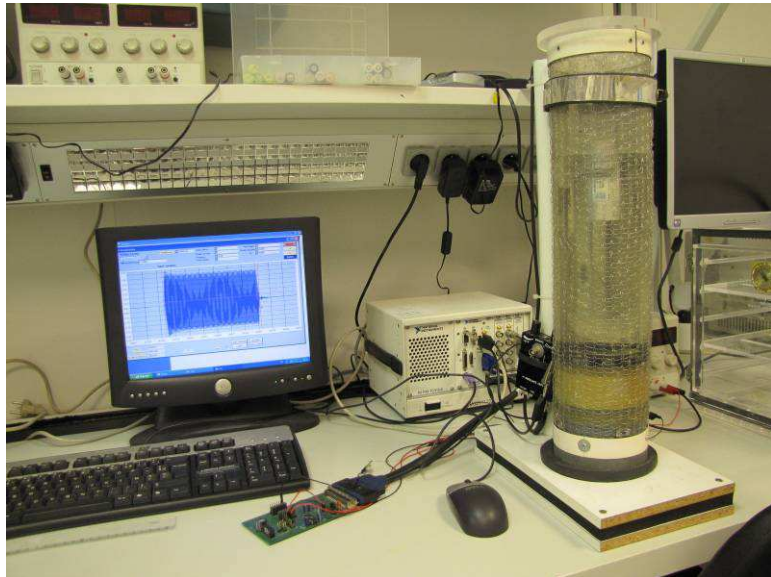
Some relative average value were noted using a Golden unit DK120 (S/N: ST28565):

Frequency:	37.2 KHz
Pulse duration:	10.3 ms
Pulse rate:	1.08 s
Pulse level:	0.6 Vpp

A measurement was made under the same conditions with the ULB of the event:

Frequency:	<b>34 KHz</b>
Pulse duration:	<b>10.7 ms</b>
Pulse rate:	<b>1.3 s</b>
Pulse level:	<b>0.02 Vpp</b>

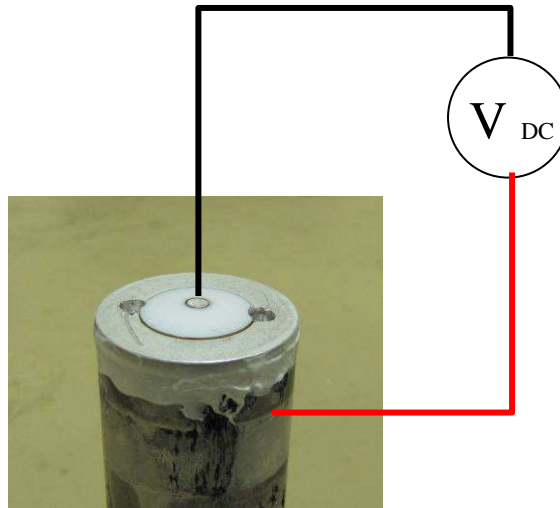
Suspecting a faulty power supply a direct measurement of the batteries voltage was made through the hydrostatic contact on the upper side of both the Golden unit and the ST24703 beacons

Voltage value measured trough the contact was :

- Golden unit / 3.2V DC
- ST24703 / **1.8V DC**

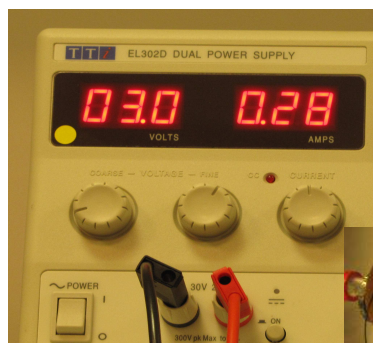
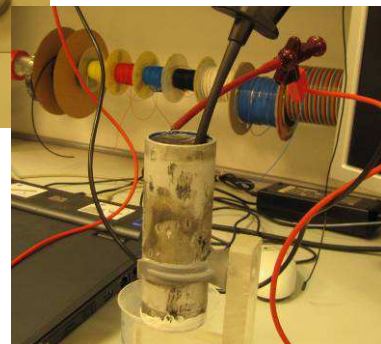
Value measured:

- Golden unit / Hydrostat-contact OFF / 0mA
- Golden unit / Hydrostat-contact ON / 280mA
- ST24703 / Hydrostat-contact **OFF** / **360mA**
- ST24703 / Hydrostat-contact ON / **360mA**

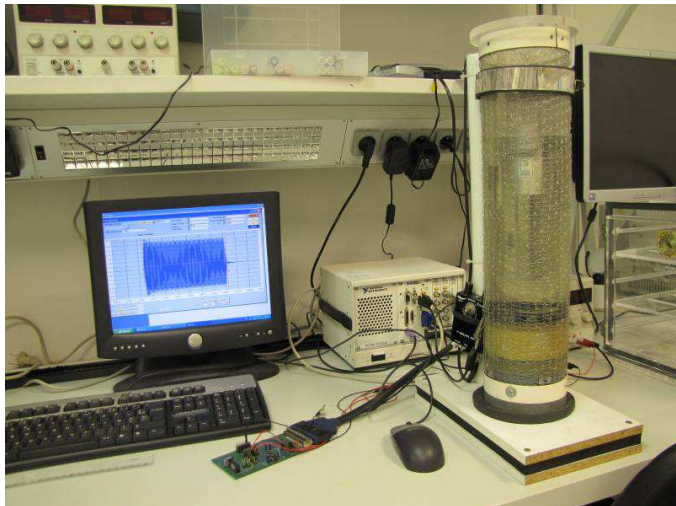
<p><b>A second acoustic check in tank were performed</b></p>	<p>Some relative average value where noted using a Golden unit DK120 (S/N: ST28565):</p> <table> <tr> <td>Frequency:</td><td>37.3 KHz</td></tr> <tr> <td>Pulse duration:</td><td>9.7 ms</td></tr> <tr> <td>Pulse rate:</td><td>1.07s</td></tr> <tr> <td>Pulse level:</td><td>0.9 Vpp</td></tr> </table> <p>A measurement was made under the same conditions with the event ULB:</p> <table> <tr> <td>Frequency:</td><td><b>36.2 KHz</b></td></tr> <tr> <td>Pulse duration:</td><td>9.7 ms</td></tr> <tr> <td>Pulse rate:</td><td>1.1s</td></tr> <tr> <td>Pulse level:</td><td><b>0.01 Vpp</b></td></tr> </table> <hr/> <p>Because of some discrepancies between the two acoustic measurements, it was then decided to check again the power supply of both the Golden unit and the CVR beacons.</p> <p>Remember that prior to starting the test the two units had received new batteries (measured unconnected):</p> <ul style="list-style-type: none"> <li>➤ Golden unit / 3.22V DC</li> <li>➤ ST24703 / 3.28V DC</li> </ul> <p>Once placed in their beacon, and immediately after the 5 minutes test in tank a new voltage measurement was made (measured unconnected):</p> <ul style="list-style-type: none"> <li>➤ Golden unit / 3.1V DC</li> <li>➤ ST24703 / <b>2.7V DC</b></li> </ul> <hr/>	Frequency:	37.3 KHz	Pulse duration:	9.7 ms	Pulse rate:	1.07s	Pulse level:	0.9 Vpp	Frequency:	<b>36.2 KHz</b>	Pulse duration:	9.7 ms	Pulse rate:	1.1s	Pulse level:	<b>0.01 Vpp</b>

Frequency:	37.3 KHz																
Pulse duration:	9.7 ms																
Pulse rate:	1.07s																
Pulse level:	0.9 Vpp																
Frequency:	<b>36.2 KHz</b>																
Pulse duration:	9.7 ms																
Pulse rate:	1.1s																
Pulse level:	<b>0.01 Vpp</b>																
<p><b>Electrical measurements of the battery were made</b></p>	<p>Measure of the current load using a direct power (3V DC sets) supplying the unit.</p> <p>Value measured:</p> <ul style="list-style-type: none"> <li>➤ Golden unit / Hydrostat-contact OFF / 0mA</li> <li>➤ Golden unit / Hydrostat-contact ON / 280mA</li> <li>➤ ST24703 / Hydrostat-contact OFF / 0mA</li> <li>➤ ST24703 / Hydrostat-contact ON / <b>350mA</b></li> </ul> <hr/>																
<p><b>Electrical measurement with direct power</b></p>	<p>In order to complete the test the battery was removed and a resistance check performed through the hydrostatic contact.</p> <p>Resistance value was:</p> <ul style="list-style-type: none"> <li>➤ Golden unit / 950 Kohms</li> <li>➤ ST24703 / 950 Kohms</li> </ul>

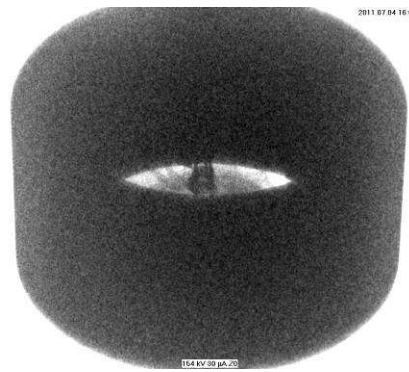
Piezo-ring view

The X-Ray inspection didn't revealed any noticeable damage to the piezoelectric ring.
