Collision with high ground in cruise in unfavourable meteorological conditions

Aircraft	Piper PA-39 "Twin Comanche" registered G-AYZE
Date and time	Friday 17 June 2011 at around 11 h 15 ⁽¹⁾
Operator	Private
Place	Peille (France)
Consequences and damage	Pilot and passenger killed, aeroplane destroyed

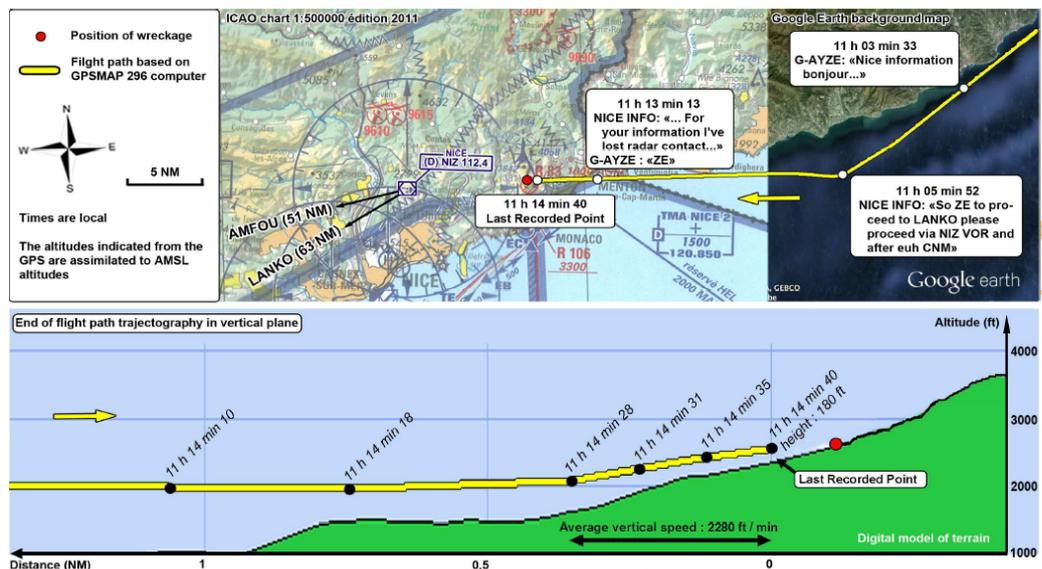
Flight Path

Readout of a GPS found on board made it possible to reconstitute the following flight path:
