**Deviation below manoeuvring airspeed on final, go-around,
triggering of Alpha Floor protection**

Aircraft	Airbus A320-214 registered F-HEPE
Date and time	3 April 2012 at 12 h 56 ⁽¹⁾
Operator	Air France
Place	Tel Aviv Ben Gurion Airport (Israel)
Type of flight	Scheduled public passenger transport
Persons on board	captain (PNF), copilot (PF), 4 cabin crew and 149 passengers
Consequences and damage	None

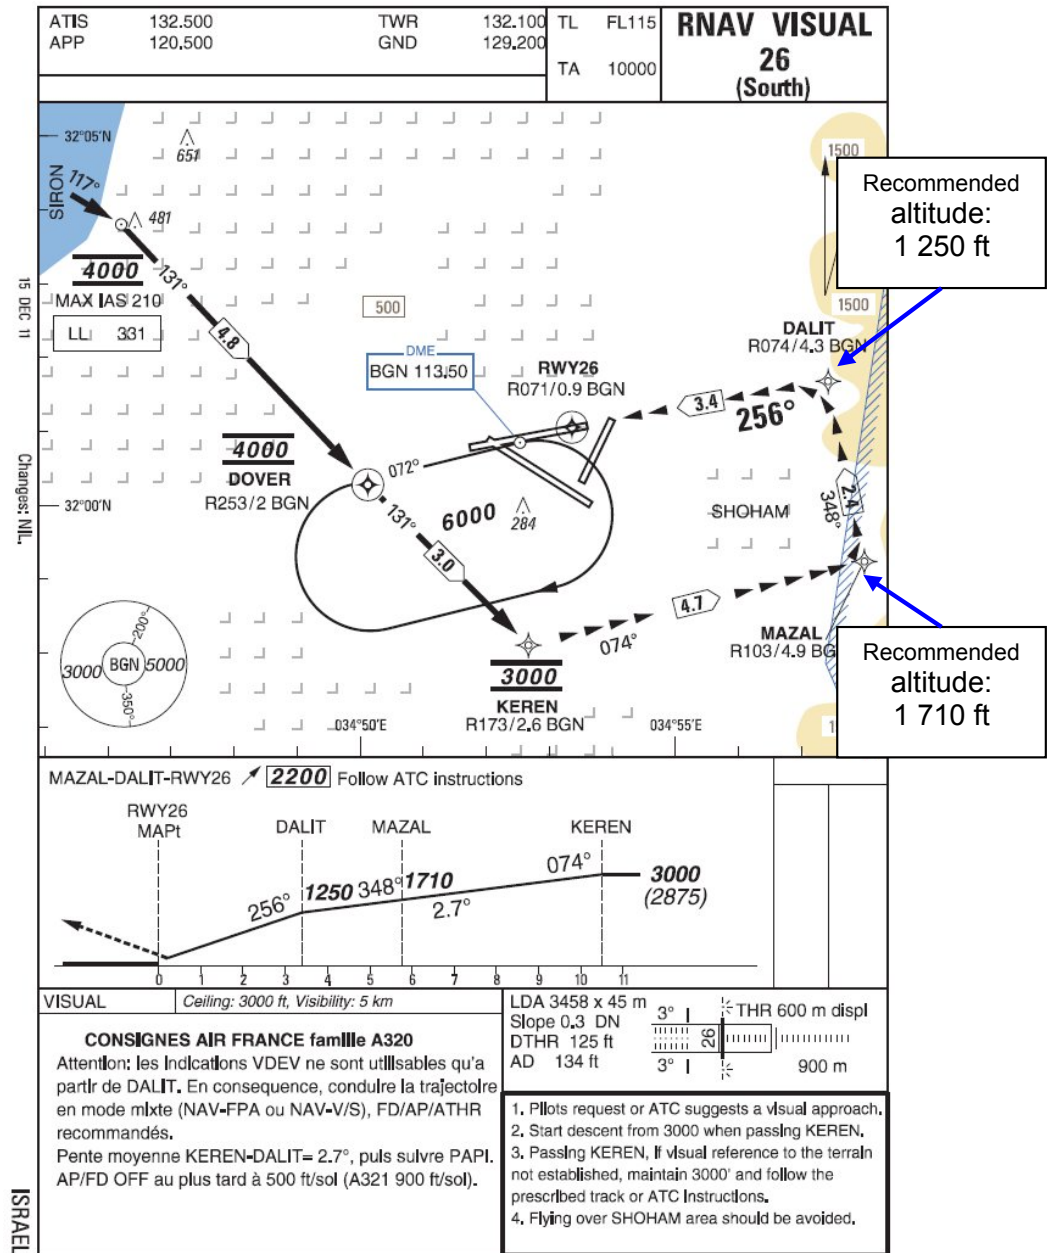
Air France approach chart for the RNAV VISUAL procedure on runway 26 from the south
valid on the date of the event

*Attention : les indications VDEV⁽⁶⁾ ne sont utilisables qu'à partir de DALIT. En conséquence, conduire la trajectoire en mode mixte (NAV-FPA ou NAV-V/S), FD/AP/ATHR recommandés.
Pente moyenne KEREN-DALIT=2,7°, puis suivre PAPI. AP/FD OFF au plus tard à 500 ft/sol.*

On A320 family aeroplanes, it is technically impossible to code several descent paths in the FMS. Air France did not wish to code a continuous descent path from KEREN to avoid possible GPWS warnings. The airline chose to code the profile only from DALIT, which explains why the VDEV was not usable before this point.

Air France therefore recommends descending on the KEREN – DALIT segment in NAV-FPA mode with a slope of -2.7° or in V/S mode. These modes combine in fact with the A/THR SPEED mode which maintains a target speed.

The operator's procedures given on the Tel Aviv RNAV VISUAL 26 approach chart recommend carrying out the approach in vertical NAV-FPA or NAV-V/S mode. In these modes, the A/THR adjusts the thrust in order to maintain the target speed.

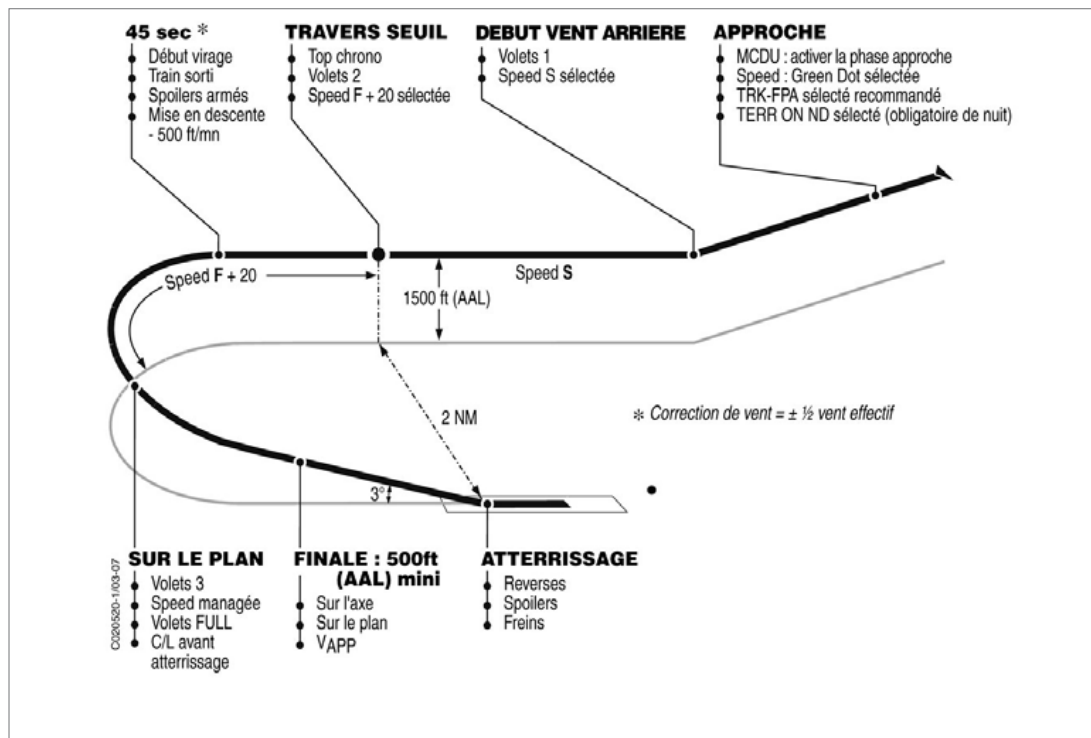
Feeling "too high, too fast", the PF configured the aeroplane very early at the end of the downwind leg in FULL configuration with landing gear extended.

The standard visual approach procedure recommended by Air France and the manufacturer provides for changing to configuration 3 then FULL once established on the glide path, just before lining up on final.

Standard visual approach procedure recommended by Air France on the day of the event
