## **SYNOPSIS, HISTORY OF FLIGHT AND ORGANISATION OF THE INVESTIGATION**

Date of accident: Thursday 27 November 2008 at 15 h 46 UTC

Aircraft: Airbus A320 – 232 MSN 2500 registered D-AXLA

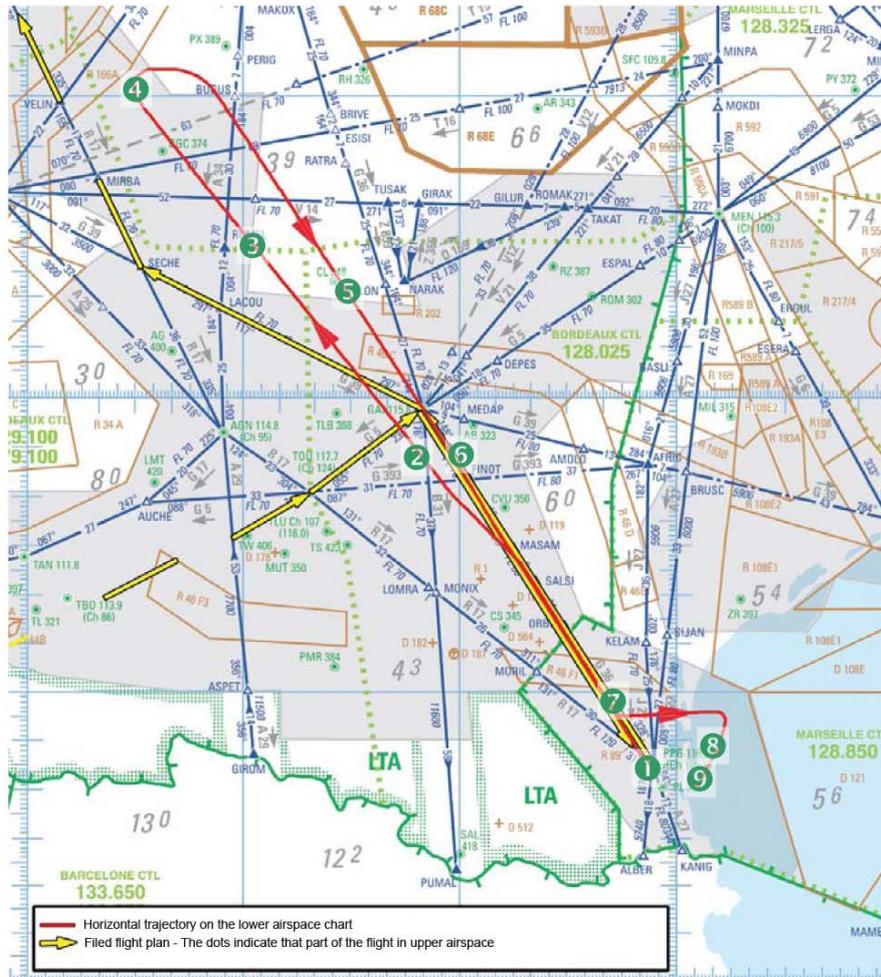
- ① 14 h 44  
Takeoff from Perpignan aerodrome
- ② 14 h 52  
The controller told the crew that they could not perform a “360”
- ③ Between 15 h 04 et 15 h 06  
Blockage of angle of attack sensors 1 and 2
- ④ 15 h 12  
Turn back
- ⑤ 15 h 22  
Arrival at FL 390
- ⑥ 15 h 26  
Beginning of descent
- ⑦ 15 h 34 min 34 s  
Co-pilot: “(...) we’ll appreciate a radar vector the approach”
- ⑧ 15 h 43 min 41 s  
Thrust levers on IDLE  
Beginning of the check on the low speed angle of attack protections
- ⑨ 15 h 45 min 05 s  
Stall warning
