Safety Investigation Following the Accident on 1ST June 2009 to the Airbus A300-203, Flight AF 447

Summary

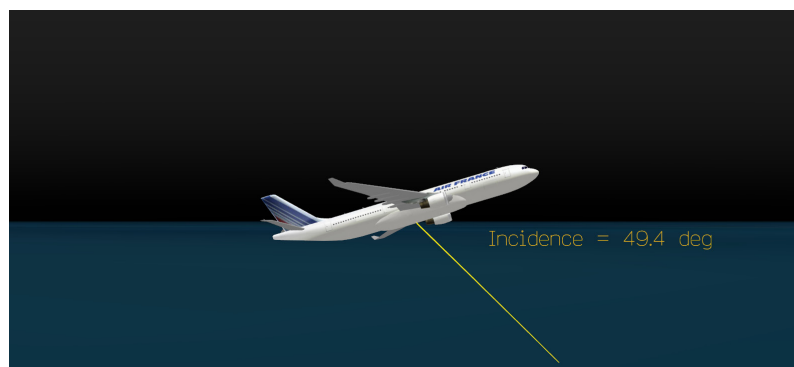
- The aeroplane was intact at the moment of impact;
- It struck the surface of the water with a positive pitch-up attitude, slight bank and a high vertical speed;
- No preparation had been made for ditching;
- No depressurisation had occurred;
- An inconsistency in the measured speeds had occurred shortly after 2 h 10;
- This inconsistency had led to the loss of some automated systems;
- The accident had occurred between 2 h 14 min 26 min and 2 h 15 14.

Aeroplane attitude in the final seconds of flight
