FINAL REPORT

the ACCIDENT of the FALCON 900B

registered SX-ECH,

- 14 September 1999 -

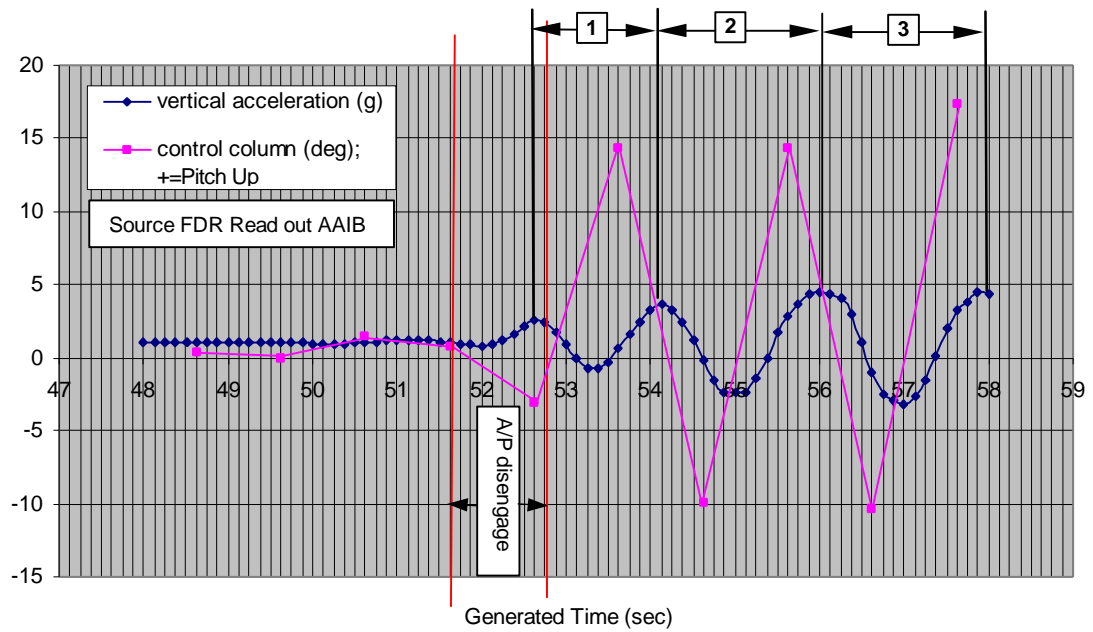
Figure: Oscillations 1-10

- the control column inputs were anti-phase with aircraft oscillations
-

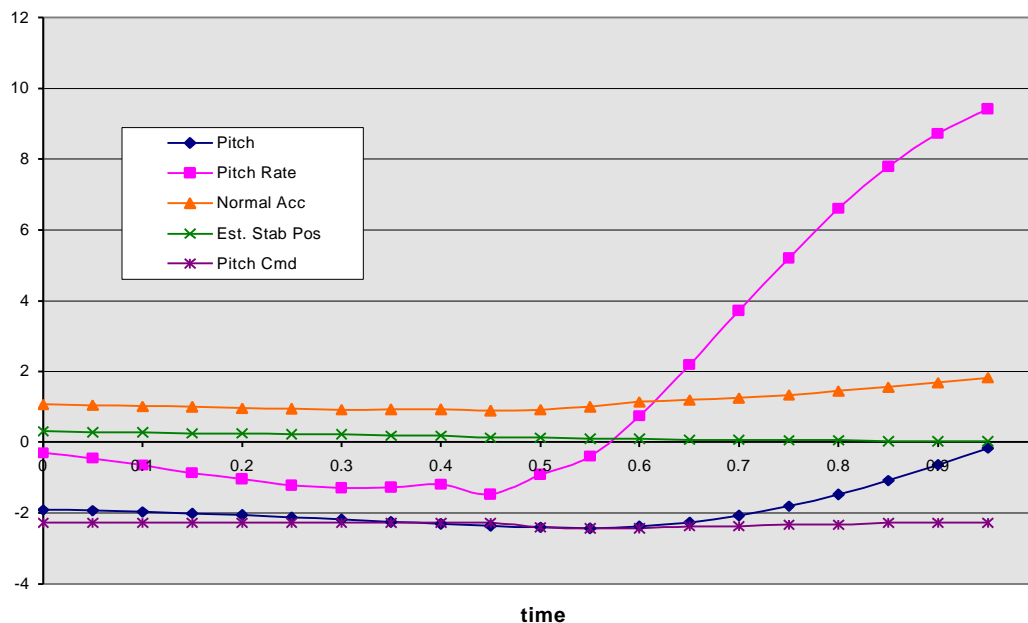
Figure 2: FGC2 Pitch Parameters

Figure 2 shows the pitch related parameters recorded from the A processor data in FGC2.

Examination of the discrete data recorded by FGC2 shows that it disengaged approximately only 0.5 seconds after FGC1. Consequently there is approximately a 0.5 seconds overlap between the data.

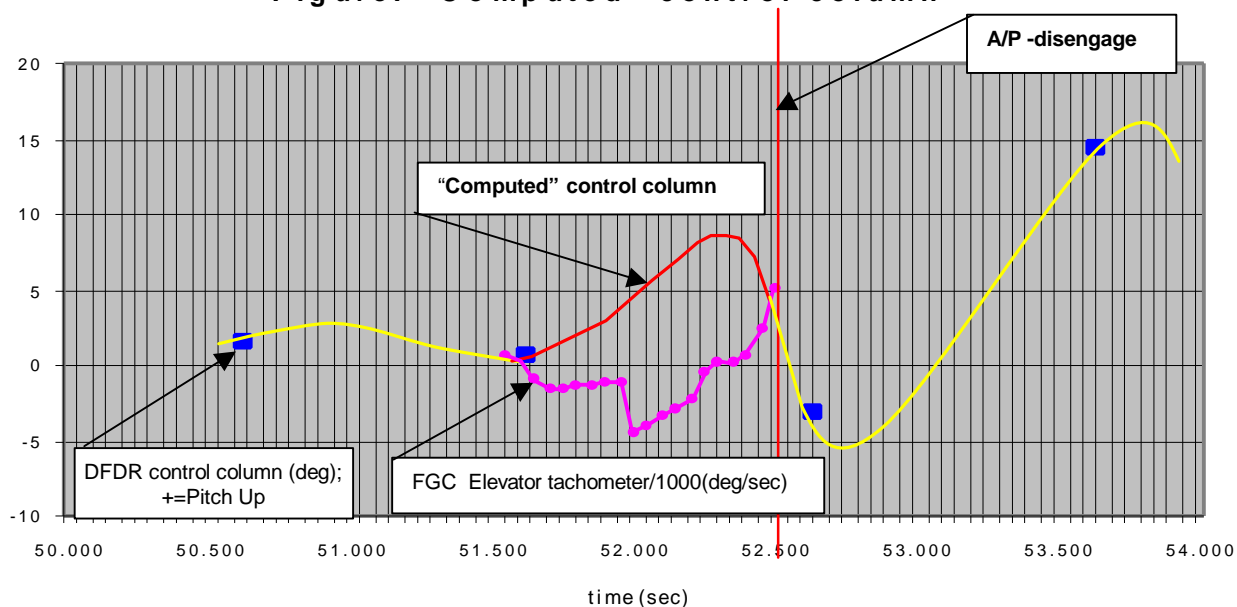
Figure: "Computed" control column

During the A/P disconnection phase the normal acceleration data (nose up 2.5g) recorded by the DFDR and FGC, can not be explained by the recorded control column and stabilizer (nose down) data. There, some control column inputs (nose up) are missing due to DFDR recorded rate (1 record/second).

Based on the elevator tachometer data recorded by FGC which indicates how fast the elevator control moves, was computed BY INTEGRATION the control column inputs. The “computed” control column inputs confirmed the results from simulation work. The figure "Computed control column" show how should be complemented the DFDR data.

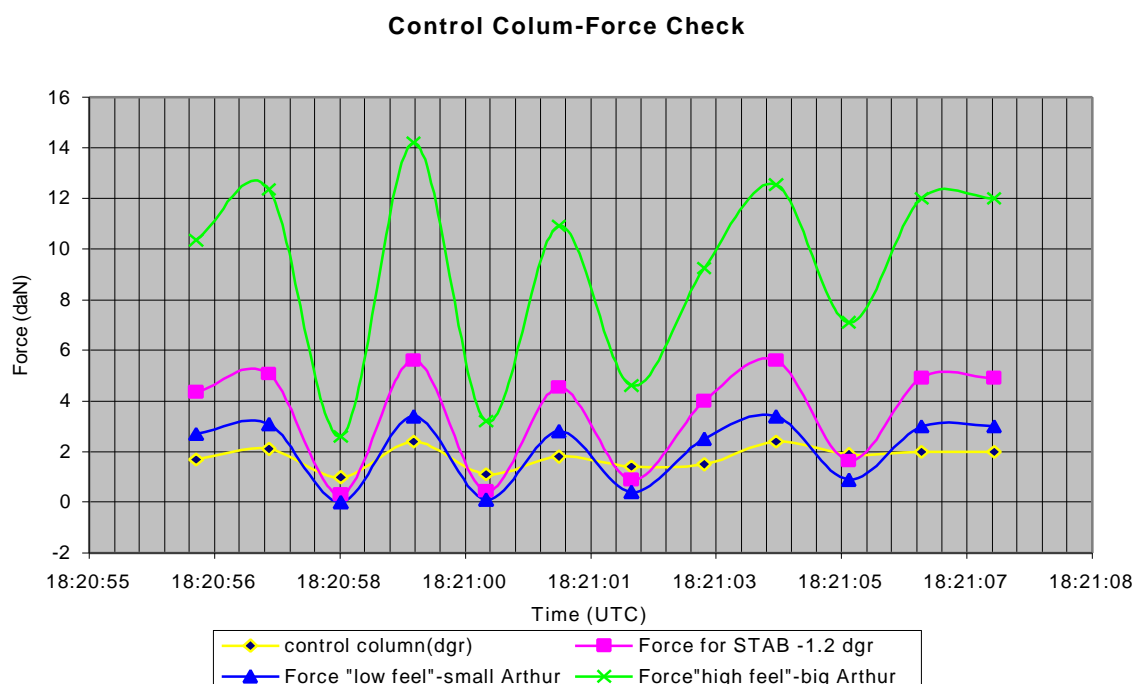
The red line shown in the same next figure, represents the forces corresponding to the NORMAL operation of the Arthur Unit for STAB position – 1,2⁰ reached when the forces on the control column were checked.

The green line represents the theoretical forces, for highest feel, when STAB position reaches +1,25⁰.

On the above mentioned conditions, the PIC was not able to determine that the Arthur unit had failed in “low speed” position.

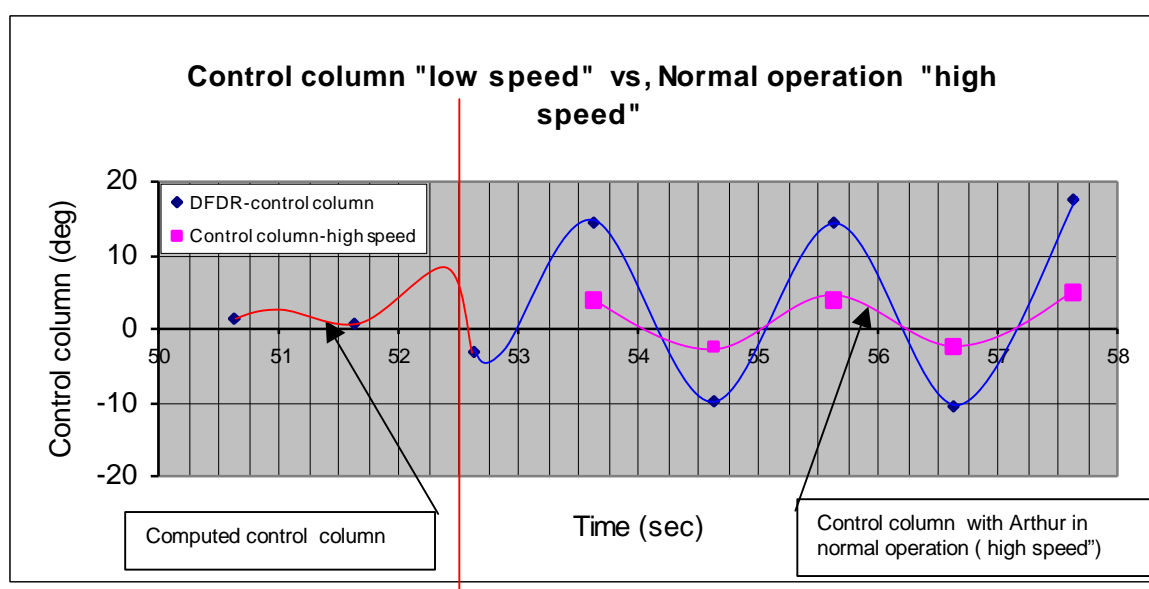
Based on the flight data, during the first oscillation, the PIC was able to move the elevator from -3° to 14 ° (max. speed movement of 17 deg./sec). For this deflection, according to Certification Report Q801 provided by Dassault Aviation, the maximum force applied by PIC on control column was 12 daN.

At the same force, in case with Arthur servo operating normally (high-speed for STAB position 0.16), the PIC should be able to deflect the elevator only to 4 deg NOSE-UP. Similarly, it can be determined the control column movement in the case of PITCH FEEL operating normally (“high speed”) and the PIC had had the same behaviour, as shown in the next figure.

Since, elevator movement angle should have been four time smaller, it is reasonable to conclude that, with PITCH FEEL in normal operation, (function in “high speed” mode), PIC’s possibility to induce oscillations should have been reduced.
