*Accident  
on 25 July 2000  
at "La Patte d'Oie"  
in Gonesse (95)  
to the Concorde  
registered F-BTSC  
operated by Air France*

**Interim report (10/07/2001)**  
**f-sc000725ae2**

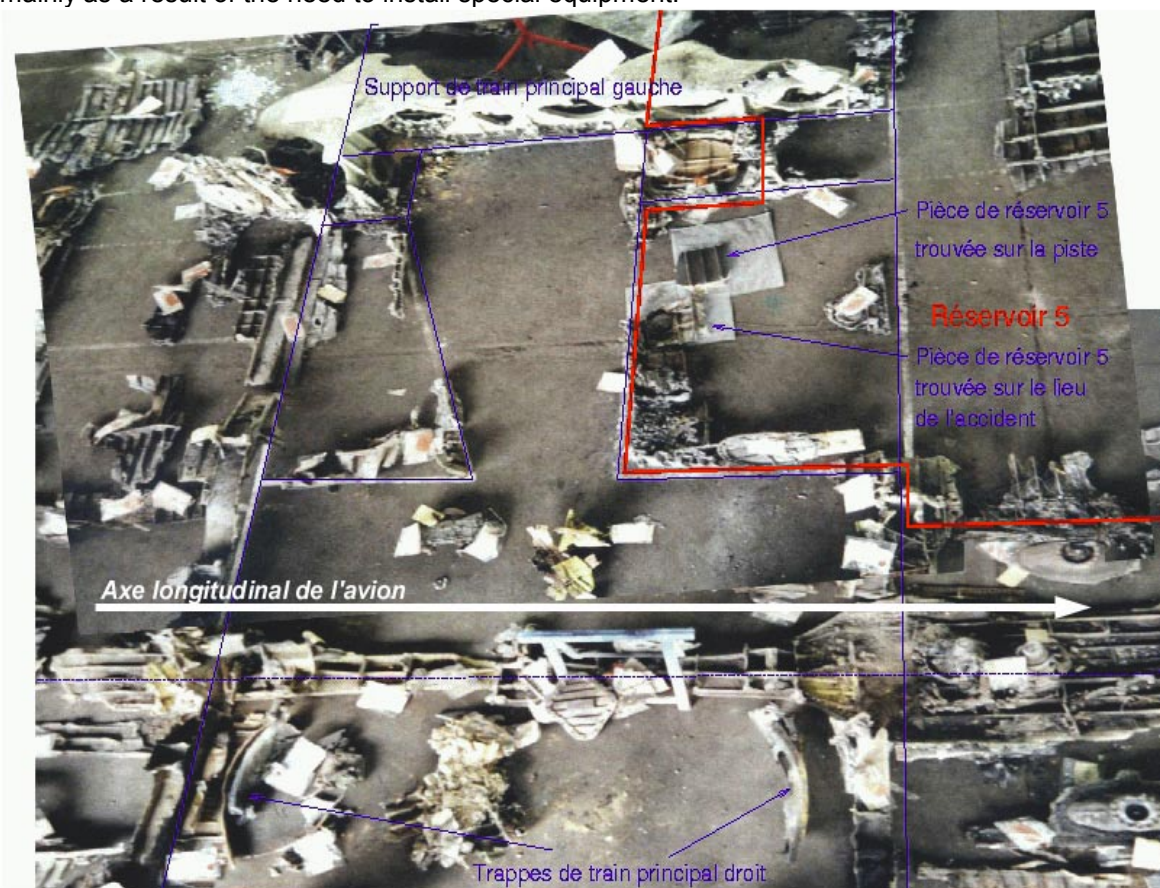
The parts found at the accident site were sorted according to geometrical criteria, so as to create groups of pieces before identifying and positioning them. The pieces of the wing were laid flat on two areas representing the upper and lower wing surfaces. The condition of the wreckage did not, however, allow much useful information to be gleaned for the investigation.

Figure 13: View of the wing reconstruction in the hangar

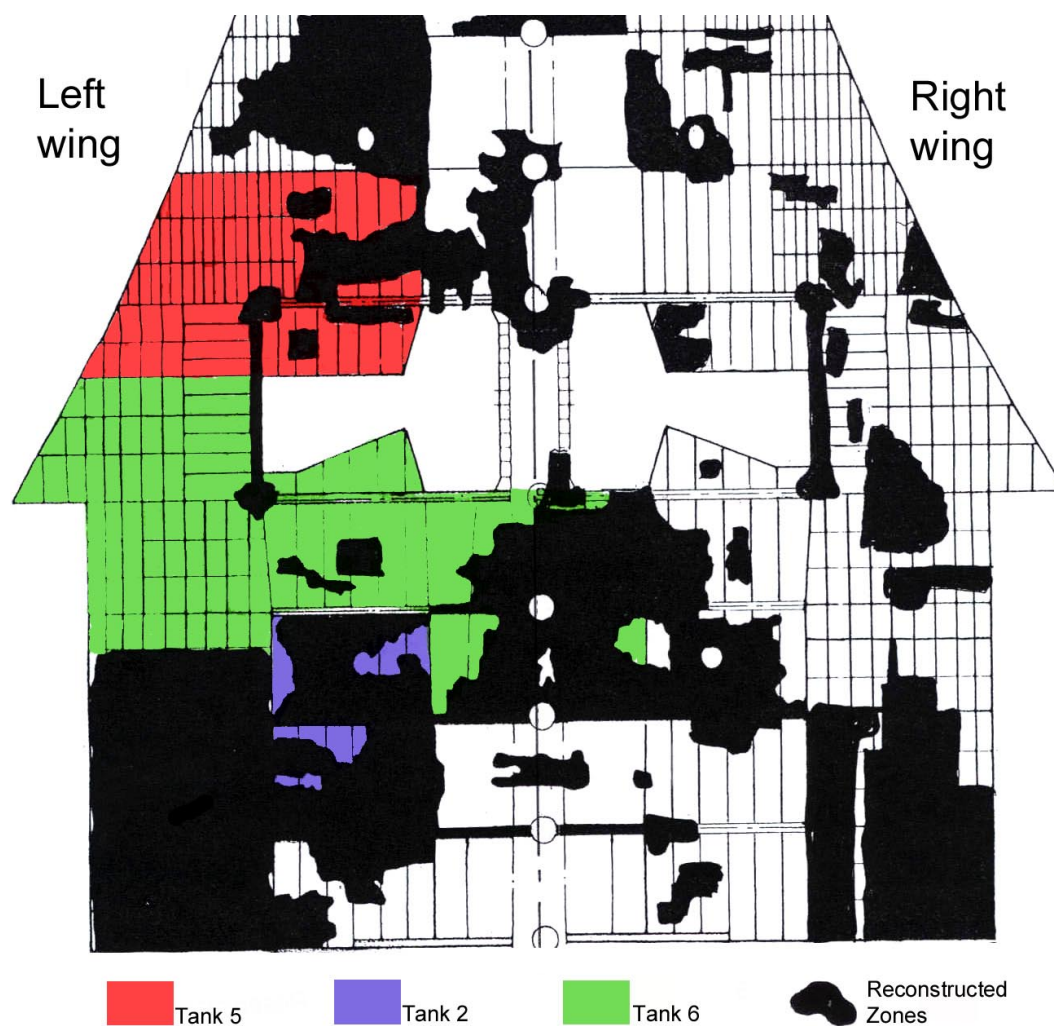
It was impossible to reconstruct the surfaces located near the landing gear well, nor the majority of the right wing.

Figure 14: Computerised representation of the upper wing

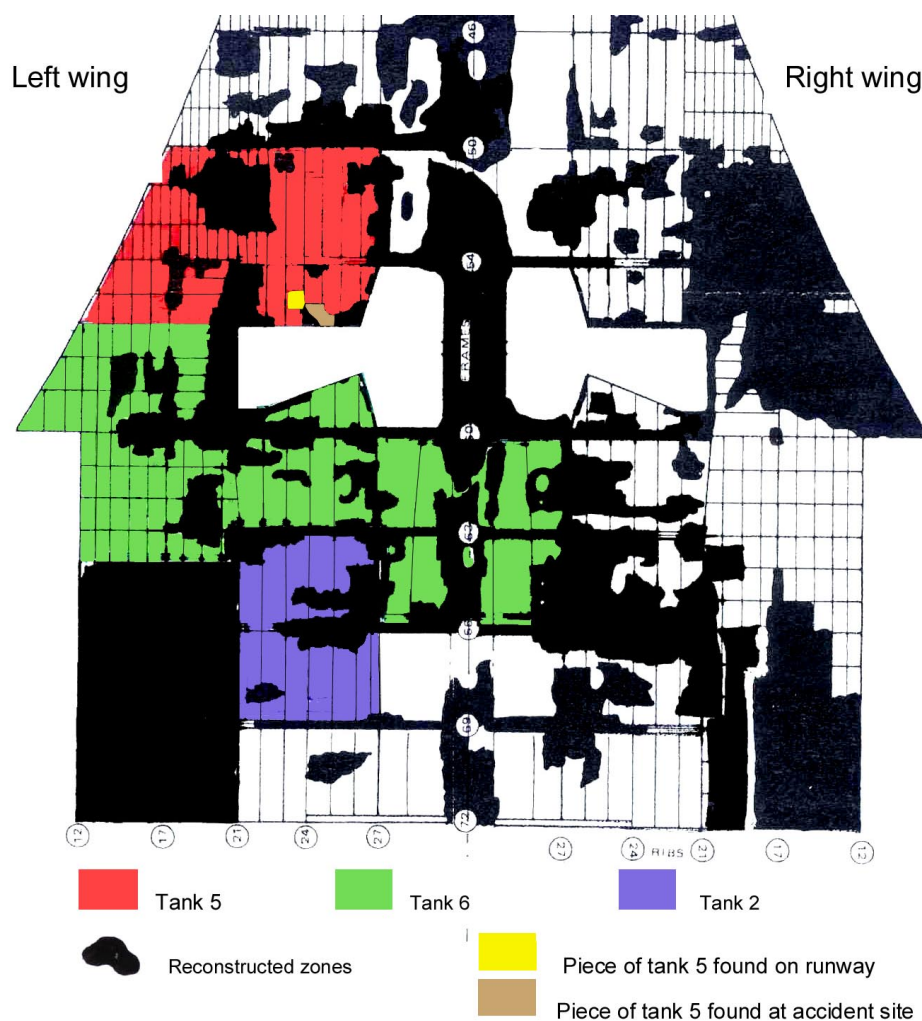
Almost nothing from tank 5 was recovered. Only one part of the edge of the landing gear well and two sensor locations were still visible near the location of the piece found on the runway.

Figure 15: Computerised representation of the lower wing

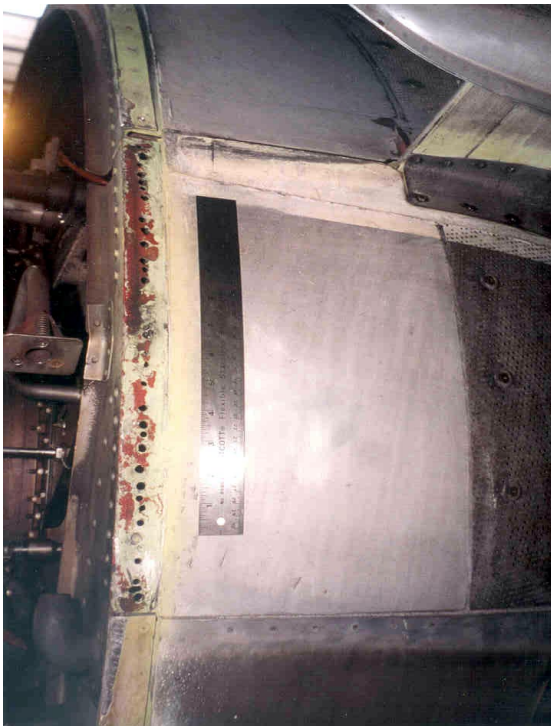
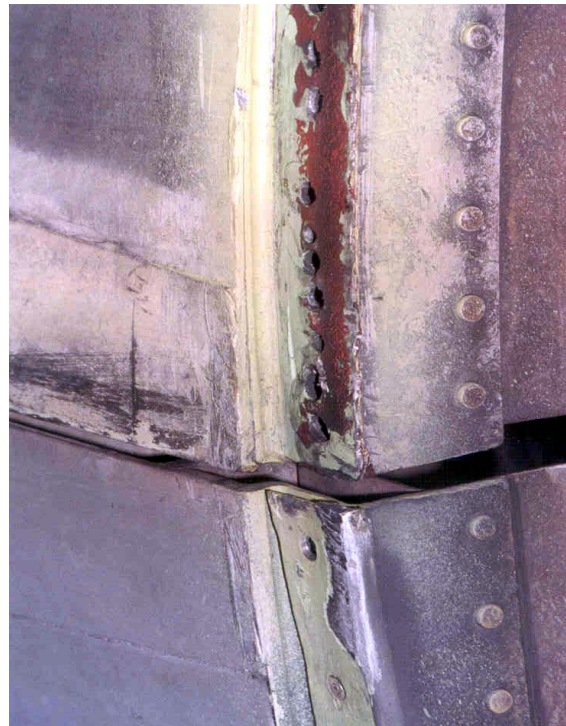
- the lower left wear strip, about forty-four centimetres long, was missing. When closed, the forward part of the core door usually rests on the wear strip,
- the support was painted with green epoxy primer,
- in the position where the missing part would be, the support was covered in red type RTV 106 mastic
- there was no trace of RTV 106 on the other parts of the support,
- there was no trace of RTV 106 on the wear strips which are in place,
- there were numerous paint runs on the support and on the wear strips and the paint partially overlapped onto the fan reverser cowl,
- in the position of the missing part, the support still possessed several rivets,
- the support was drilled with thirty-seven holes, of which some had gaps between them that were less than twice the diameter of the holes.

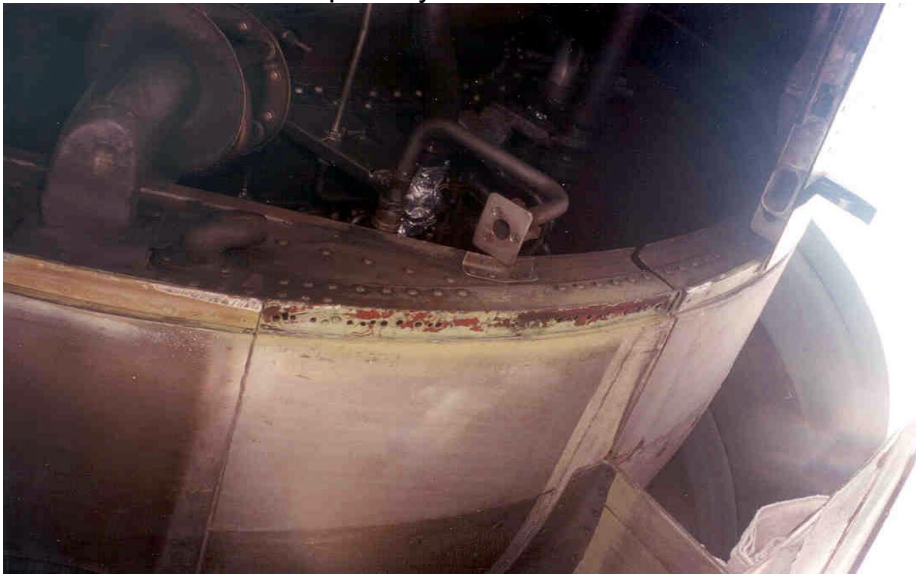
Figure 20

- the right wear strips appeared to be original parts made of stainless steel (angled section at the tip),
- the left wear strips had been replaced, and did not appear to be original parts,
- spacing between rivets on the wear strips in place and their alignment appeared to be correct,

- the level of wear on the strip adjacent to the missing strip had clearly exceeded the tolerances accepted by the manufacturer.

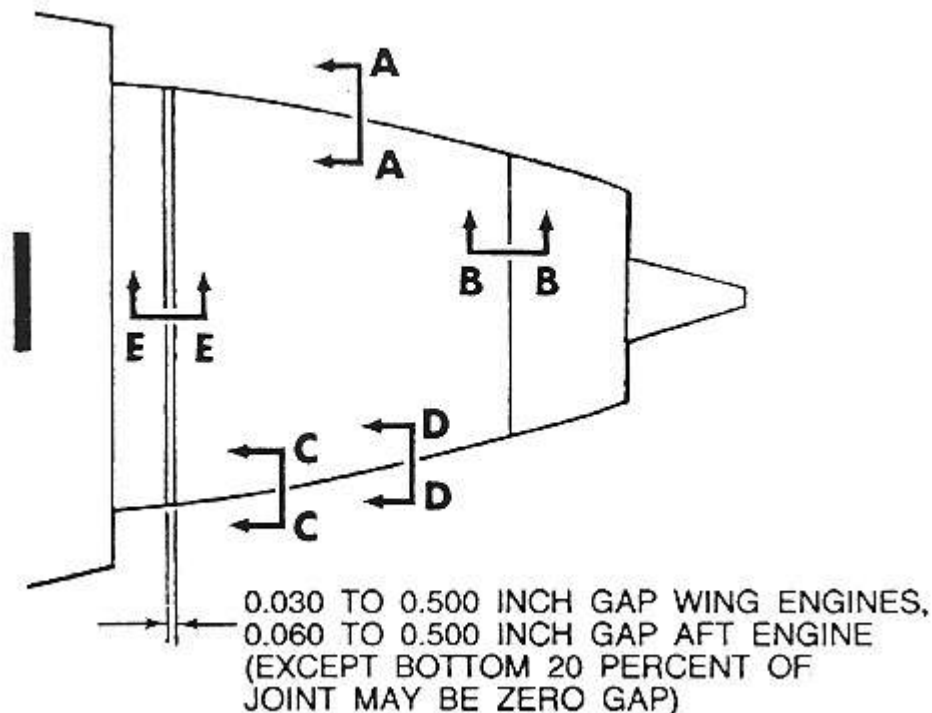
Figure 21: Play between the core door and the fan reverser cowl

During the investigation, it was noticeable on various aircraft that the play measured with engines stopped could exceed these values without touching the width of the wear strip. However, with the engine running, particularly when under takeoff thrust, the pressure inside the cowls is very high. Their deformation may then allow loss of a wear strip no longer attached to its support.

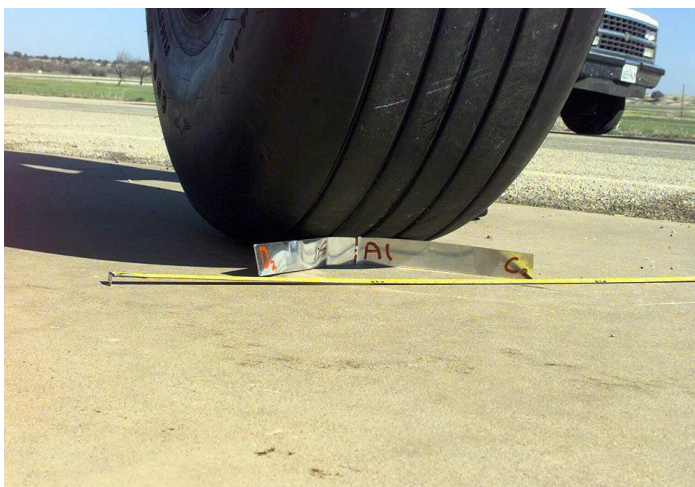
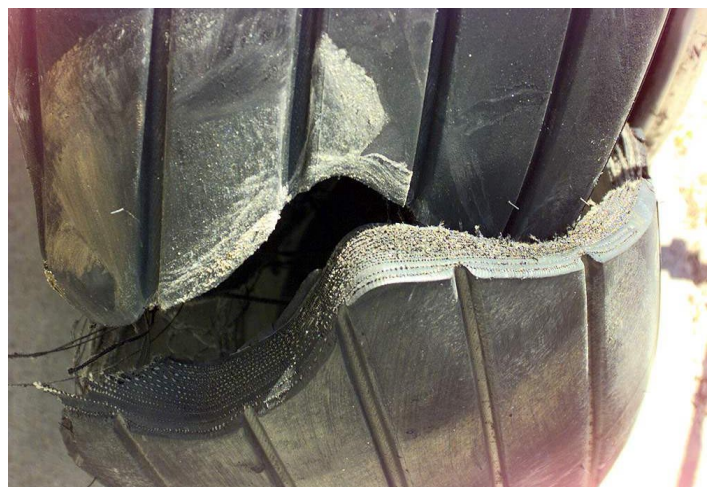
- an initial positioning of the strip, done with the titanium strip, resulted in its being flattened by the tyre,
- in a second position, the strip remained stable on its cutting side and the tyre was cut into,
- the tyre cut went right through its thickness, practically all across the width of the area in contact with the ground and in accordance with the shape of the strip,

- this cut continued onto the tyre shoulders and sidewalls through a static rupture in the direction of the reinforcing material of the tyre body,
- the static ripping spread as far as the tyre beads, in other words slightly more deeply than the ripping noted on the remains of tyre n° 2 on Concorde.

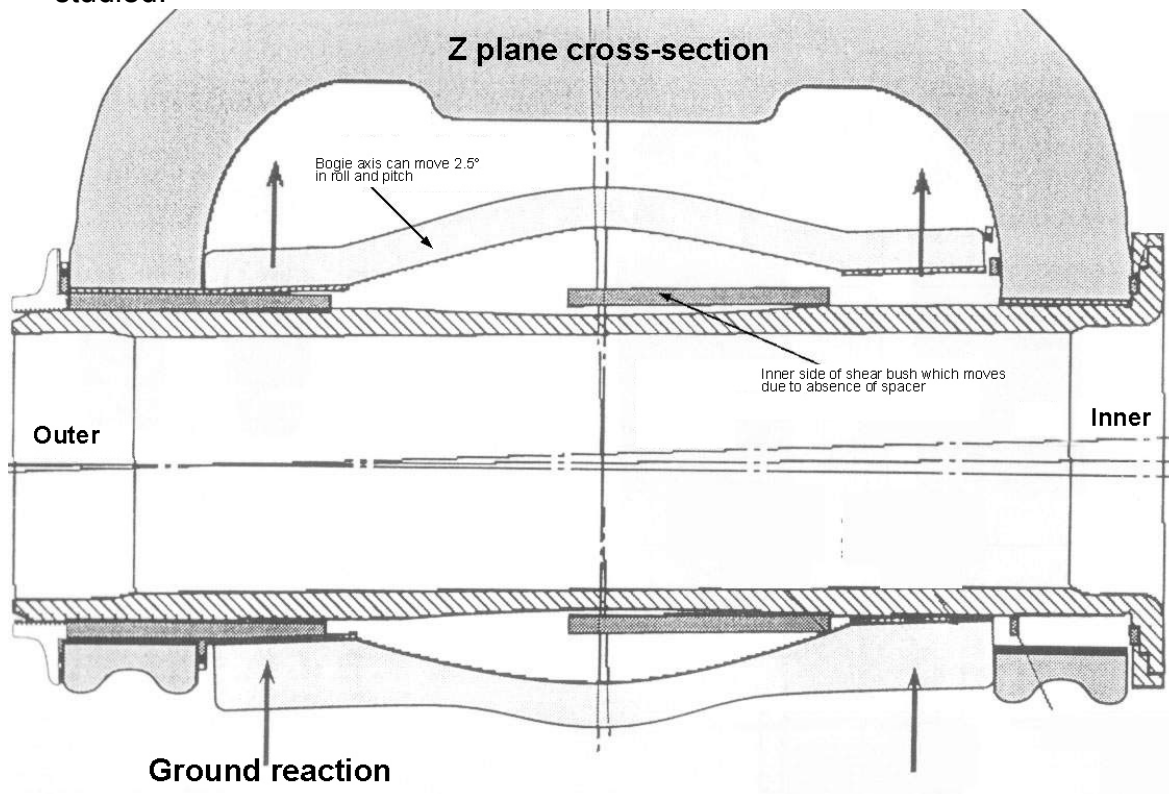
Figure 26 : Landing gear without spacer

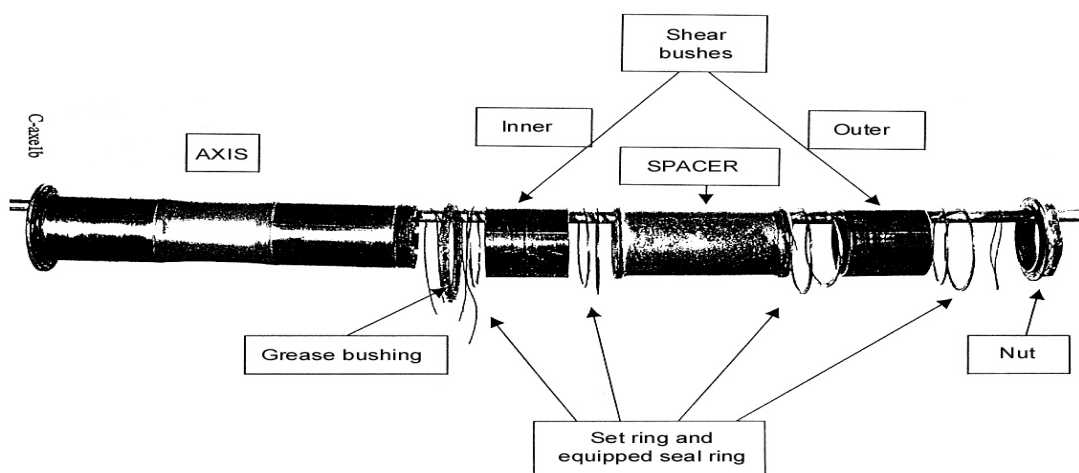
During reinstallation, the shear bushes were positioned directly in their receptacle on the drum, before the axle was reinstalled. This made it impossible to detect the absence of the spacer on the new bogie.

Figure 27 : Right landing gear: bogie beam fittings

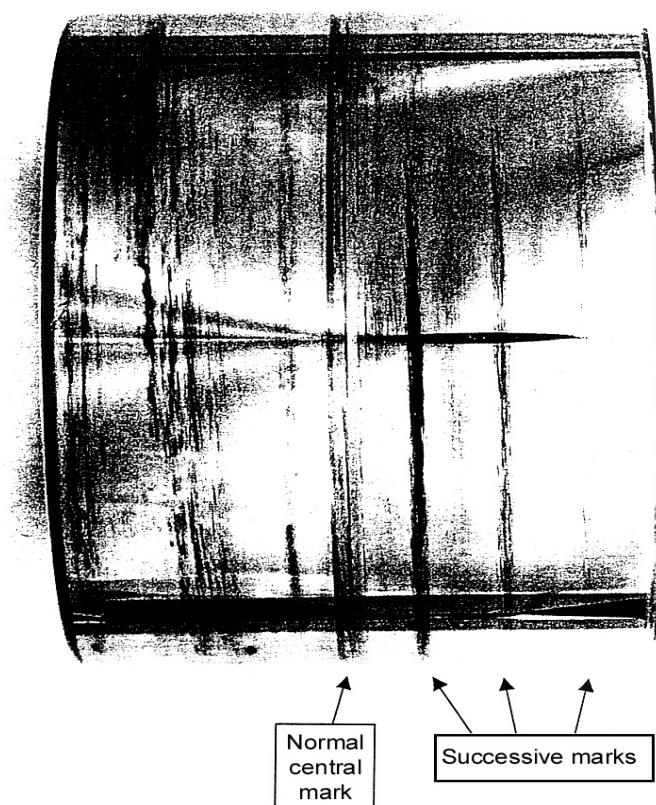
The exact chronology of this displacement is, however, difficult to determine since the bush was not new and certainly bore marks related to its previous usage. The only marks observed on the mechanical parts correspond to movements in the vertical plane alone or to normal oscillations of the bogie.

*Figure 28: Left landing gear: inner shear bush*

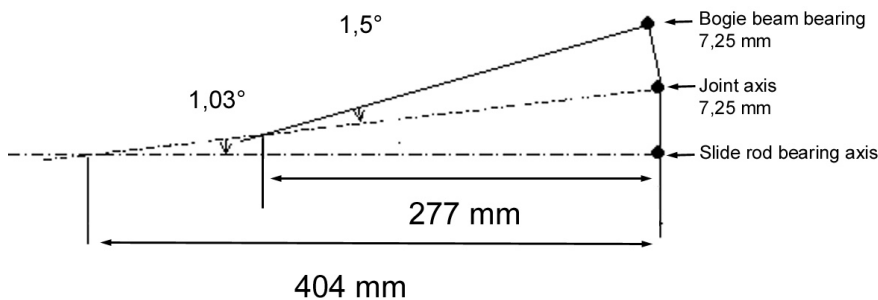
Maximum displacement of the geometrical axis of the bogie beam results from the combination of the two movements described above, which corresponds to 14.5 mm at the radius, thus a cone angle at the apex of  $5^\circ$ , the tip of the cone being located at the centre of the outer bearing.

Figure 29: Effect of the absence of the shear bush on bogie geometry
