## Stick Shaker Activation during Rotation

<b>Airplane</b>	Boeing 737-300 registered F-GIXD
<b>Date and time</b>	10 January 2011 at around 12 h 30 UTC <sup>(1)</sup>
<b>Operator</b>	Europe Airpost
<b>Site of accident</b>	Montpellier Méditerranée aerodrome (34)
<b>Type of flight</b>	Ferry flight
<b>Persons on board</b>	Captain (PF); Co-pilot (PNF)
<b>Consequences and damage</b>	None

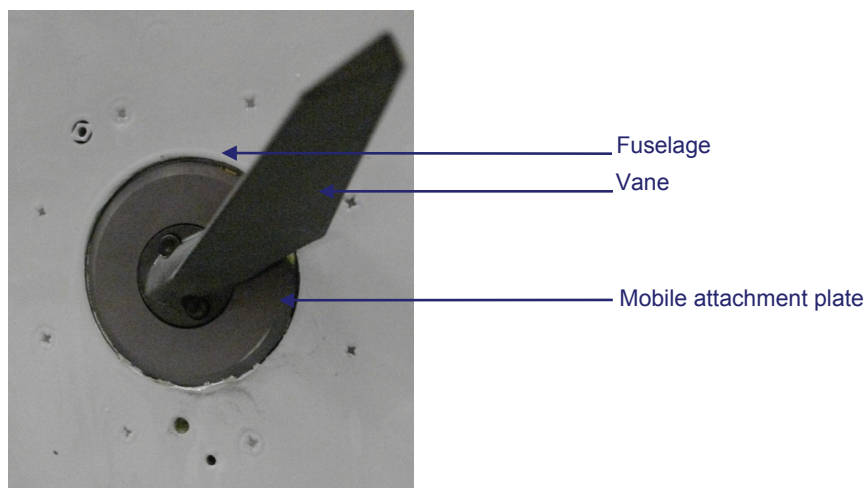
Left AOA sensor

Examination of the left AOA sensor revealed the presence of several layers of paint on the base of the mobile part, the attachment plate and the seal between the attachment plate and the aeroplane. In some places, up to three coats of paint were identified: yellow - white - yellow.

Photo taken at the time of the reception inspection before the second painting operations

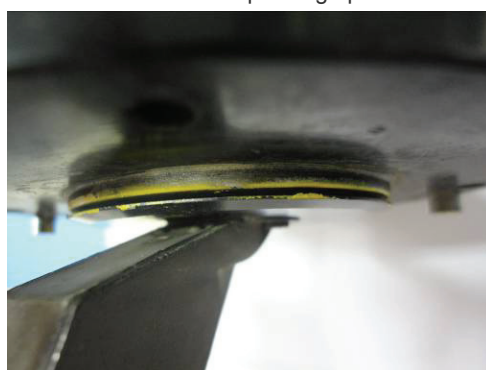
AOA sensor  
Photo taken during examinations

The blocking of the AOA sensor is most likely due to the presence of white paint between the base of the mobile part, the fuselage and the attachment plate.

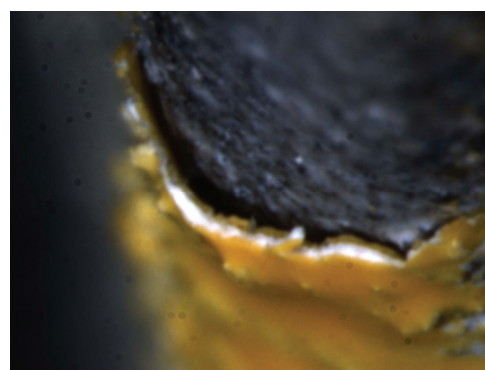
Different layers of paint

These layers of paint seem to result from different painting operations performed on the aeroplane: previous yellow paint, white paint added in Montpellier, yellow paint added in Toulouse.
