# Report

Accident on **4 July 2012**  
at **Franqueville Saint-Pierre (76)**  
to the **Piper Aircraft PA-34-220T Seneca III**  
registered **D-GABE**  
operated by **Pixair Survey**

## Fuel starvation on final, collision with the ground during a radio relay flight

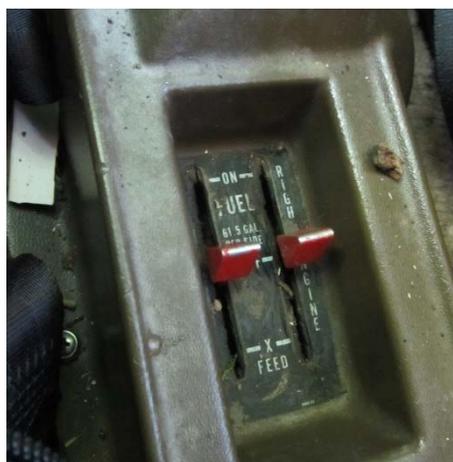
Figure 1 - Fuel selectors on D-GABE

If necessary, the selectors can be placed in the « CROSS FEED » position, which makes it possible to supply an engine with fuel from the opposite-side tank. The selection of the « CROSS FEED » position is only mentioned in the flight manual in case of an engine failure. This selection allows the engine to operate with fuel from both tanks. The logic of the fuel return is not modified in the « CROSS FEED » position.

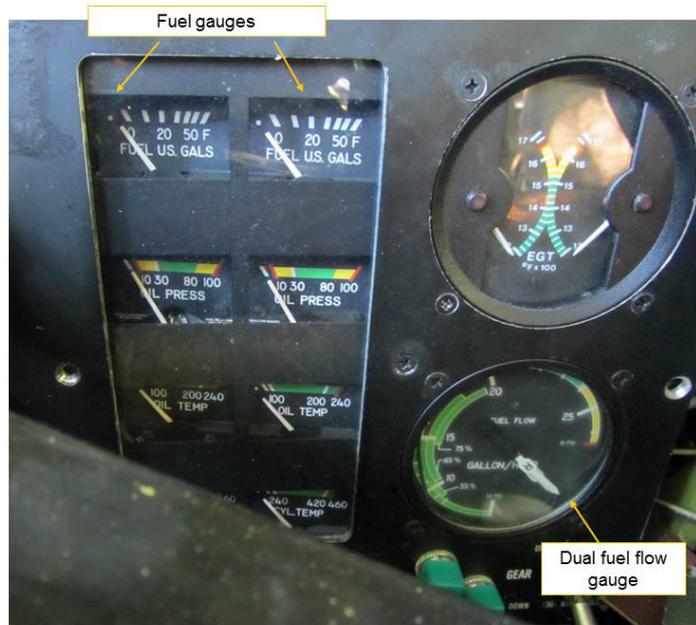
The aeroplane was equipped with an instant fuel flow indicator with needles and a fuel level indicator for each of the tanks. There was no low fuel level indicator.

Figure 2 - Photograph of the fuel indicators on D-GABE taken after the accident

The distortion of the propellers and the marks on the vegetation showed that neither of the engines was delivering power during the impact. Observation of the engines, in particular of the filters and of the pumps, showed an absence of fuel in the engines. The right wing tank contained no fuel but the left wing tank contained about 13 USG.

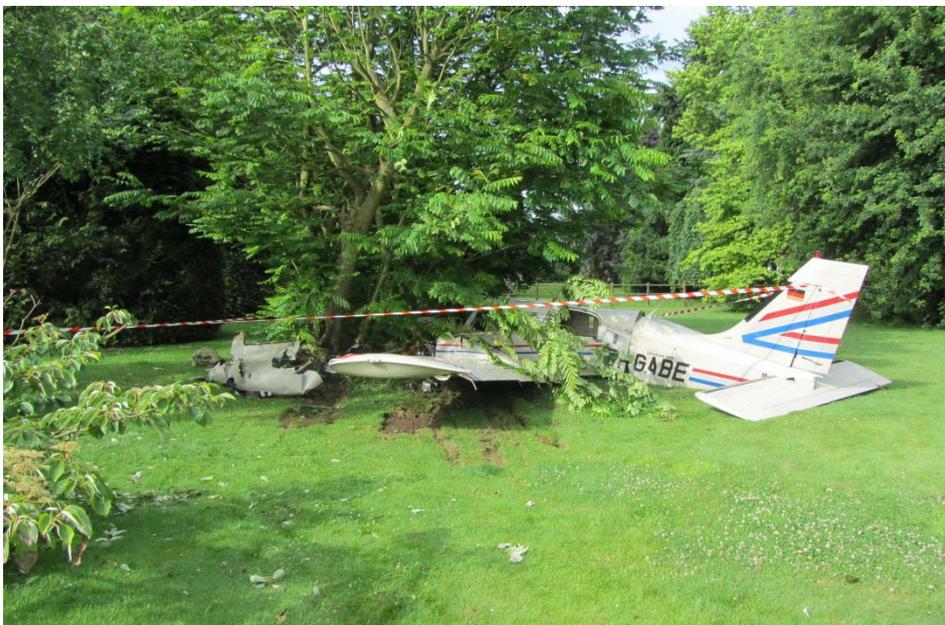
The accident occurred near a dwelling in a landscaped garden with an area of about 1 000 m<sup>2</sup>. The aeroplane arrived with the wings almost horizontal and a steep descent slope. The left engine struck a rock located in front of the trees. The aeroplane pivoted to the left and came to a stop in the trees. The cockpit passed between the trunks and did not suffer high impact.

Figure 5 – Photo taken in the direction of the impact trajectory
