## Strong turbulence in cruise, momentary loss of control of the flight path by the crew

| <b>Aircraft</b> | Airbus A330-200 registered F-GZCG |
| <b>Date and time</b> | 27 February 2012 at 00 h 48 <sup>(1)</sup> |
| <b>Operator</b> | Air France |

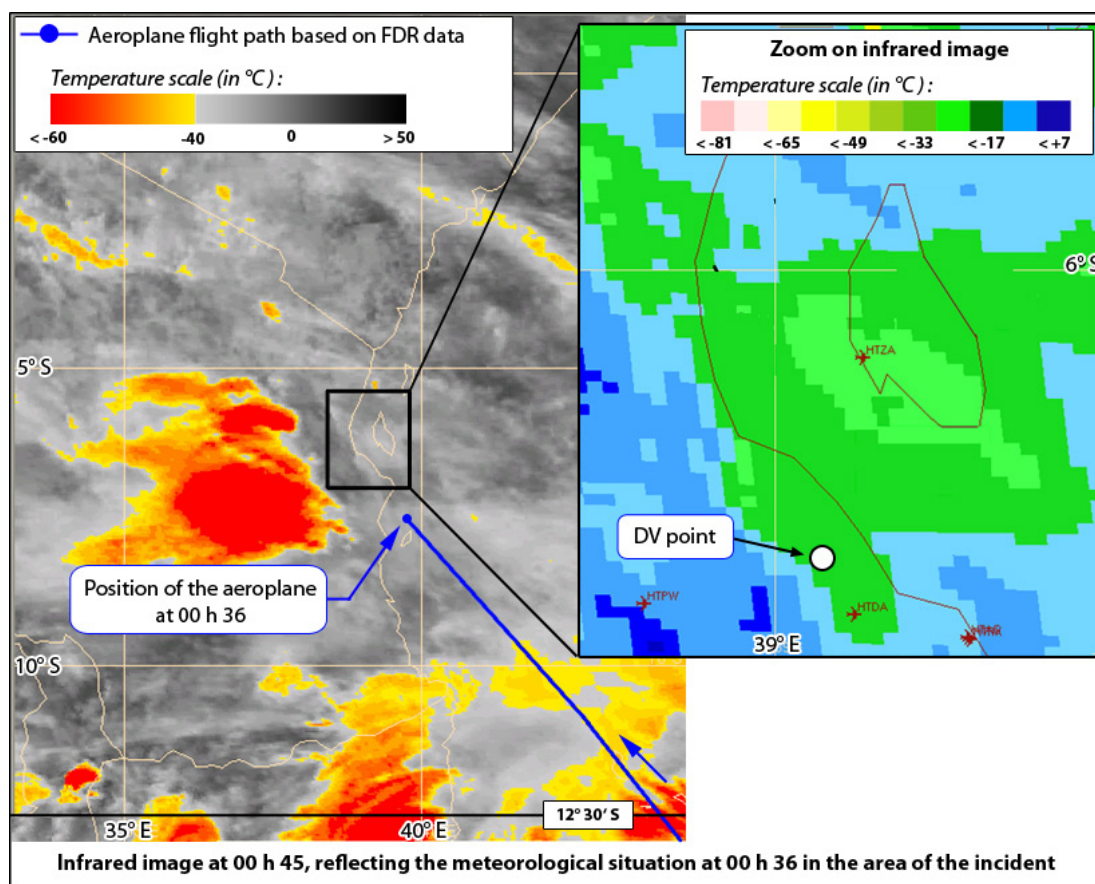
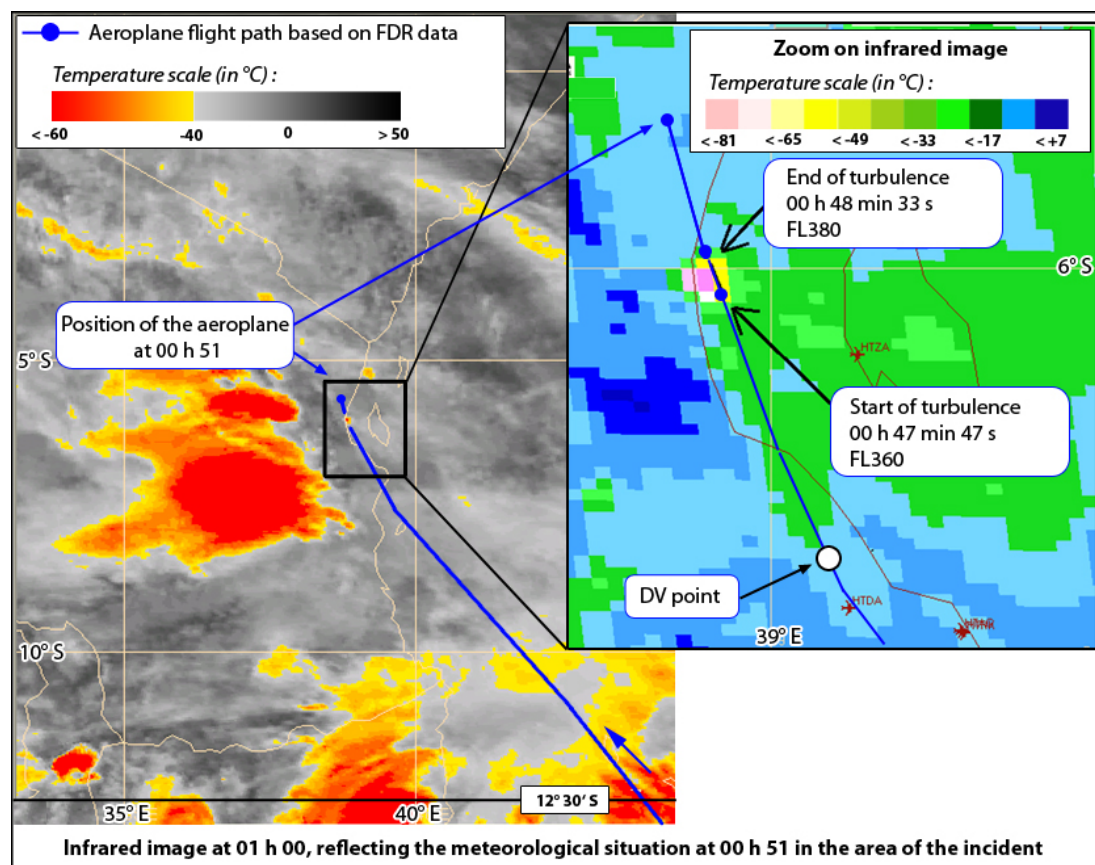
Figure 2: IR images and position of the aeroplane

On the image corresponding to the situation at 00 h 36, there is cloud cover whose top is located around FL280/300 (dark green). The cell was probably building up, but still undetectable by radar at that time. On the image corresponding to the situation at 00 h 36, cloud tops can be observed between FL360 and FL450 (pink dots). For this reason, the relatively small convective cell is not visible on the image at 00 h 45 but is easily detectable on the image at 01 h 00.

It is therefore a case of particularly rapid development of an isolated thunderstorm cell. The development of this cell into a large convective cluster within a few hours may suggest the presence of strong updraughts and severe turbulence. In addition, this rapid growth could explain the violent phenomena encountered, related to the dynamism and not to the size of the cell.
