Loss of control, collision with the ground, instruction flight

Aircraft	Cirrus SR-20 registered F-HCPT
Date and time	31 July 2013 at 15 h 25 ⁽¹⁾
Operator	Club
Place	Poncins (42)
Type of flight	General aviation
Persons on board	Instructor and student
Consequences and damage	Instructor and student killed, aircraft destroyed

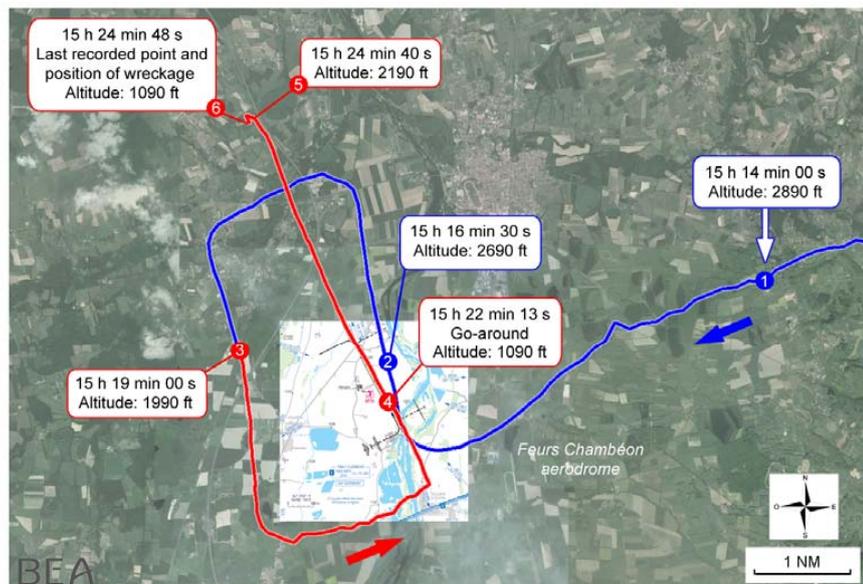
They flew to Feurs aerodrome (42) where they circled the aerodrome before performing a go-around on short final on unpaved⁽²⁾ runway 33. The data taken from radar recordings shows that the aeroplane climbed away from the aerodrome along this runway's extended centre line with a constant ground speed of about 80 kt and with an average vertical speed of about 475 ft/min. When the aeroplane reached an altitude of 2,200 ft, i.e. a height above ground of about 1,000 ft, the flight path descended significantly and turned to the left.

The wreckage was found immediately beneath the position of the last recorded point.

— F-HCPT flight path based on Clermont-Ferrand radar data between 15 h 13 min 30 s and the last recorded point

The altitudes shown are calculated on the flight levels transmitted by the transponder (mode C) and corrected to QNH 1020
