N° 9
June 2008

Incidents in Air Transport

Hydraulic Failures

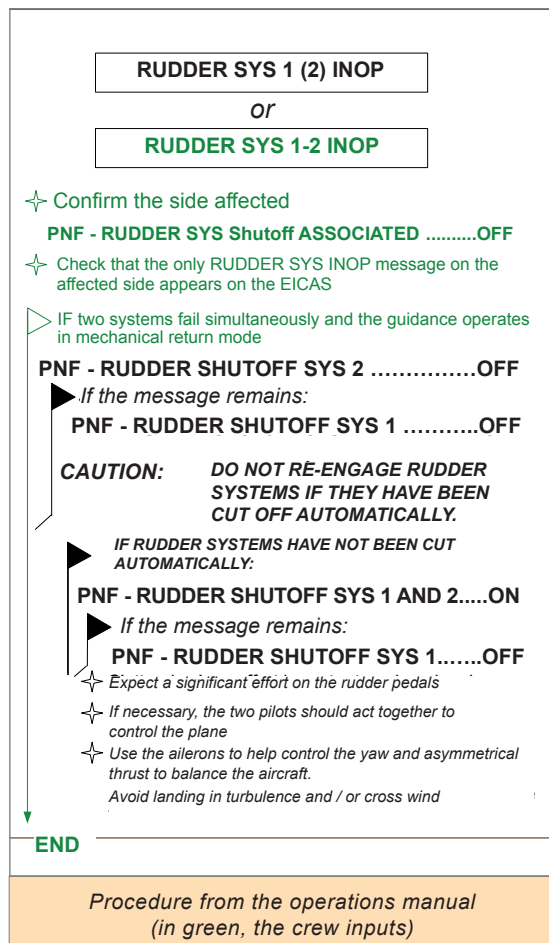
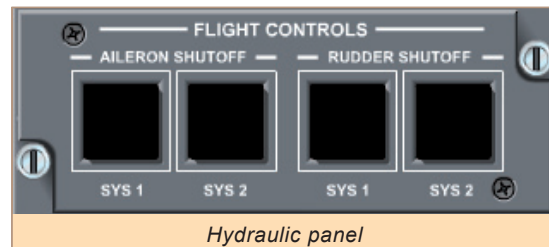
An ERJ 145 was cruising at FL 280 at a speed of 0.77 M when the autopilot disconnected. The RUDDER SYS 1-2 INOP warning appeared on the EICAS. The crew dealt with the failure by following the procedure described in the operations manual.

As the EICAS message indicated that both systems were affected, the PNF stopped systems 1 and 2, in compliance with the start of the procedure. This led to control of the rudder moving to direct mechanical mode, without hydraulic assistance. The crew concluded, according to the procedure, that there was no other action. They announced an urgency situation but performed the approach and landing safely, the crosswind component being low.

At a speed above 135 kt, system 1 of the actuator is normally depressurized. In case of failure of system 2 pressure switch, pressure always available in system 2, system 1 does not take over. However the SYS 1-2 INOP warning is presented to the EICAS because neither of the two pressure switches can detect pressure.

The manufacturer had allowed for this case since the QRH procedure allowed doubts to be dispelled. However the flight manual procedure was less explicit. The manufacturer has since changed it to harmonize with the QRH.

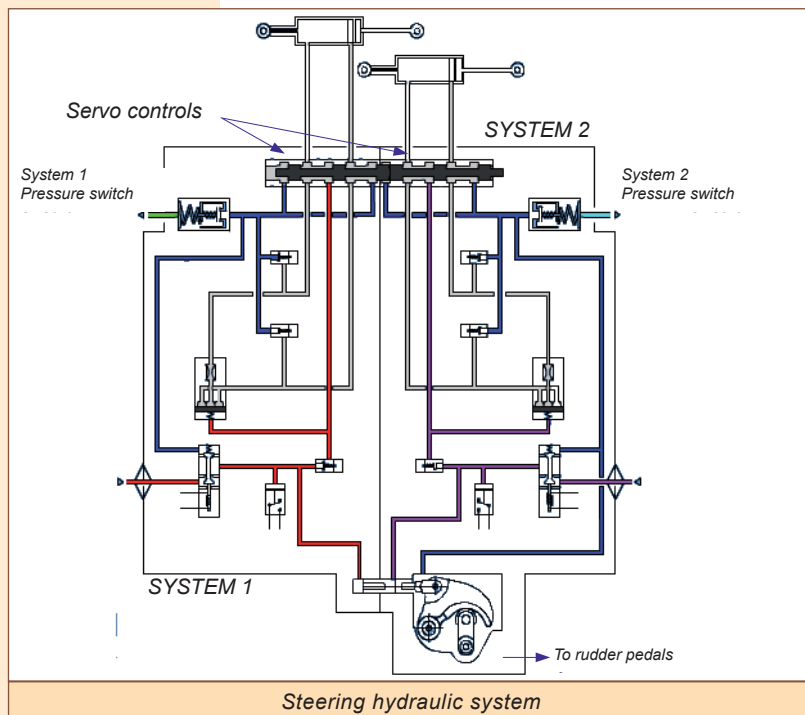
Additional Information Steering system

La gouverne de direction est actionnée par The rudder is operated by two hydraulic actuators each controlled by one of two systems of a dual system servo-control, which is itself controlled mechanically by the rudder pedals. At speeds below 135 knots, the two systems operate in parallel⁽¹⁾. Above this speed, only system 2 is active, system 1 being in passive redundancy. In each system of the steering control, the presence of pressure is monitored by a pressure switch. Its function is to send

electric signals to generate EICAS messages relating to the steering system. Sensors also measure the pressure on the two main hydraulic systems; they are located at the level of the mechanical and electric pumps of each system. In the case of a drop in pressure in hydraulic system 2 above 135 kt, the pressure sensor of this system controls the activation of system 1 of the servo.

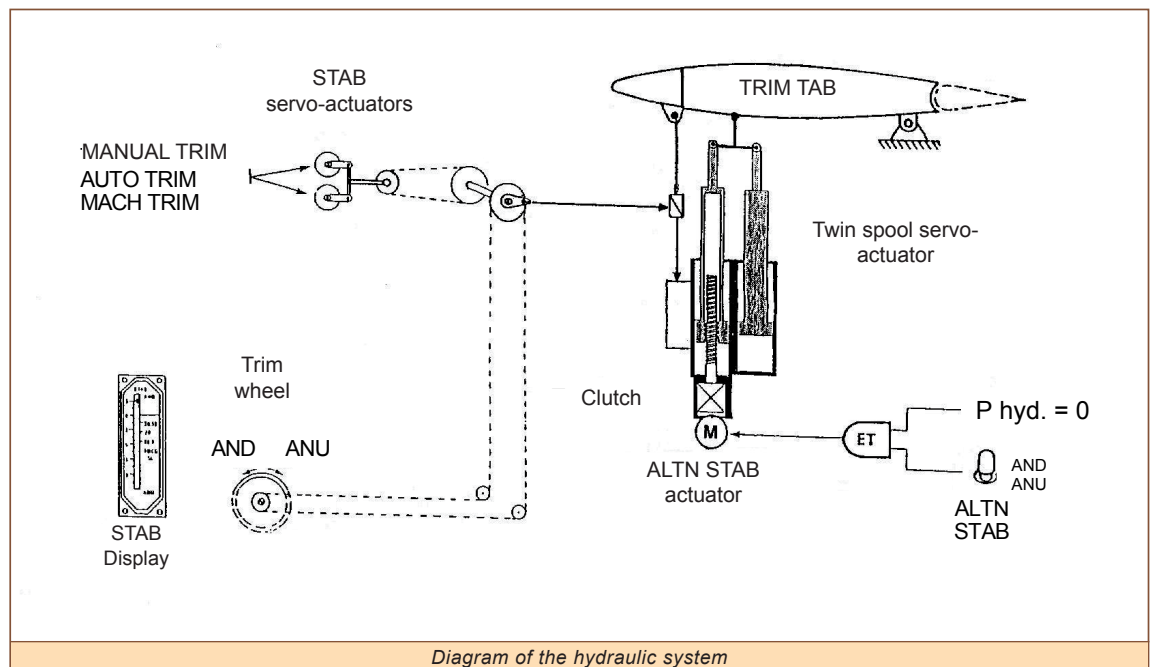
The Captain took the controls and requested clearance for a return. He started the descent by adjusting the trim system, which caused it to make a rapid pitch-down movement. The copilot, now PNF, prepared to take up STAB TRIM 1 AND 2 procedure which calls

This warning is triggered when the AFCAS system is no longer able to control the trim system. This is the case when the system does not have the data required to carry out calculations or when the flight control surface does not respond (locking, major friction or servo control problem).

As the warning is triggered in case of the trim system being mechanically locked, the associated procedure forbids the use of the emergency electric mode so as not to damage the hydraulic servo control.

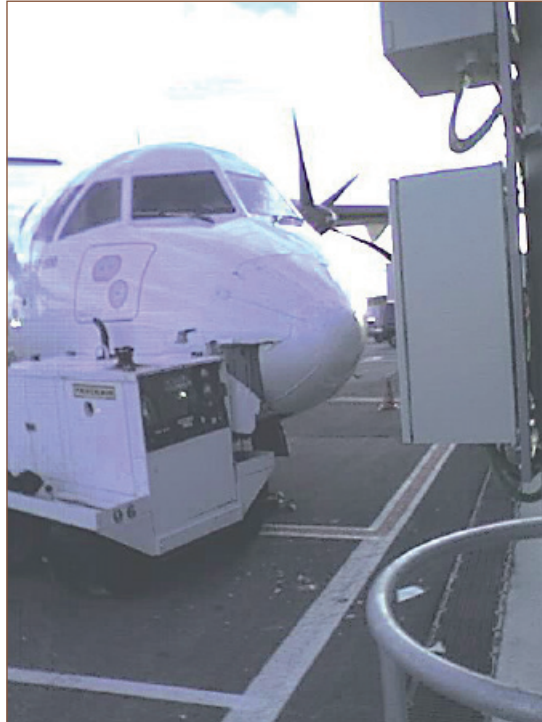
It was only when the Captain activated the brakes on the ground agent's signal that he noticed that these were ineffective. The copilot called out two hydraulic pressures at 2,000 psi at the same moment and also tried to brake, in vain. The Captain touched the

throttle lever to confirm their position in the ground idle setting; he was then no longer able to immediately activate the emergency brake. To avoid the walkway and the ground signalman, he steered the airplane to the right, then activated the emergency brakes, which were effective but the collision with the ground power unit could not be avoided.

The analysis of this incident led the operator to modify its internal procedures which now provide for:

- the callout of the working condition of the ACW electric generator at the end of taxiing during verification of hydraulic pressure after the left engine propeller feathers;
- the suppression of Pitot heating in the actions after landing in order to comply with the FCOM keeping a warning panel switched off;
- raising Captains' awareness of the position of their right hand on the emergency brake at the end of taxiing;
- raising crews' awareness of the importance of dealing fully with failures occurring on the ground.

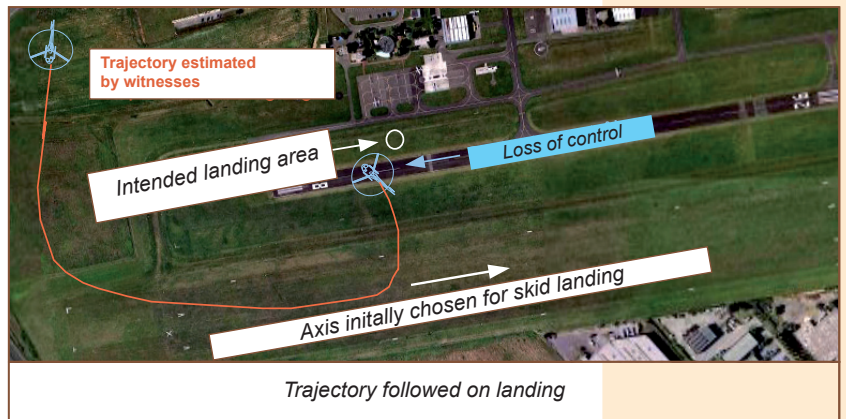
Hydraulic power failure procedure from the Operations Manual

- Reduce the collective pitch without rushing and look for a Vi of about 40 kt to 60 kt in level flight.
- Shut down the hydraulic system on the collective pitch

In this configuration, force required is around 3 to 5 kg on the control and collective columns and 15 to 30 kg on the rudder bar. On approach to hovering, these loads are considerably increased because of:

- reduced stability in yawing,
- increased power required for flight, particularly with a heavy weight,
- modification of aerodynamic handling caused by the change in direction of rotor airflow which produces a modification of load on the cyclic pitch control, which can be perceived as an inversion.
