## Serious incident to the EMBRAER ERJ190-100LR registered **CS-TPV** on 6 November 2017 at Nice Côte d'Azur (Alpes-Maritimes)

## Rejection of take-off run on a taxiway at night

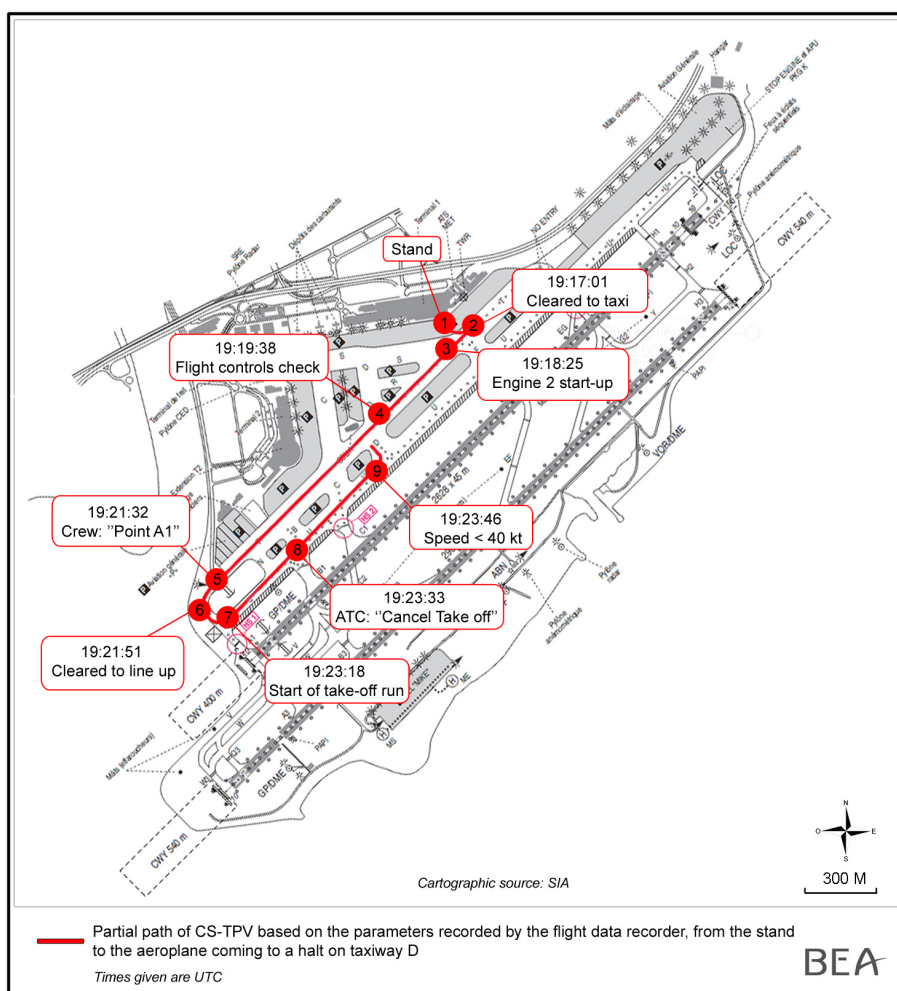
The crew left parking area 10B (cf. ❶ figure 1) more than an hour late on the scheduled time, with a west-facing push-back proposed by the controller for taxiway T, for a flight bound for Lisbon. The captain was the PF and the first officer was the PM.

The ground controller cleared the crew to taxi via taxiways T and A ❷ and to hold at holding point A1 in order to take off from runway 04L. The crew read back the route but not the instruction to hold at the holding point. One minute later, at the crew's request, the ground controller confirmed the taxi route.

The crew then started up the second engine ❸. A few seconds later, the PM carried out the flight control tests while the aeroplane was taxiing ❹.

As the aeroplane approached point ❺, the crew indicated that they were at holding point A1 and ready for departure. The ground controller asked them to contact the tower controller. At this moment, the aeroplane was on taxiway T, level with the sign indicating taxiway A on the left, i.e. 350 m before holding point A1.

The crew contacted the tower controller and indicated that they were at holding point A1 for runway 04L, ready for departure. The tower controller cleared them to line up on runway 04L<sup>(4)</sup> with the indication "line up four left". The crew read back the alignment for runway 04L. At this moment, the aeroplane was in the middle of the bend from taxiway T to taxiway A ❻.

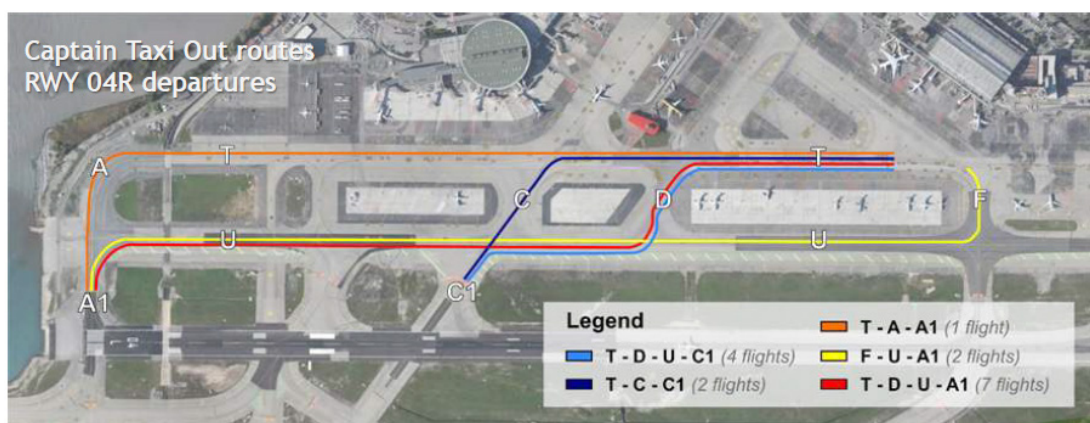
Figure 2: routes previously used by the captain

Since becoming captain and thus PF while taxiing (cf. section 2.7.2), he had carried out 20 rotations at Nice of which at least 16 with a take-off from runway 04R. Only once when taking off from runway 04R had he taxied via taxiway T to taxiway A. This was at night, in August 2016, during his first flight as PF while taxiing.

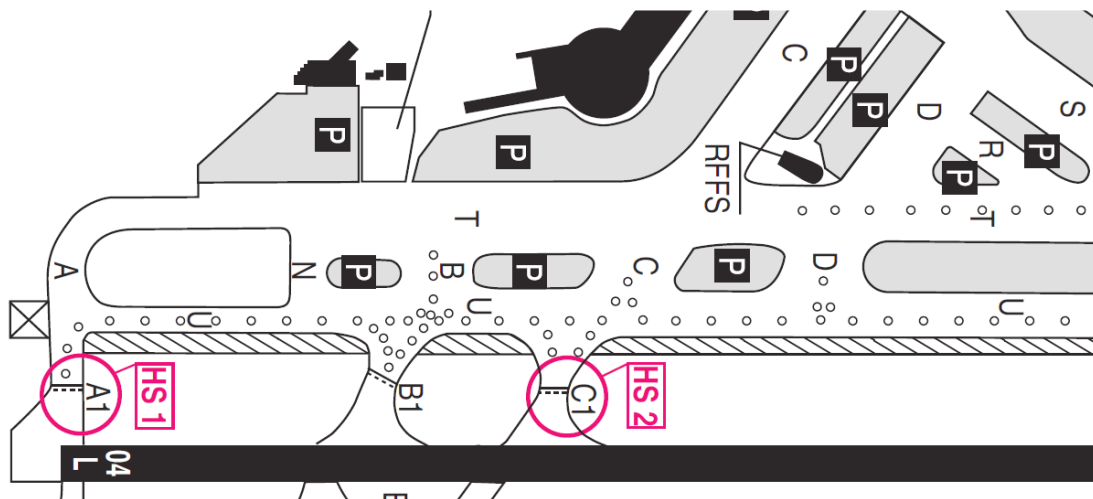
Figure 3: taxiway lighting

From the intersection with taxiway D and up to the intersection with taxiway U, taxiways T and A do not have green centreline lighting but single-direction blue edge lighting. These differences are shown in the chart below:

The lighting of these taxiways and the signs comply with the aerodrome certification requirements. In particular, a sign on taxiway A indicated the identification of the taxiway and the direction of taxiway U on the left.

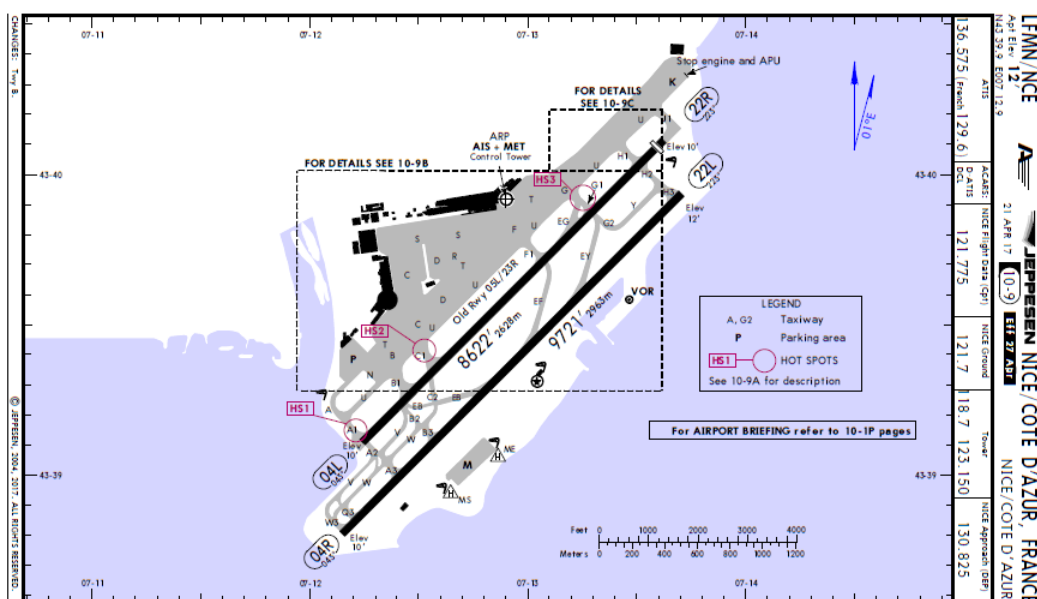
Figure 4: Jeppesen chart

On the Jeppesen chart used by the crew, the taxiways are identified. The fact that taxiway U is old runway 05L/23R is mentioned.
