## Accident to the Piper PA-31 "Navajo" registered F-HGPS

on 21 August 2018

at Verneuil-sur-Vienne (Haute-Vienne)

## Fuel exhaustion, forced landing, collision with vegetation, during an aerial photography flight

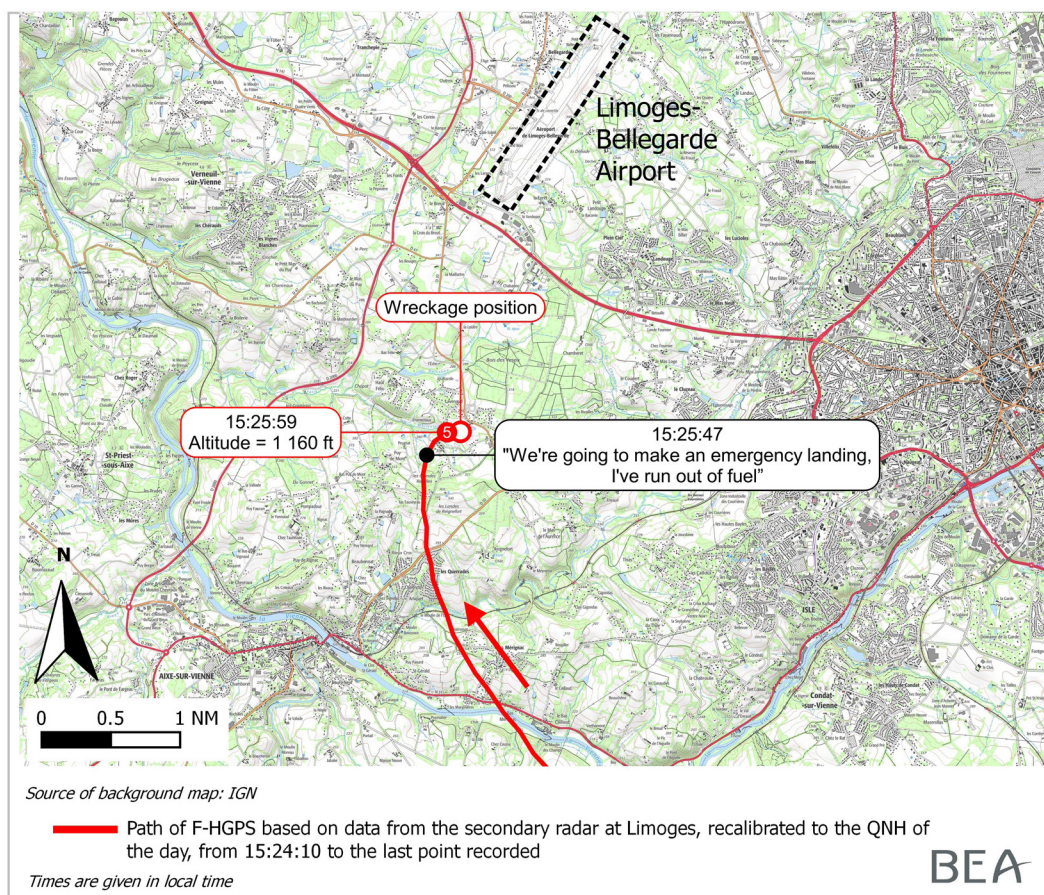
Figure 2: Wreckage position

Shortly after this last message, the aircraft collided with trees and then with the ground 2 NM south of the threshold of runway 03. The pilot and the operator sitting in the rear were seriously injured.

The wreckage was grouped together and oriented at 077°, about 20 metres from a grove of trees at the bottom of a small valley. About 10 trees in this grove had been headed at a height of approximately 10 metres. The presence of open, flat fields about 700 m to the east of the accident site was noted.

Serious damage as a result of the impact with the trees and the ground was observed. On each half wing, the portion from the engine to the wing tip was severed at the time of impact with the trees. Because of the damage to the fuel tanks, the remaining fuel level could not be determined.

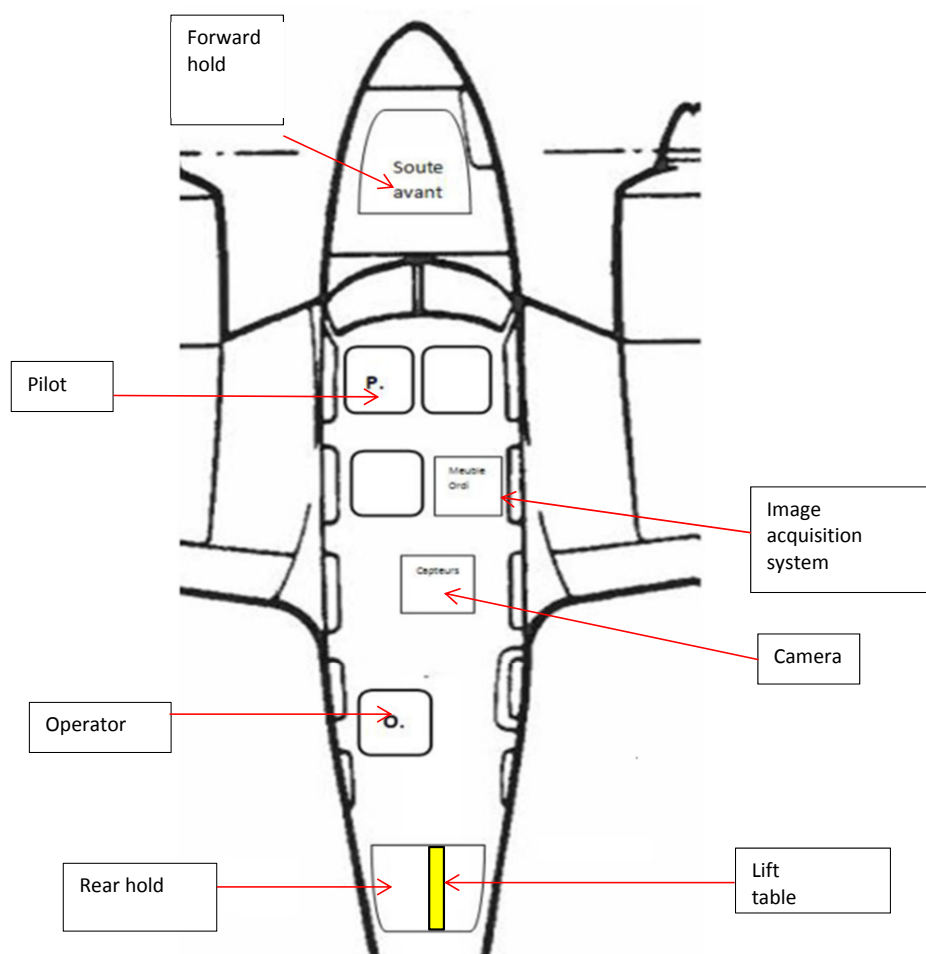
Figure 3: diagram of the interior of F-HGPS

A lift table<sup>(4)</sup> in the aircraft's rear hold, behind the operator's seat, was used to install the camera in the aircraft, or to unload it. Although not necessary, it was usually kept onboard the aircraft during missions.

It was not secured during the flight. When the aircraft hit the trees and then the ground, it was thrown against the operator's seat. The operator's seat then folded forward and was torn from the floor. The operator was trapped between the camera and the lift table, which remained on the back of her seat.

However, with the modification made in 2010 and the associated STC, instructions were added to the flight manual specifying, among other things, that during take-off, landing and in emergencies, the operator must be in the "copilot" seat to the right of the pilot, or in the seat behind the pilot's seat. The instructions specify that a label<sup>(17)</sup> must be positioned in full view of the operator, at or near the operator's position when taking photographs. In the flight manual supplement, this instruction has also been added to the take-off and landing checklists.

When F-HGPS was acquired in 2015, the company operated the aircraft in the same way as the other two PA-31s. It had not realised this instruction existed, and therefore had not implemented it when carrying out these flights. Nor had it affixed the labels in full view of the operator onboard F-HGPS. The operator always sat in the rear seat for the entire flight in accordance with the company's operations manual.

- ❑ Pilot testing of a smart clock with audible and visual reminders to help monitor consumption. The test results could lead to the installation of these clocks throughout the fleet.
- ❑ Amendment of the operations manual to incorporate the instructions added to the F-HGPS flight manual. These instructions on where operators should sit will be applied during take-off and landing and in emergencies for all missions.
- ❑ Carrying of the lift table, secured in the aeroplane's rear hold, only on ferry flights.

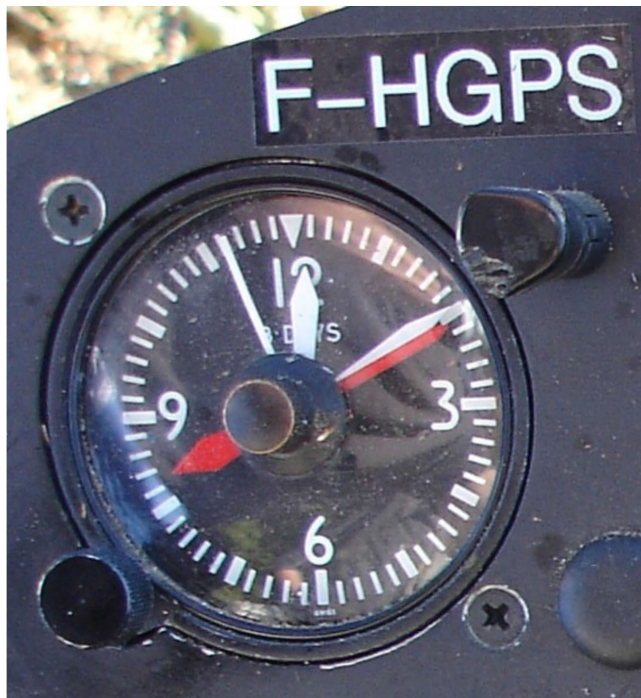
Figure 4: Photo of the clock at the accident site

The aircraft's clock stopped at 12:10<sup>(5)</sup>, about four hours after the start of the flight, and about 1 hour and 15 minutes before the accident. The take-off time (red hands) indicated is 08:11 UTC<sup>(6)</sup>, which is consistent with the actual take-off time. It is company practice to use the clock during flights, according to statements given by other company pilots, including the chief pilot.

An X-ray examination of the clock showed that the spring was completely slack<sup>(7)</sup>. The examinations and checks carried out on the clock did not reveal any significant failures, either in its operation or in its mechanism.

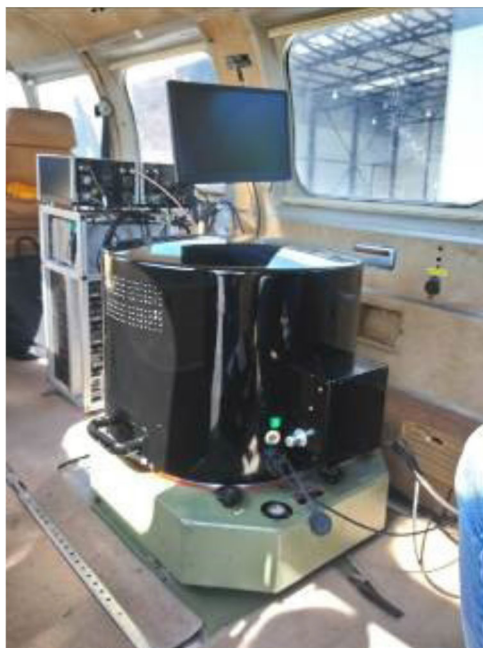
Figure 5: installation of the camera equipment onboard F-HGPS

The camera used for the photography, positioned in the centre of the aircraft, had become detached from its base, which broke during the impact<sup>(3)</sup>.

The camera installed onboard is a unique prototype designed by IMAO, which developed it specially for photometric photography. The camera is a floor camera, installed on a gyro-stabilized mount. The camera weighs about 85 kg and the mount 30 kg. The camera is connected to a rack comprising an image acquisition system that includes the nine storage hard disks, a computer and its screen. This modification to the aircraft was approved by the DGAC.
