## Accident to the Rolladen Schneider LS8-18 registered F-CIBD

on 13 April 2019

at Avize (Marne)

## Loss of control in flight, collision with the ground

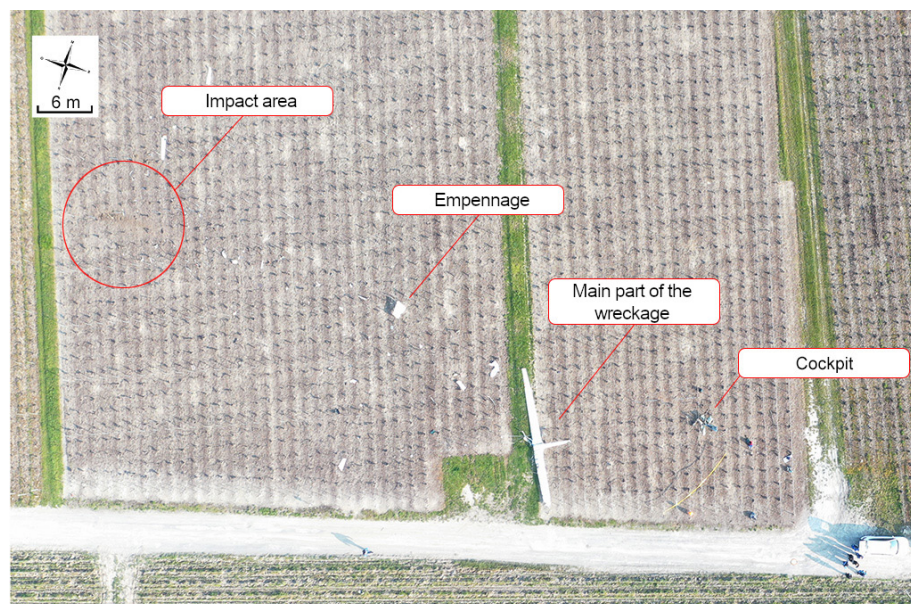
Figure 2: aerial view of the accident site

The wreckage was complete, scattered in the middle of a vineyard.

The cockpit was destroyed and the 4-point harness was found buckled on the seat. The pilot, who was equipped with her back parachute, was found several metres downstream from the cockpit. It was confirmed that these elements were not disturbed by the rescue services and the first people to arrive at the accident site. This configuration suggests that the pilot was not strapped into her harness.

The damage to the cockpit, the fact that there was little damage to the wing-tips and the topology of the tearing of the metal wires marking out the vine furrows suggest that the glider struck the ground with a nose-down attitude and its wings level.

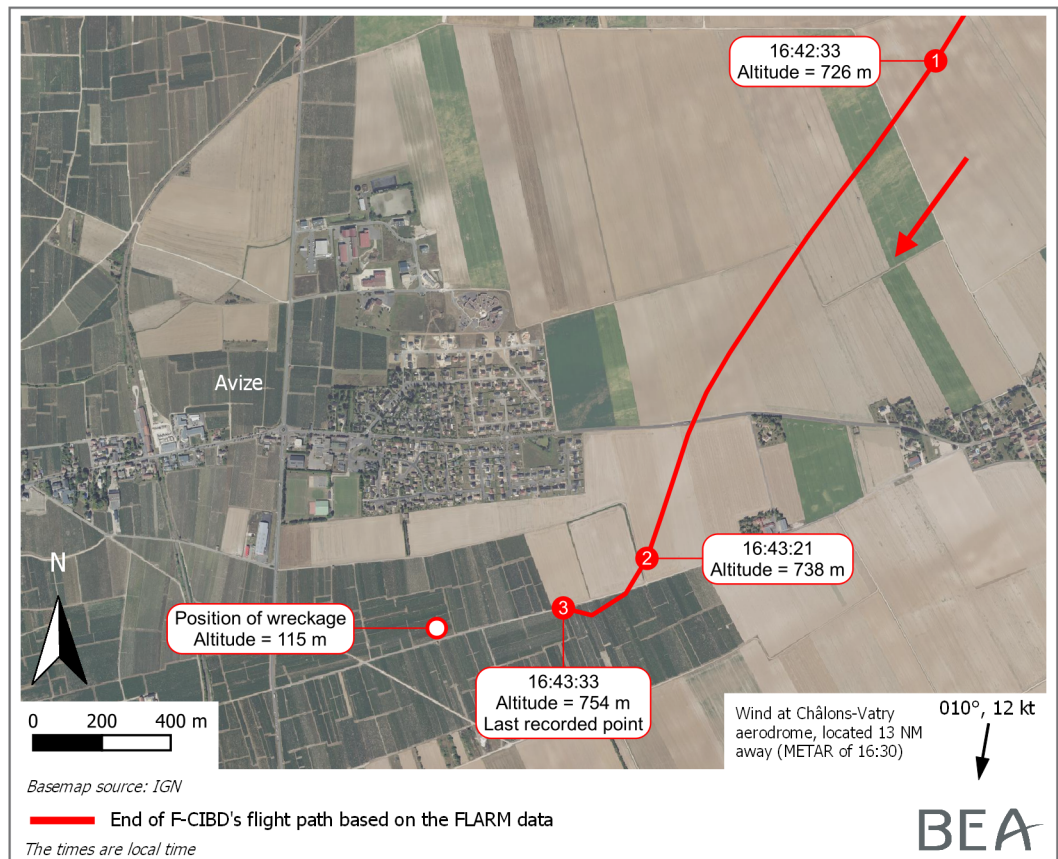
Figure 3: path during the last minute of the flight

In the minute preceding the accident up to point 2, the glider was flying in a straight line, climbing slightly and its speed was decreasing. At point 2, the ground speed was about 110 km/h. Based on the wind assumptions used, the airspeed was around 85 to 90 km/h.

The sudden loss of height between point 3 and the position of the wreckage (loss of about 650 m over a horizontal distance of less than 300 m) can only correspond to a loss of control leading to a rapid fall.
