**Collision between a tug and a glider,
on an aerodrome circuit, during an air display**

Aircraft	PA25 tug registered F-GHSH Slingsby T31b glider identified BGA 4926
Date and time	5 May 2012 at about 16 h 50 ⁽¹⁾
Operator	Aeroplane: club Glider: private
Place	Buno-Bonnevaux aerodrome (Essonne, France)
Type of flight	General Aviation
Persons on board	Aeroplane: 1 pilot Glider: 1 pilot and 1 passenger
Consequences and damage	Pilots and passenger killed, aeroplane and glider destroyed

This is a courtesy translation by the BEA of the Final Report on the Safety Investigation. As accurate as the translation may be, the original text in French is the work of reference.

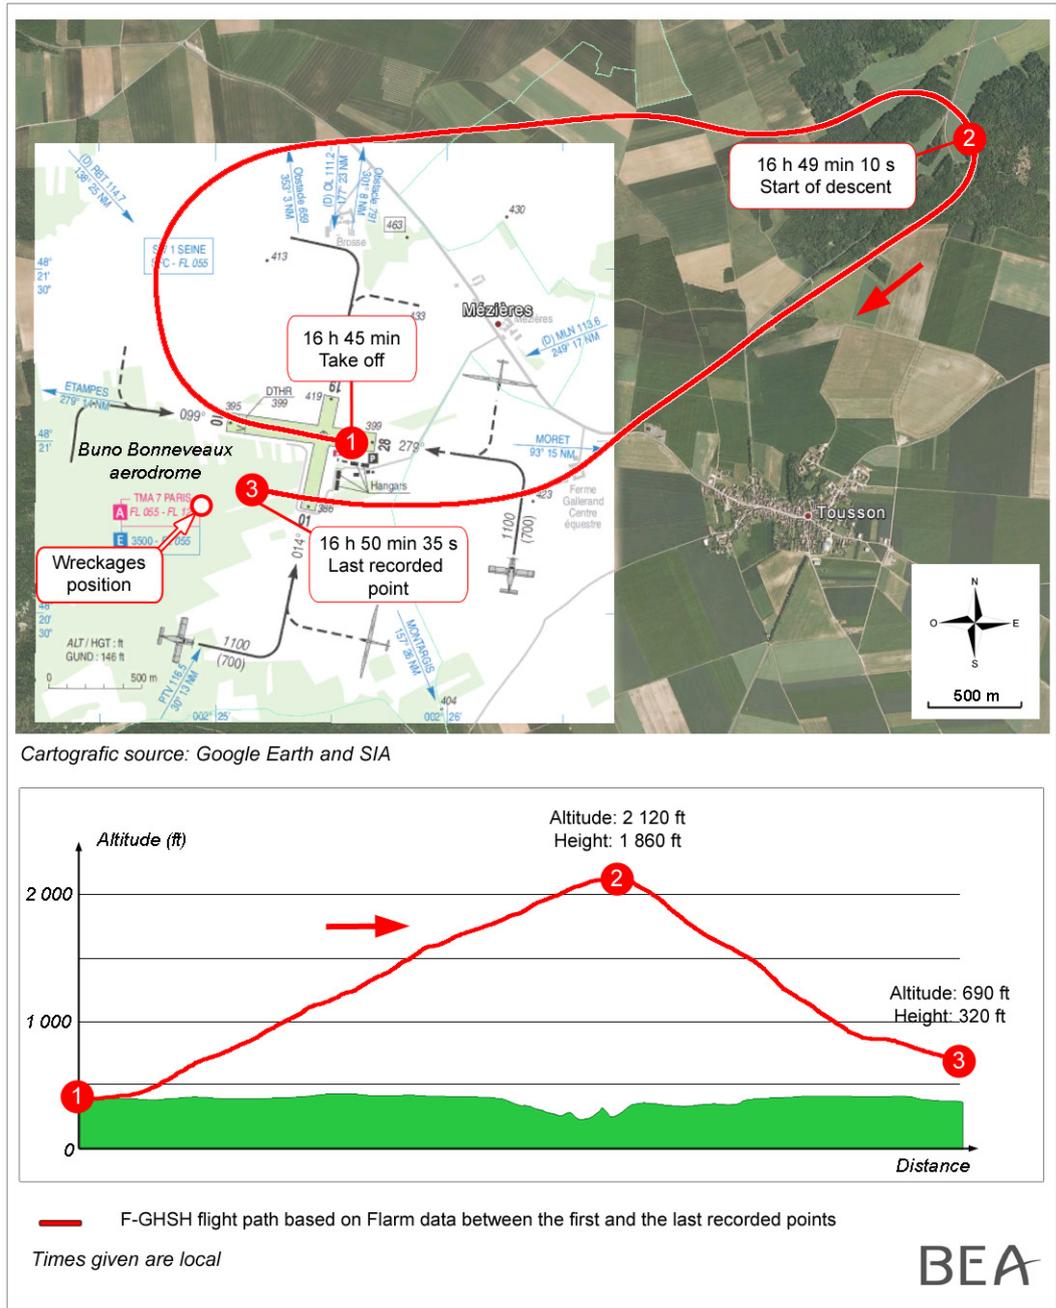
Figure 2: reconstitution of the flight path of the PA 25 based on data from the FLARM

The pilot of this aircraft had more than 2,500 flying hours experience. He was familiar with the aerodrome. He took off from runway 28 then reached a release area located to the east of the installations.

A few minutes later, at the top of his flight path, at a height of about 1 900 ft., he started a continuous descent at an average rate of 1,200 ft/mn.

Arriving at a height of about 700 ft. he stabilized in level flight for about four seconds then started to descend again with a rate of descent of around 500 ft/min, lining up the flight path of the aeroplane to the west to overfly the threshold of runway 01 at a height of about 300 ft.

From this point, the flight path of the aeroplane remained parallel to the centreline of runway 10/28, descending until the moment of the collision.

According to the testimony of pilots of tug aircraft based at this aerodrome, this circuit integration was accomplished with a flight path and an axis described as “unusual”. Further, the height passing over the threshold of runway 01 was lower than the height of the aerodrome circuit. It is possible that the pilot wanted to adopt an integrating flight path clearly separate from that of the glider flight paths by adopting a circuit to the south of the glider circuit, at a height that was lower than the latter.

The tug’s flight path could be explained by the occasional presence of the winch and the ban on directly overflying the installations. The pilot would then have wished to be in the best position to observe current activity on runway 10/28 and/or to search visually for the glider whose takeoff he would have been aware of following the winching radio message transmitted a short time before.

The pilot had a lot of experience of towing at this aerodrome, and perhaps went into his usual routine. Used to towing the gliders to the north after takeoff from runway 28, he perhaps did not realize that the recent installation of a winch on the same axis might lead pilots to turn towards the south after being winched. Wishing to optimize his flight and reduce its duration as much as possible, while taking into account the specific activity under way at that time at the aerodrome, he may have decided to ignore the aerodrome circuits on the VAC chart.
