## Accident to the Evektor Aerotechnik Team Eurostar EV 97 identified 59CVF

on 31 July 2015

at Berck-sur-Mer (Pas de Calais)

## Untimely opening of the canopy during take-off, loss of control, collision with the ground

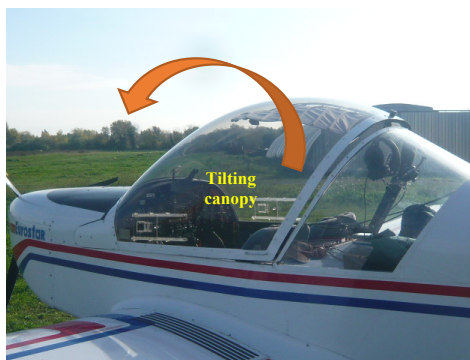
The microlight canopy, swivelling around two pins, tilts forwards to open with the help of two push-up damper-actuators and is held in the open position by these two damper-actuators fixed near the instrument panel.

Figure 1: Photograph of the Evektor canopy

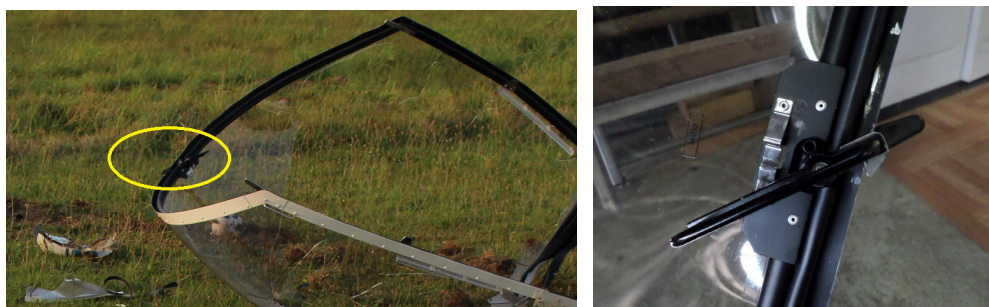
The examination of the wreckage revealed that the locking handle of the canopy was not in its "closed" position (see figure 2). The canopy broke away from its front fastenings upon impact as evidenced by the tearing off of the damper-actuators (see figure 3). The locking pin was not damaged. These elements confirm that the canopy was not locked during the flight.

Figure 2: Handle in unlocked position (not inserted in its retaining spring)

On 24 November 2015, after the accident, the manufacturer published a service bulletin<sup>(5)</sup> requesting the addition of a mechanical catch on the frame of metal frame canopies. This modification means that the canopy is held and prevented from opening fully in the event of untimely opening.

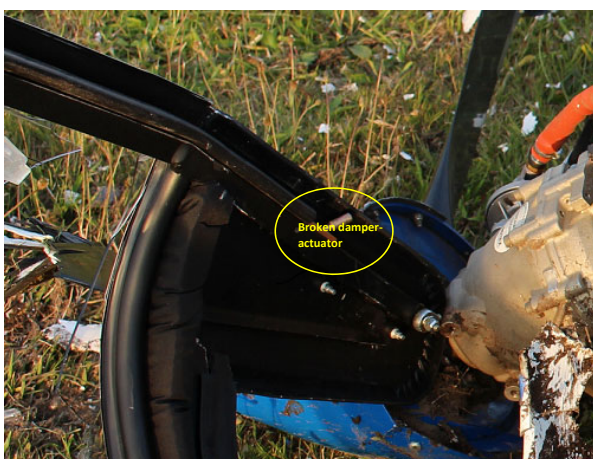
Figure 3: Broken damper-actuator
