Accident to the Gaz'Aile 2 identified 17TA

on 28 September 2017

at Saint-Jean-d'Angély (Charente-Maritime)

Loss of engine power in initial climb, turn-around, loss of control, collision with the ground, fire

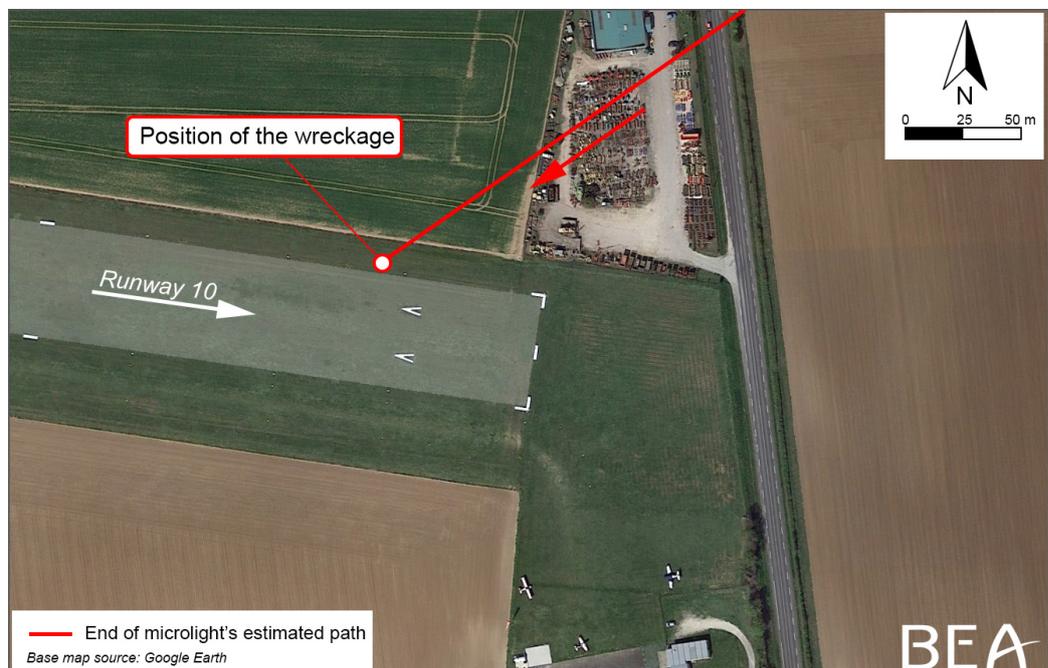
The wreckage, not dispersed, was located to the north and exterior of the runway, 50 m from the threshold of runway 28.

The examinations conducted on the propulsion system were limited due to destruction caused by the fire that broke out on the ground after the accident. Several areas of damage observed in the mechanical reduction gearbox and obviously caused by the impact with the ground solely evidenced an axial load from front to rear. The engine unit had no fractured components.
