Accident to the HELI-SPORT SRL CH 77 RANABOT⁽¹⁾ identified 83ARG

on 13 July 2018

at Saint-Raphaël (Var)

Error message on the instrument panel, autorotation, collision with the ground, fire

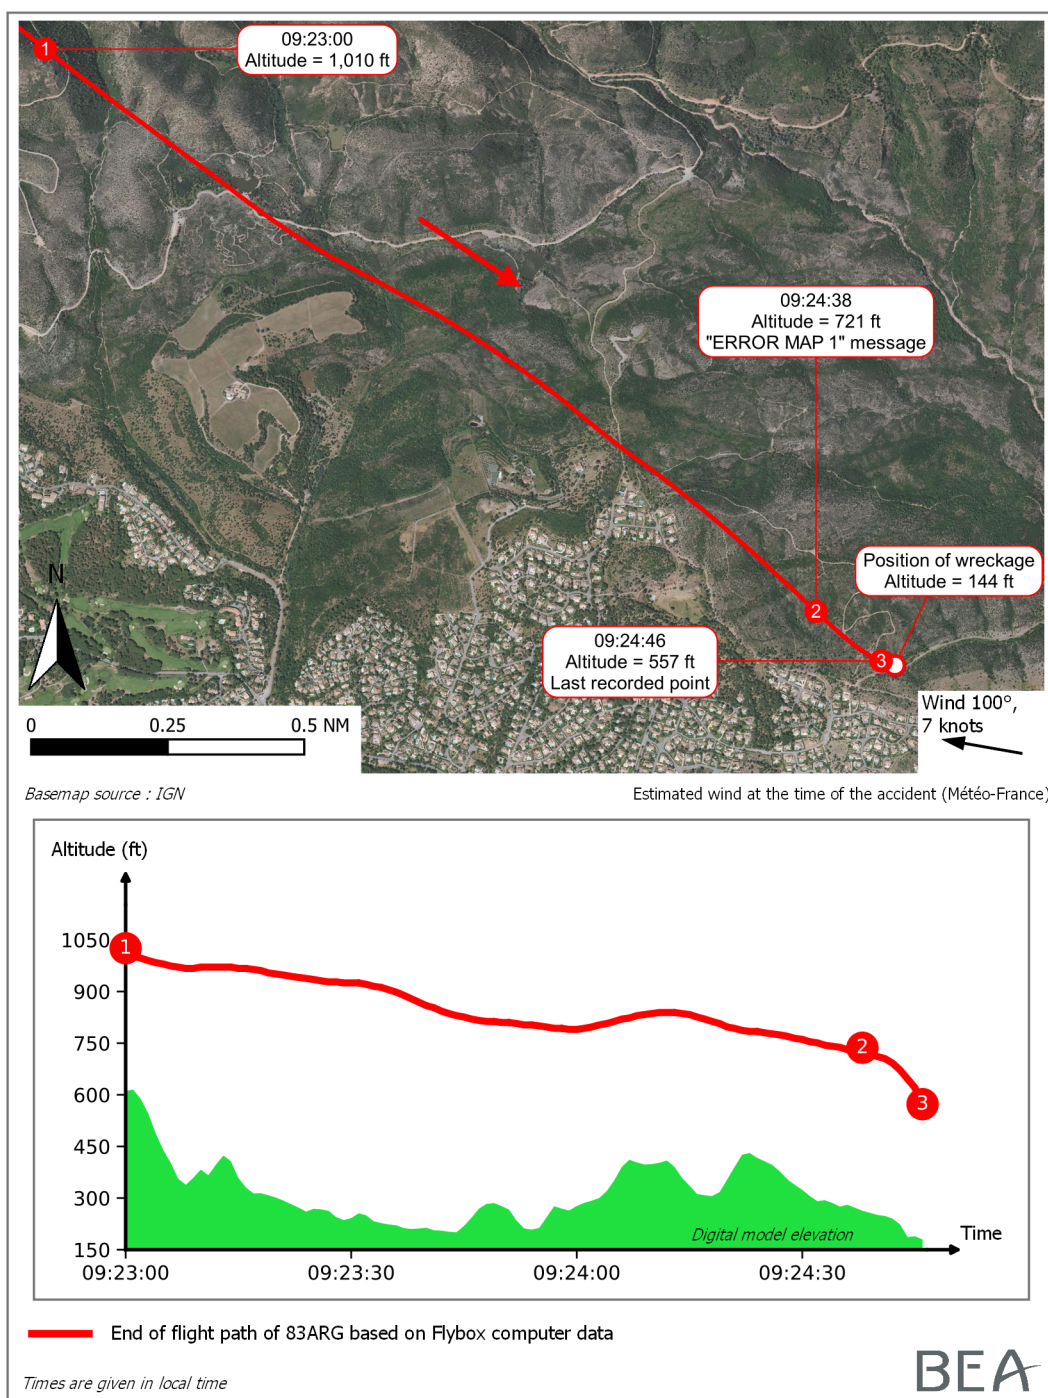
Figure 1: End of the ultralight's path

Whilst he was flying over a hill north-east of Saint-Raphaël at a height of around 500 ft, witnesses heard a reduction in the engine's power then saw the main rotor blades spinning slowly. They then saw the ultralight descend and pick up speed. The ultralight collided with the ground. A fire broke out upon impact.

At the last recorded point, the altitude was 550 ft, i.e. height of more than 300 ft. The last seconds of the flight were therefore not recorded. This can be explained by the sudden stop of the computer upon impact.

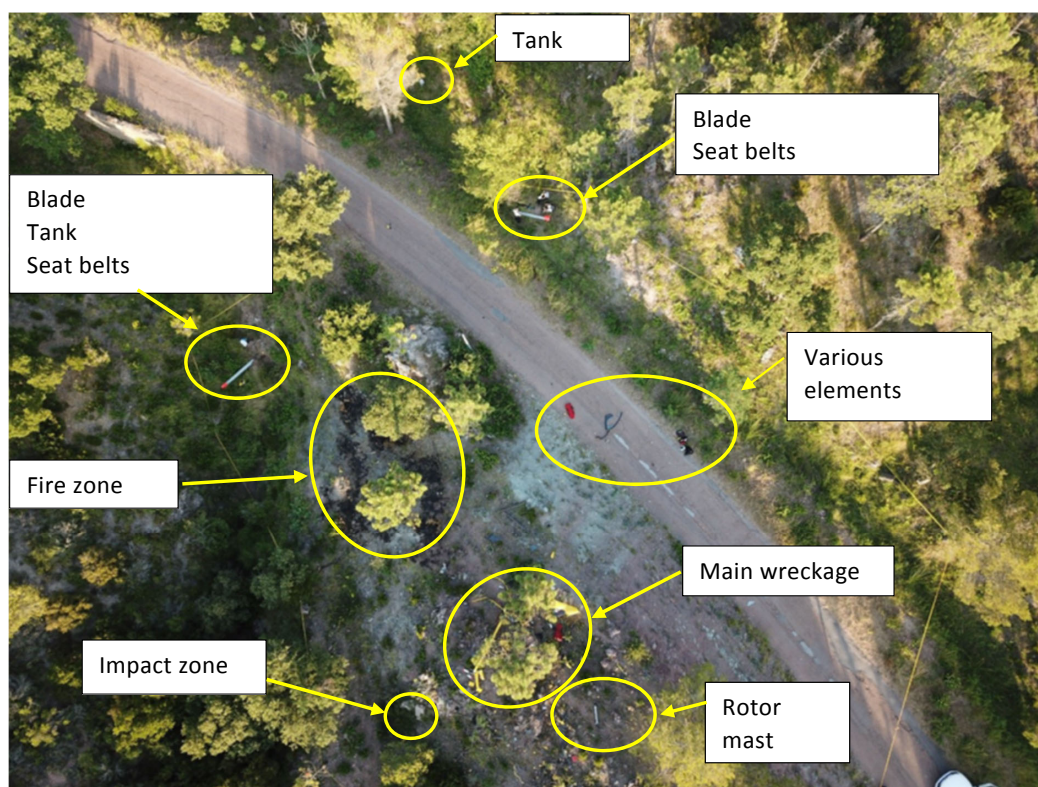
Figure 2: Aerial view with areas of debris

The site of the wreckage is a sloped wooded area, near a private road. Signs of impact with the ground and vegetation constituting the initial area of impact were found around 10 m before the main wreckage. Below the wreckage, in an area approximately 10 m in diameter, signs of fire were observed. Pieces of debris were found more than 50 m further on from the main wreckage.

Examination of the site found that, on its final path, the ultralight had a horizontal or slightly banked attitude with a high horizontal energy and moderate vertical energy.

Both of the main rotor blades were broken where they attached to the rotor mast. These failures were the result of stresses borne by the ultralight when it collided with the ground.

All of the damage observed was caused when the ultralight collided with the ground.

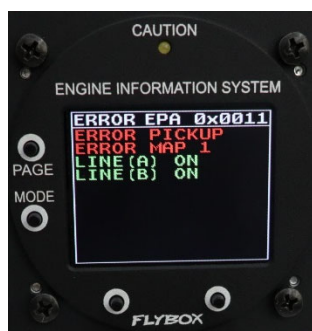
Figure 5: Example of a sensor alarm

The Mini EIS user manual also specifies that there is another type of alarm, known as the “*sensor alarm*”, which is activated when the computer receives no information from a sensor. The engine manufacturer says that a sensor alarm of this type will also be activated if there is a sudden variation in the value of the associated parameter. In terms of the MAP, this would be the case if the value received varies by more than 15 inHg in one second. The parameters display page is then replaced with a page that identifies the alarm (displayed in red on a black background).

The equipment user manual specifies that, in this case, the cables and sensor must be checked for damage. There is no associated procedure and it does not specify that the pilot needs to press the pushbutton to go back to the main page.

Examples of alarms are listed in the equipment manual but the MAP alarm is not mentioned.

- ☐ The display ergonomics of alarms and error messages may have caused confusion, red generally being used for alarm messages requiring immediate action.
- ☐ An inadequate description of the MAP sensor error and its display in the Mini EIS user manual.
