Accident to the ROBIN - DR400 - 180 registered F-GSBZ

on 26 August 2018

at Saumur - Saint-Florent (Maine-et-Loire)

Loss of control at landing, collision with ground in safety area to left of runway

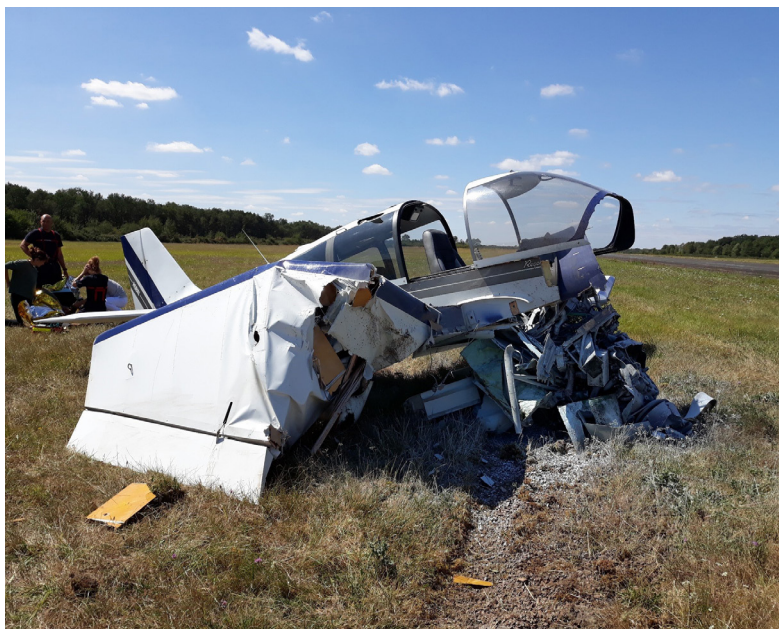
The aeroplane was around 450 m from the threshold of runway 28 and 12 m to the left of the edge of the runway.

The right wing was folded in two places along its length and its leading edge was destroyed (see illustration). The left wing was intact with the exception of the flap, in the landing position, which was slightly damaged at its trailing edge. The propeller and the engine were lying under the front of the fuselage, almost vertical (see illustration). The propeller blades showed evidence of power at the time of the collision with the ground.

Photograph taken after the emergency services had intervened
