Accident to the Cessna Reims-Aviation F152 registered F-GEMS

on 21 October 2018
at Lingreville (Manche)

Engine failure in climb, off-airfield forced landing, collision with tree on short final

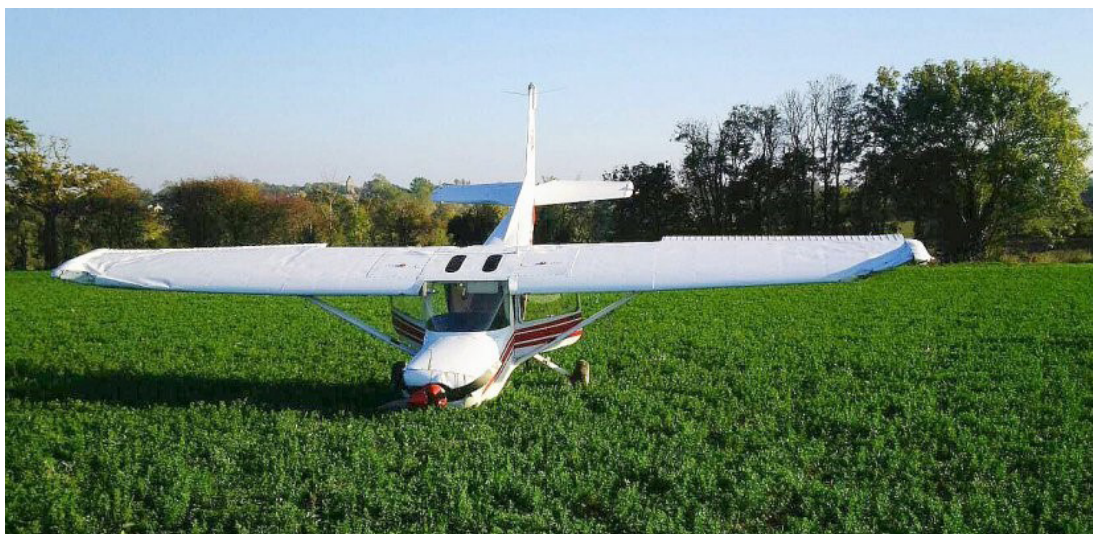
Figure 1: Accident site

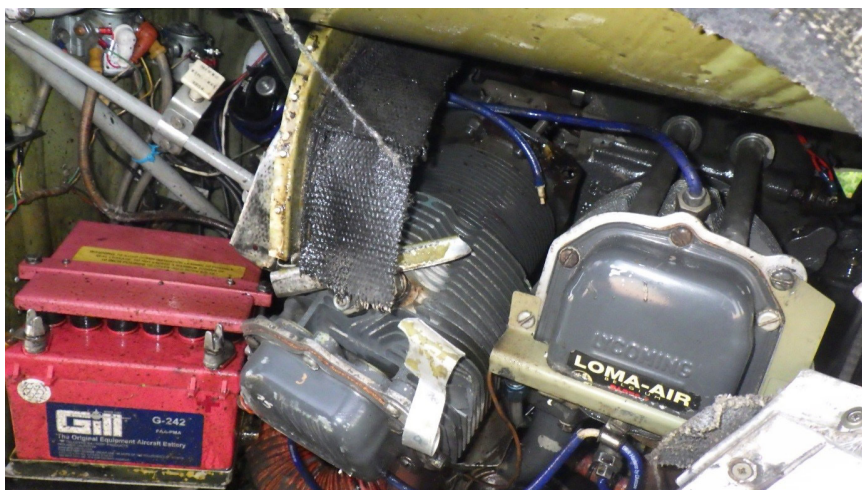
The Cessna Reims-Aviation F152 registered F-GEMS was equipped with an air-cooled, flat-four Lycoming O-235-L2A engine. This direct-drive engine with a wet sump had a maximum power of 118 hp at 2,800 rpm. After the accident, a visual examination of the engine found that the right rear cylinder had separated from the crankcase.

Figure 2: Right rear cylinder separated from crankcase

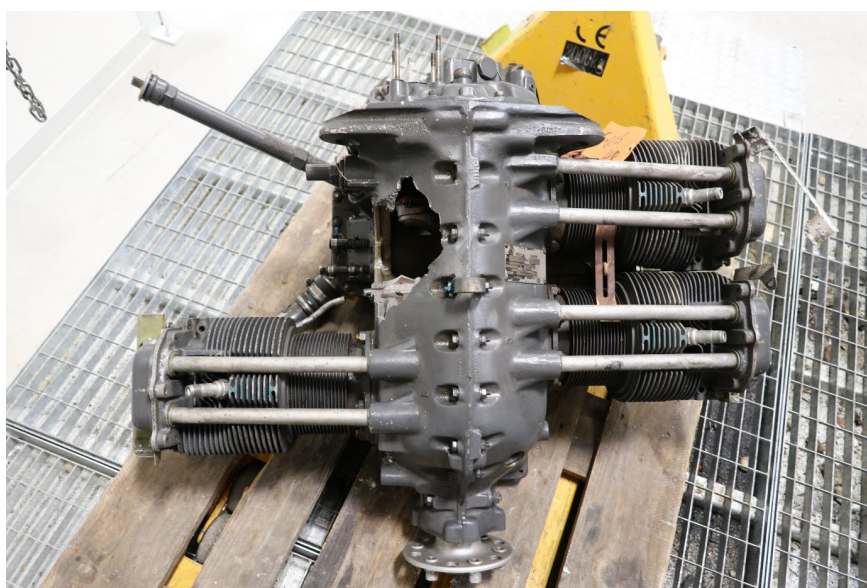
The engine was removed to be examined at the BEA. The crankcase had ruptured around the base plate of the right rear cylinder (cylinder No 3). The three other cylinders were in position without any visible damage.

Figure 3: Engine at its arrival at the BEA

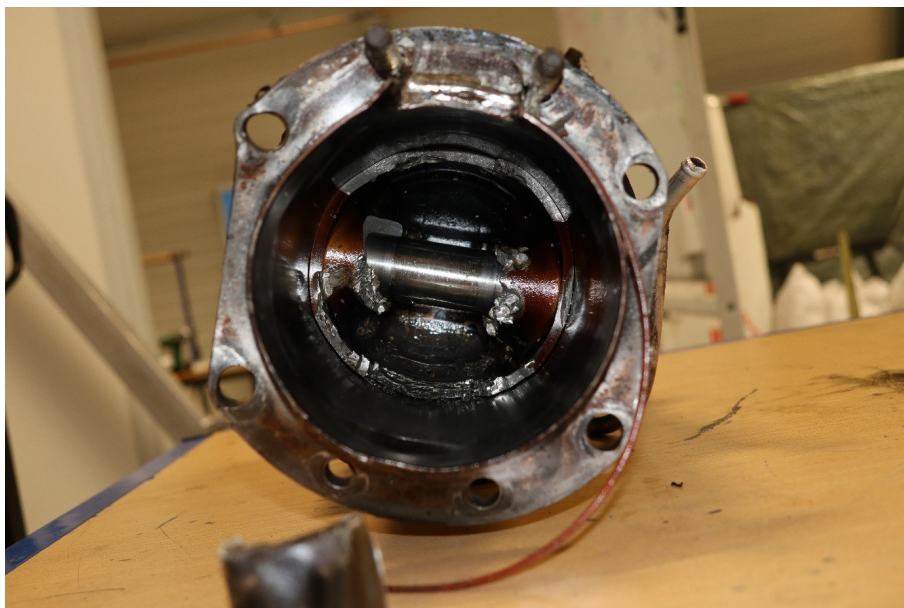
The piston was blocked inside cylinder No 3. The pin coupling the piston with the rod was present and in good condition. There were no marks or signs of overheating on it. The piston was partially destroyed.

Figure 4: Piston blocked in cylinder No 3

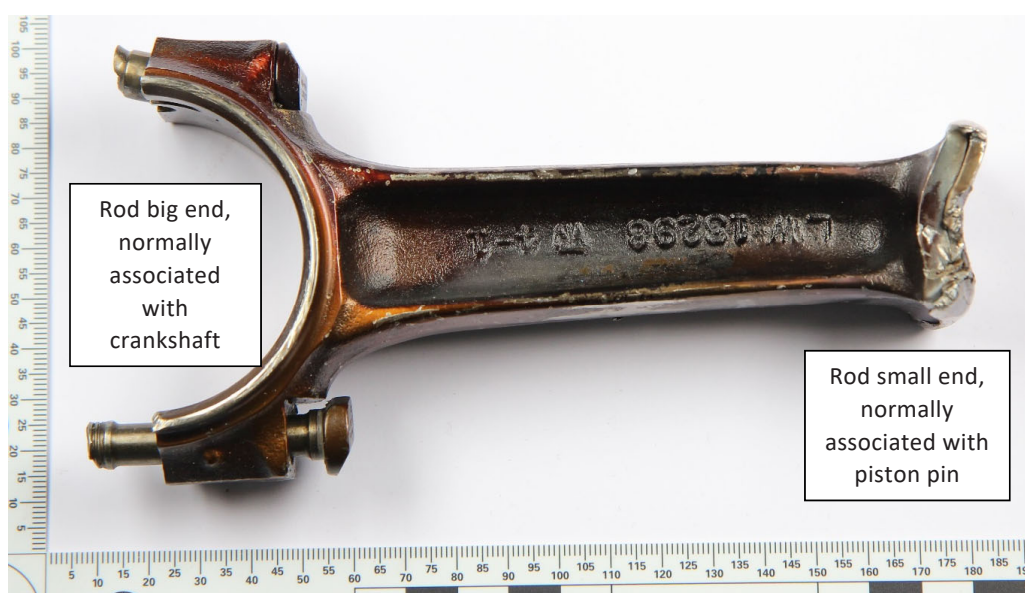
The cylinder No 3 rod was substantially damaged. It had separated from the crankshaft and piston pin.

Figure 5: Rod of cylinder 3

The rod big end (crankshaft side) had only slight damage; the two bolts holding the rod cap had broken. The examination of the fractures of these two bolts showed a sudden rupture due to an overload phenomenon following the failure.

The rod small end had broken and showed deformation and peening resulting from the hammering of the rod small end while the crankshaft was still being driven. The extent of the damage meant that it was not possible to determine the nature of this failure. The bushing, normally positioned between the rod small end and the piston pin was not found.

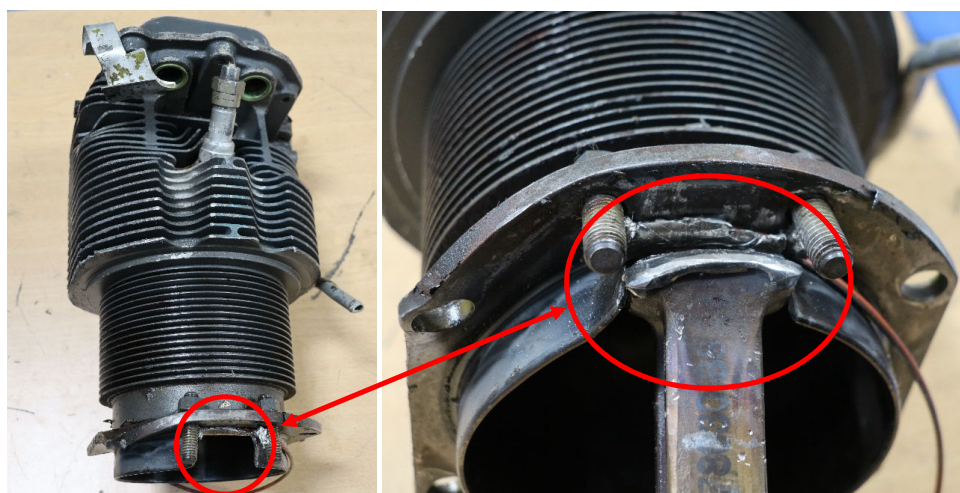
The base of cylinder No 3 showed local damage caused by the repeated hammering of the rod small end. The separation of cylinder No 3 from the crankcase was clearly the consequence of prior damage to the rod.

Figures 6 and 7: Cylinder No 3 and rod small end opposite cylinder damage

All of the examinations carried out by the BEA indicated an initial failure at the small end of the cylinder No 3 rod. Due to the extent of damage on this rod, it was not possible to define the rupture scenario in more detail.
