## Accident to the ROTORWAY - EXEC (162 HDF/A600) registered F-WSPM

on 5 November 2018

at Saint-Pierre (Saint Pierre and Miquelon)

## Loss of control during take-off, collision with ground

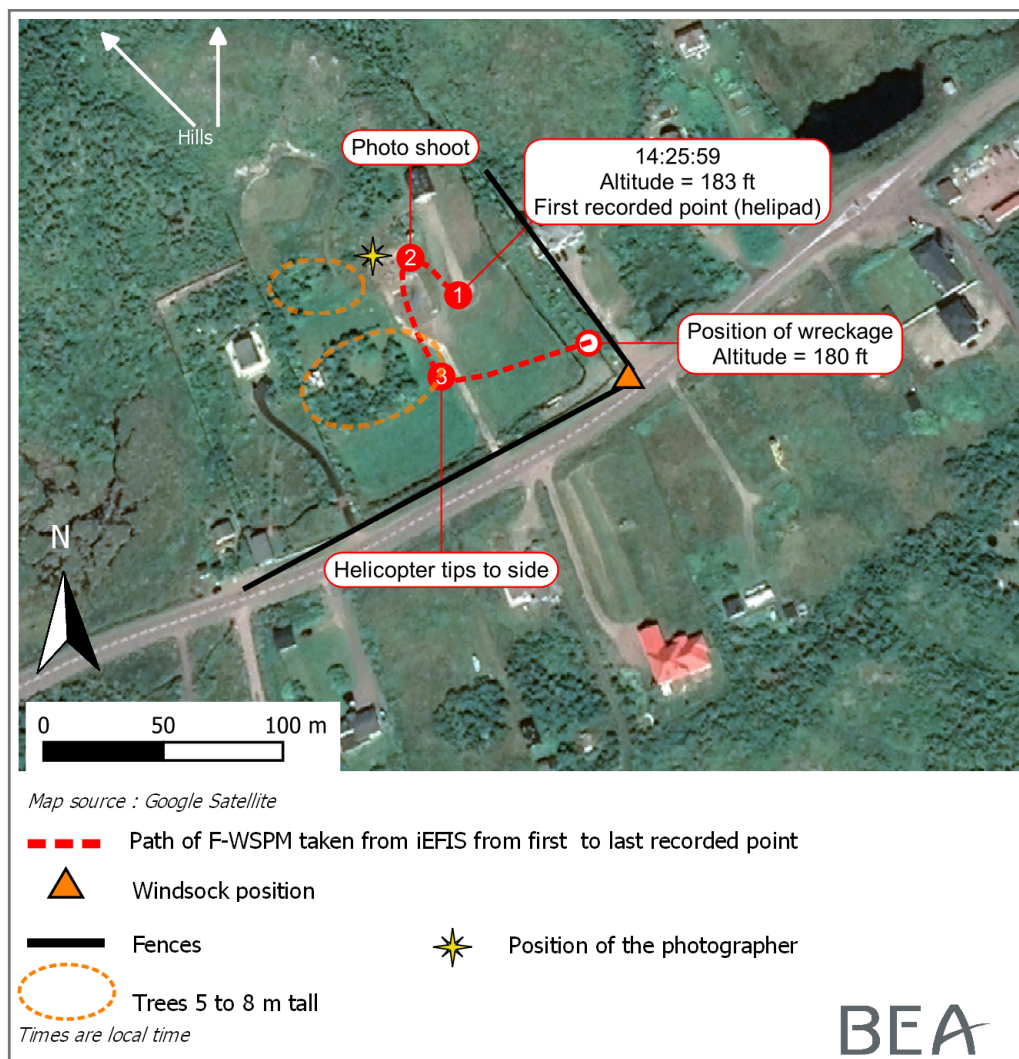
Figure 1: Path and position of wreckage

While in its initial climb, facing south-east, at height of around ten metres, the helicopter suddenly banked to the left and started side slipping. It lost height and the forward left section of the airframe collided with the ground. The helicopter bounced, turned over and came to rest on the right side a few metres from the initial point of impact.

After engine start-up, the pilot had hovered, staying in the ground effect at around 50 cm in height. He then flew forward at low speed to position the helicopter in hover close to a friend who was taking photos (point 2 of Figure 1).

The helicopter remained hovering for around 30 s. The pilot then took off from hover by carrying out a forward climb to a height of around 15 to 20 m. The engine was at high speed. Immediately, the wind pushed the helicopter sideways (point ③ of [Figure 1](#)). The latter tilted steeply to its left side. The helicopter fell.

After taking off in straight flight overhead the path in a south-easterly direction, the helicopter suddenly tipped to the left side (point ③ of [Figure 1](#)). It stayed tilted to the left up to its collision with the ground. They considered that the engine was operating normally up to the collision with the ground.

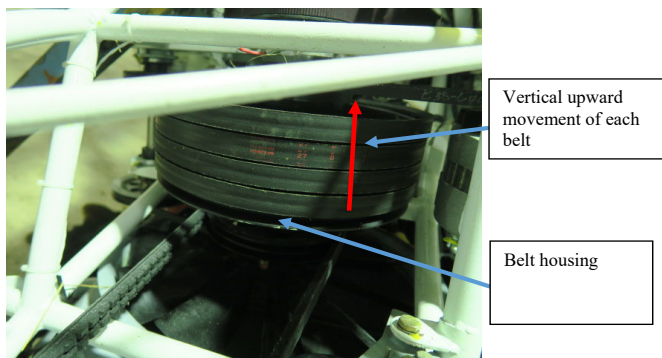
Figure 2: Drive belts outside their respective housings

Each of the four belts was displaced to the next highest housing (cf. Figure 2). The belts were taut and in good condition.

These findings indicate that the engine was operating at the time of impact and was supplying power to the rotors. The latter were suddenly blocked on coming into contact with the ground, generating an overtorque resulting in the belt jumping.

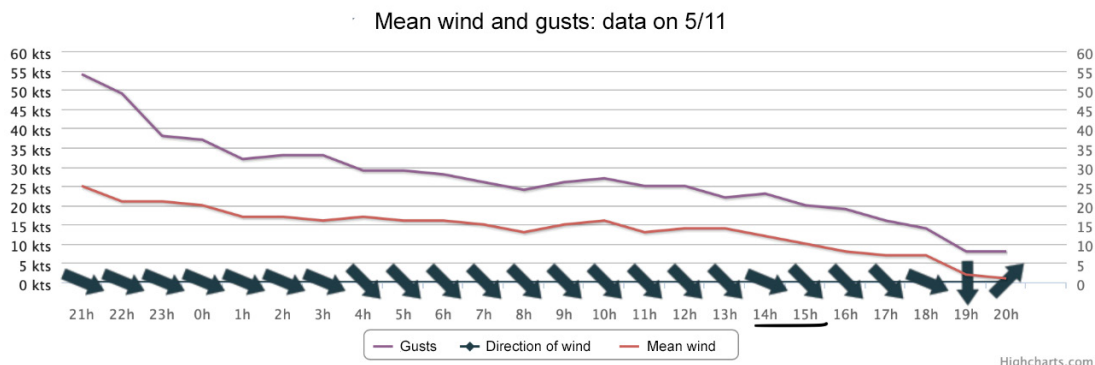
Figure 3: Wind measurements at Saint-Pierre Pointe-Blanche airport (LFVP)

At the time of the accident, the weather station based at Saint-Pierre Pointe-Blanche airport, situated at around two kilometres south of the helipad, measured a westerly to north-westerly wind of 12 to 25 kt. However, more marked variations in the wind direction between 270° and 360°, between 14:00 and 15:00, were observed. According to the Saint-Pierre Météo-France weather expert, even if they do not appear significant compared to what can be found at the airport, the risk of a small vortex phenomenon<sup>(4)</sup> or a small becalming phenomenon<sup>(5)</sup> linked to the proximity of high ground, trees or buildings may have existed very locally on the accident site.

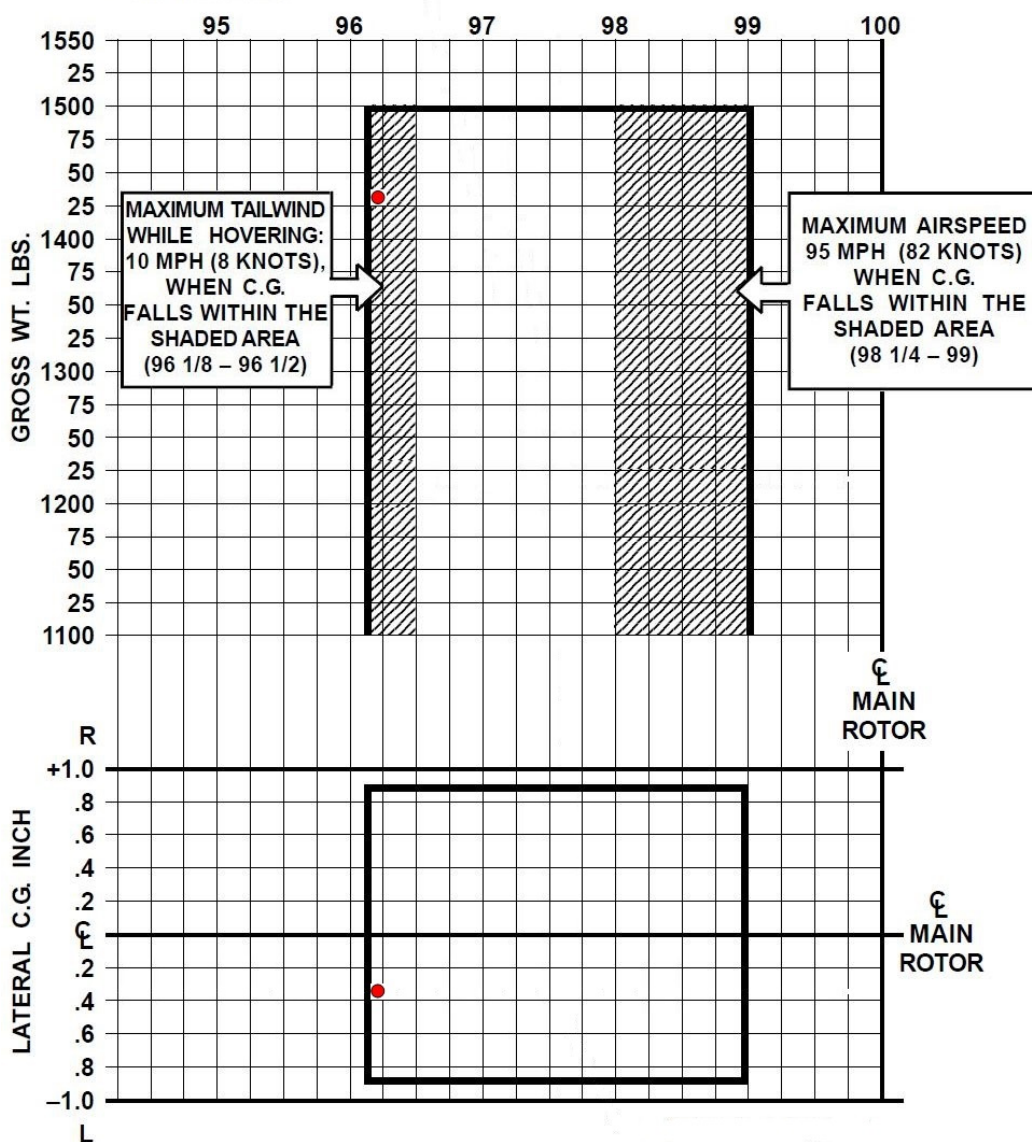
Figure 5: Weight and centre of gravity on day of accident •, diagram taken from flight manual

The flight manual states that a counterweight<sup>(8)</sup> must be attached to the rear of the airframe under the tailboom for a flight with two persons on board. The photos taken during the accident flight show that the helicopter was not equipped with a counterweight.

After the first flights, the pilot had replaced the original battery which weighs 12 kg with a lighter battery weighing 2.5 kg. In this configuration, with the two co-owners on board, no counterweight and a full tank, the helicopter was within the weight limits but at the edge of the centre of gravity envelope. The aircraft had a forward left centre of gravity (cf. [Figure 5](#) below).

In the flight conditions, the centre of gravity was located in the shaded area. In this area of the diagram, the helicopter will require very quick, large-amplitude reactions from the pilot to keep control of it during hover. In this area of the diagram, gusts can amplify this phenomenon.

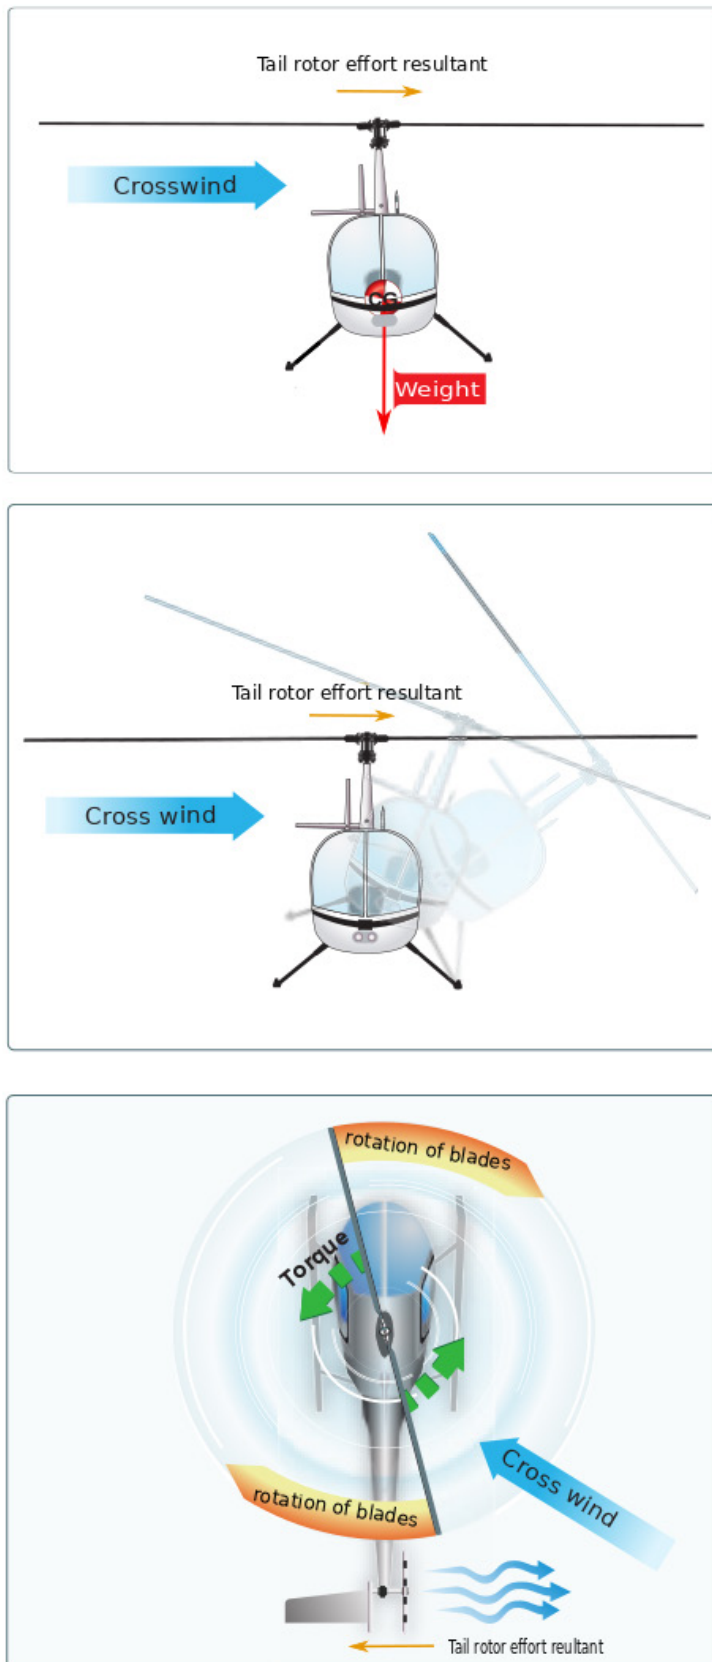
Figure 6: Reaction of a helicopter to a right tailwind gust

With a right tailwind, the relative speed of the retreating blade of the main rotor (right side of helicopter) increases and the relative speed of the advancing blade of the main rotor (left side of helicopter) decreases. This leads to greater lift on the right side of the helicopter and less lift on the left side. The main rotor disk plane then tilts to the left causing the helicopter to enter a left roll.

In the event of a strong gust, it is possible that the lift generated by the advancing blade significantly decreases. The start of roll may be very sudden.

To manage such a situation, the pilot must counter the start of left roll by a quick right input on the cyclic control of sufficient amplitude.
