## Accident to the CIRRUS - SR22 GTS registered F-HUGE

on 10 December 2018

at Beaubery (Saône-et-Loire)

## Loss of control in flight without external visual references, collision with ground

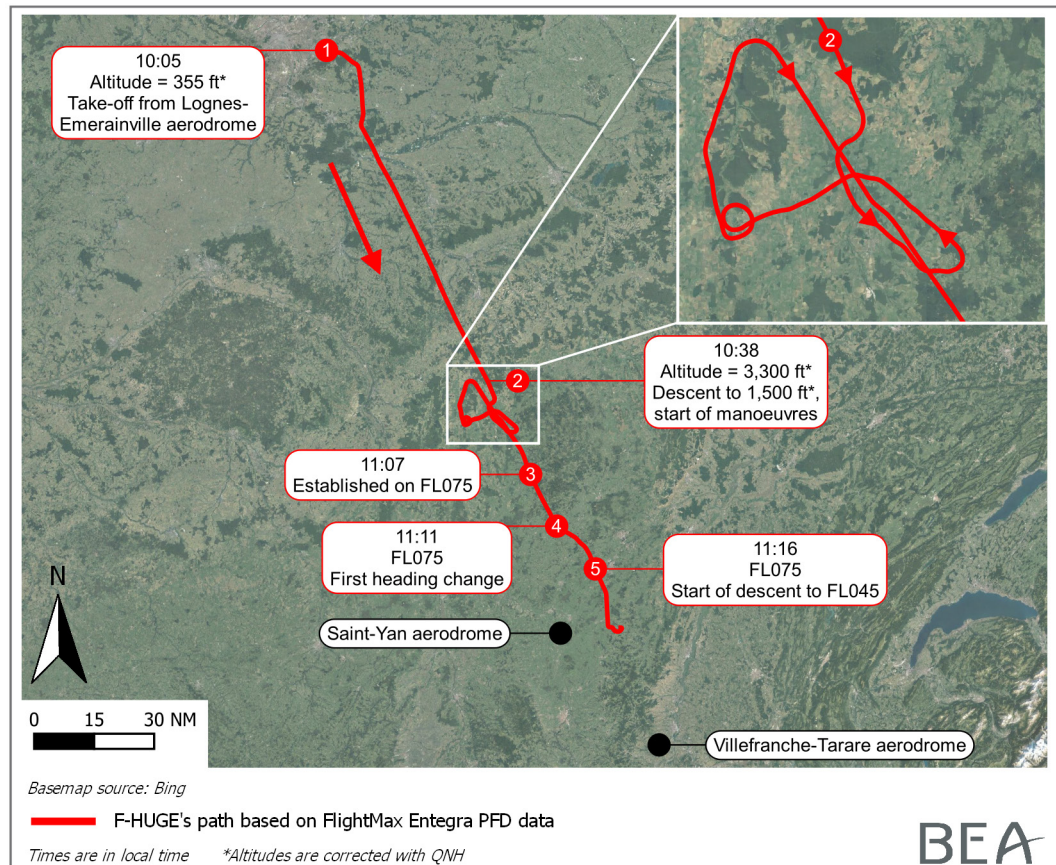
Figure 1: Flight path

The pilot<sup>(2)</sup> took off at 10:05 (point ① of Figure 1). The first part of the flight was carried out with the autopilot in lateral NAV mode at altitudes which were frequently modified, varying between 2,500 ft<sup>(3)</sup> and 3,500 ft.

Midway into the flight, at 10:38, the pilot started a descent to 1,500 ft <sup>(2)</sup> and changed the autopilot settings in quick succession (alternation between NAV and HDG modes, selection of different headings) resulting in him making a U-turn during which the aeroplane reached a minimum height of 330 ft before turning west. The pilot then disconnected the autopilot and flight director (FD) and started climbing. He made a 360° turn. On completion of the turn, at an altitude of 5,000 ft, the passenger in the right seat contacted the Clermont FIS. He indicated that they intended to pass above the cloud layer and asked for the weather conditions at Lyon-Bron (Rhône) and Saint-Yan (Saône-et-Loire) aerodromes. The pilot then headed north and activated the flight director in HDG mode.

At 10:58, the pilot made a U-turn and continued at FL065<sup>(4)</sup> towards Villefranche-Tarare aerodrome with the autopilot in lateral NAV mode. A video taken by the passenger sat in the rear showed that they were above the clouds. The aeroplane was then established on FL075 <sup>(3)</sup>.

At 11:11, the pilot made a sidestick input to change the heading by around 30° to the left <sup>(4)</sup>. During this manoeuvre, the aeroplane reached a left bank angle of 45°. The pilot then disconnected the autopilot which resulted in the cancellation of the opposing load on the controls<sup>(6)</sup>. He continued in manual flight for one minute and then re-engaged the autopilot with the lateral HDG mode and progressively returned to a southward path (160°). The pilot then selected different flight levels (FL070 and then FL075 again) before starting a descent at 11:16 to FL045 with the vertical VS mode <sup>(5)</sup> set to -1,000 ft/min.

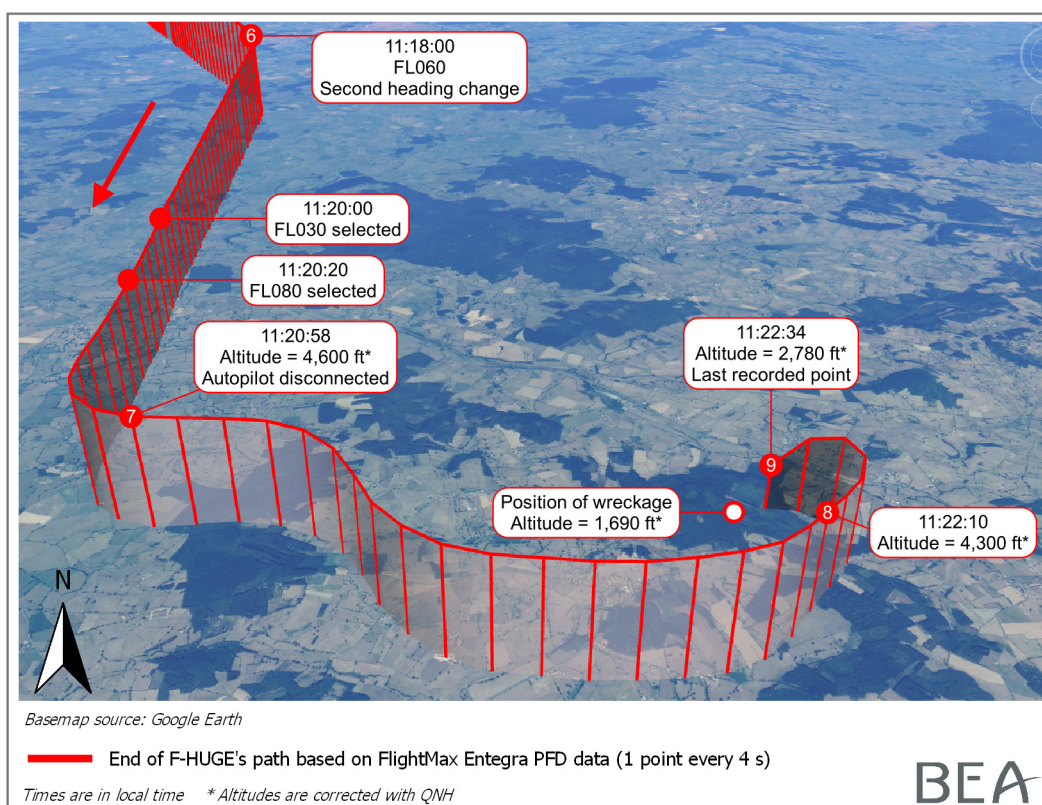
Figure 2: End of the path

At 11:18, flying through FL060, the pilot changed the heading again by around 20° to the right (route 180°) with the lateral HDG mode (point 6 of Figure 2) and then selected FL040. At 11:20, the pilot selected FL030 and a vertical speed of -500 ft/min.

At 11:20:20, the descent was stopped at around 4,500 ft by selecting a vertical speed of 0 ft/min, then +500 ft/min and FL080. The aeroplane climbed again. Twenty seconds later, as the autopilot was executing the climb with an attitude of around 3°, the selected vertical speed increased to +950 ft/min. Once again, the pilot overrode the autopilot by banking the aeroplane 45° to the left. The pilot then disconnected the autopilot (7) and the flight director. He next made a right turn followed by a left turn with bank angles of around 30 to 40°. During this left turn, the plane's bank and attitude were not stabilized but the altitude remained between 4,300 and 4,600 ft.

At 11:22:10 (8), the pilot started a left turn with a bank angle exceeding 90° and a nose-down attitude reaching 30°. The aeroplane collided with the ground with high energy around 30 s later.

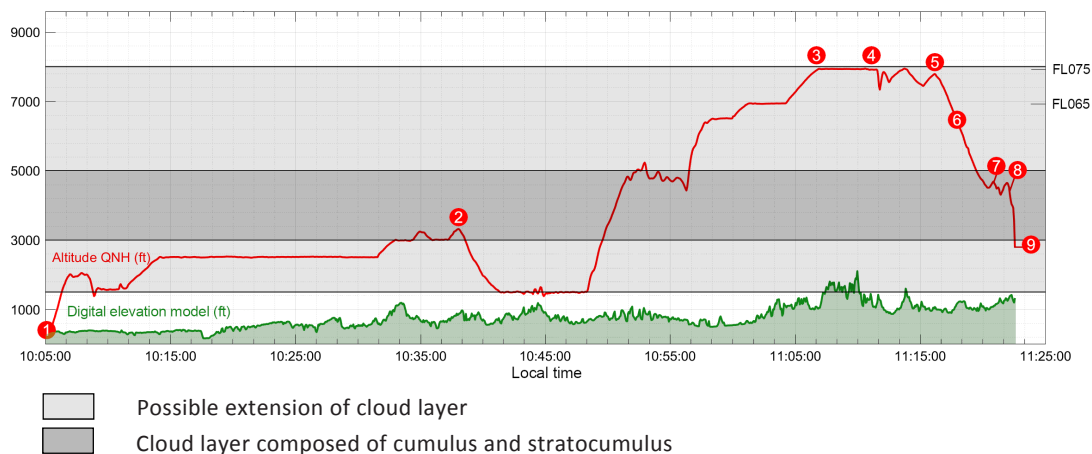
Figure 3: Vertical profile of flight and cloud layer according to 10:00 FRANCE SIGWX chart

The major part of the path, excluding the departure, was situated in a single zone marked out by a scalloped line. The main information concerning the path was the presence of:

- ☐ cumulus (Cu) and stratocumulus (Sc), broken (BKN) and locally scattered (LOC SCT), based at an altitude of between 1,500 ft and 3,000 ft, with the tops between 5,000 ft and 8,000 ft;
- ☐ rain and showers;
- ☐ moderate icing between 3,000/4,000 ft and 8,000 ft;
- ☐ visibility greater than 8 km and locally reduced to values between 5 and 8 km, probably due to rain.

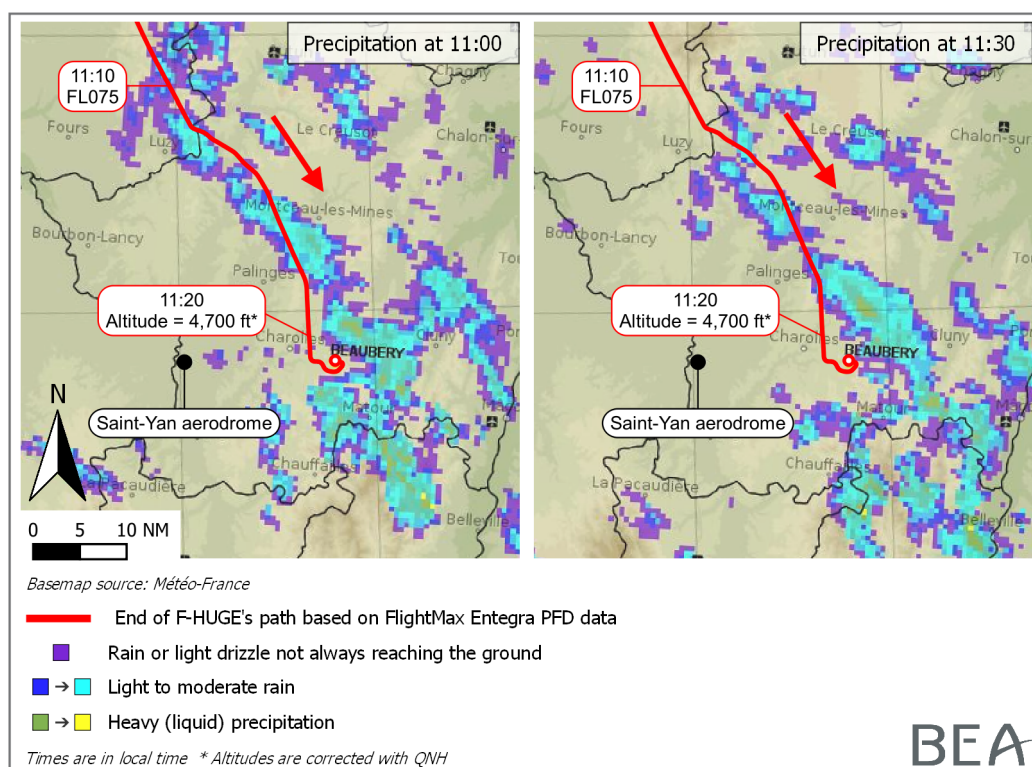
Figure 4: Rain charts at 11:00 and 11:30

When the aeroplane's path is overlaid on the rain charts, it can be seen that the pilot was heading towards an area of precipitation.

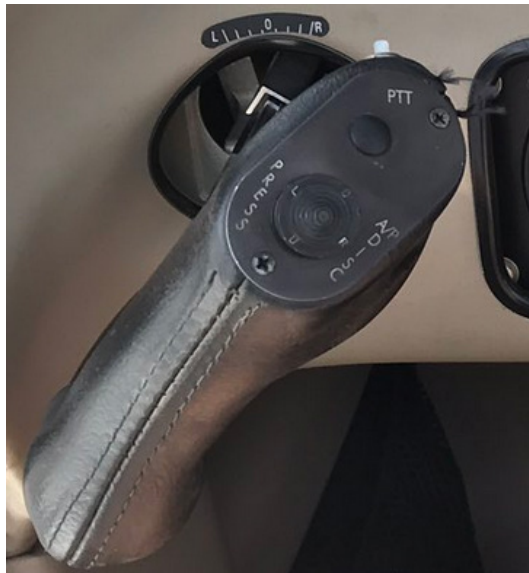
Figure 5: Stick on pilot's side

The aeroplane was equipped with an electrical control system for the pitch and roll trim. It is operated by a four-way trim switch installed on each sidestick (refer to [Figure 5](#)). This switch can only be used to trim the plane if the autopilot is not engaged.

On F-HUGE, the autopilot could be disconnected by pressing the four-way trim switch<sup>(10)</sup>. Pressing this switch also disconnects the flight director.

A stick input would not disconnect the autopilot and the loads would accumulate.
