## Accident to the Airbus AS 350 B3 registered F-GKMQ

on 7 January 2019  
at Puylaurens (Tarn)<sup>(1)</sup>

## Loss of control while setting down a slung load, collision with vegetation and then ground

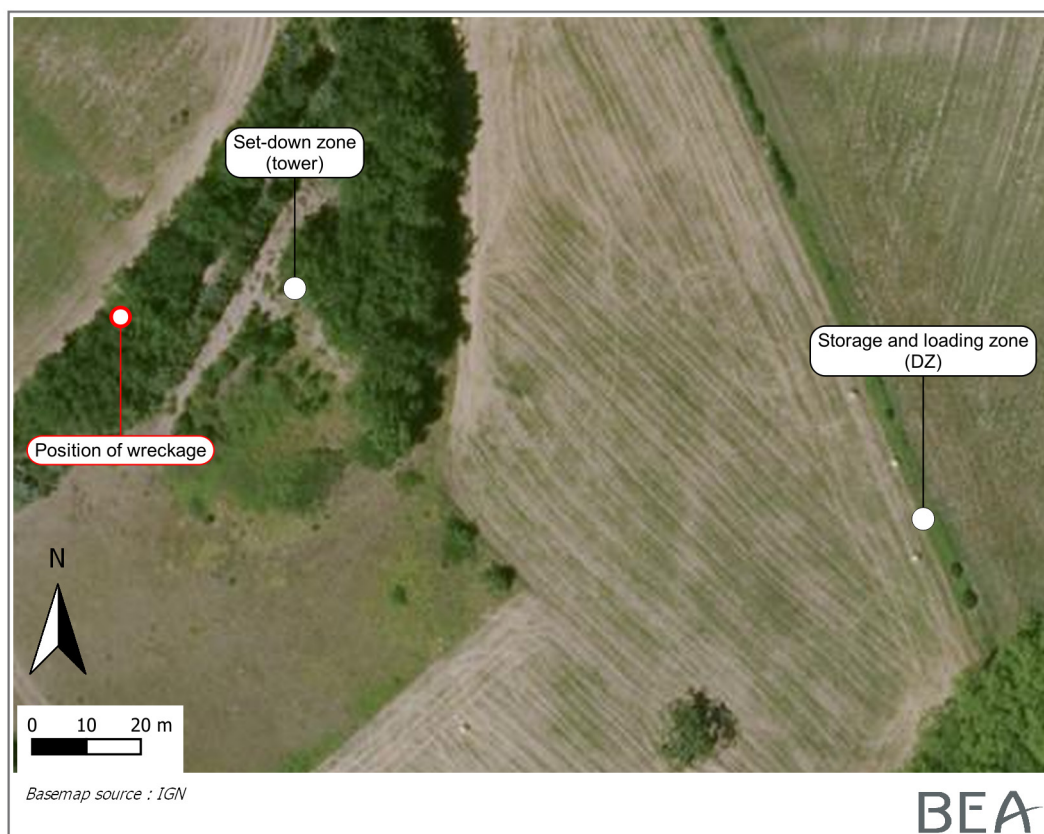
Figure 1: F-GKMQ manoeuvring zone

The two other pins were about to be fitted when the helicopter slightly descended and then suddenly climbed with the section, separating it from the rest of the structure. The pilot lost control of the helicopter which entered a roll, striking trees before the left side collided with the ground below the tower installation zone (see Figure 1).

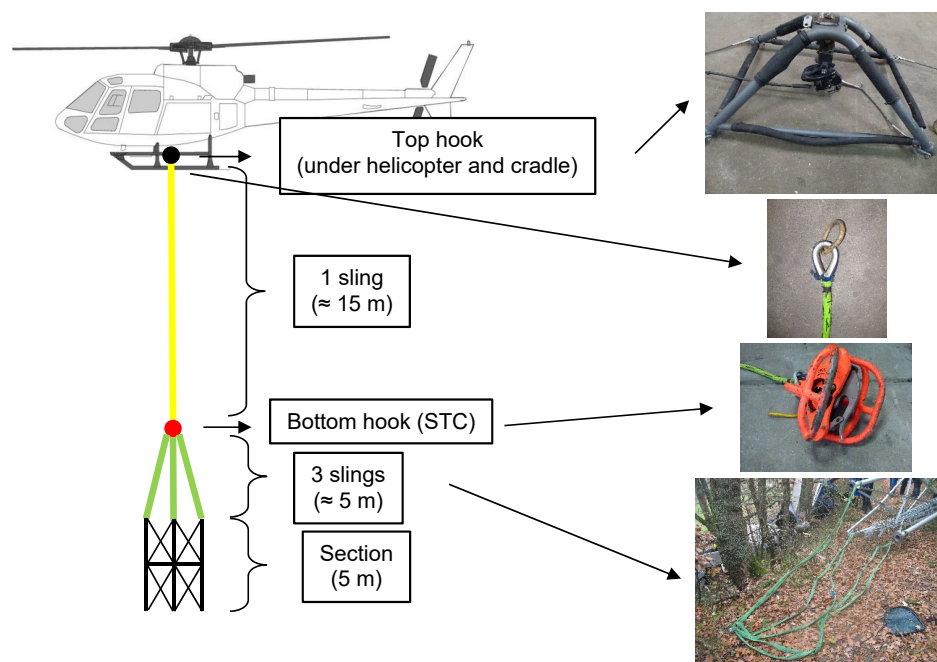
Figure 2: Diagram of slinging system

The system is composed of a sling around 15 m long connecting the helicopter's top hook to a bottom hook installed under an STC. A shackle is then attached to this bottom hook, connecting three slings around 5 m long, each attached to a leg of the section being transported (see Figure 2).

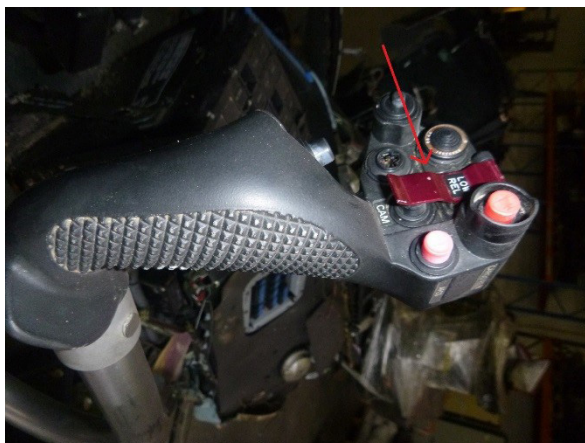
Figure 5: “LOW REL”

The collective pitch twist grip was found in the “*FLIGHT*” position. The “*LOW REL*” control tab was found in the raised position, probably the consequence of the collision with the ground<sup>(8)</sup>.

The electrical power supply of the bottom hook release system is provided by the helicopter’s electrical master box. Tests found that the fuse in the electrical master box protecting the bottom hook control system was damaged. Given the substantial damage to the front of the helicopter, in particular to the pedestal, the damage to this fuse was very probably caused by a short-circuit during the accident sequence. After being replaced, the bottom hook release system operated correctly. It is thus very probable that the bottom hook release system was operational during the occurrence.

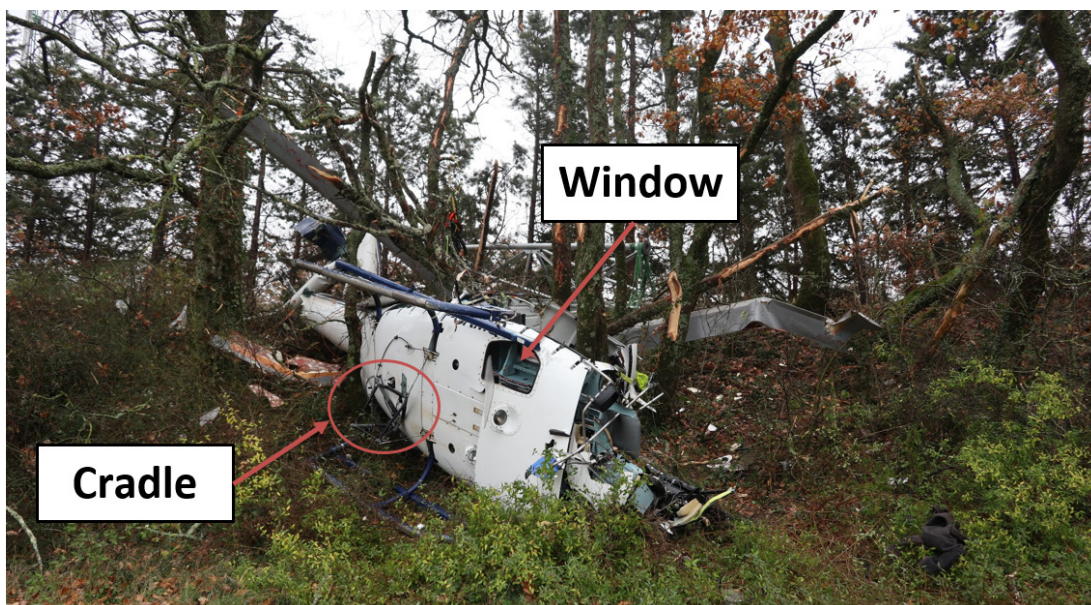
Figure 6: General view of wreckage

The wreckage was situated in a wooded area, below the zone where the tower was installed. It was resting on its left side.

The fourth tower section was situated a few metres higher than the wreckage. The three slings were connected to its legs and joined to the shackle found disconnected from the bottom hook. An attachment pin was in position on one of the tower's legs.

The bottom hook was found under the wreckage in the closed position. The sling joining the bottom hook to the top hook was still connected to the bottom hook and was wrapped around the main rotor shaft. The top ring of the sling, found near the tower section, was not connected to the top hook. The latter was found closed and correctly attached to the helicopter by the cradle system.

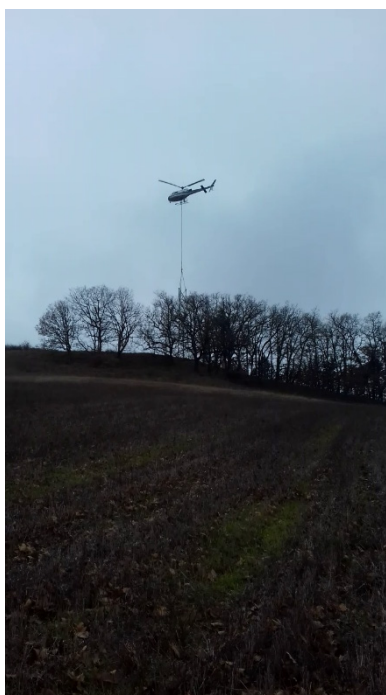
Figure 7: Image taken from sequence filmed by technician

The video recording shows the helicopter from the side (nose pointing left) hovering above the tower for around 20 s, the fourth section was stable and positioned above the tower at the end of the taut sling.

The helicopter then slightly tipped downwards and forwards losing height, causing the sling to slacken. The helicopter quickly regained height by moving forwards which drew the sling tight until the fourth section separated from the structure.

The helicopter rolled to the right until reaching a nose-up position while the load was raised and the sling was slightly slack. The load then fell, tightening the sling and dragging the helicopter towards the ground. The last visible images of F-GKMQ show the helicopter pointed towards the camera with a zero attitude and decreasing, and a bank angle of around 45° to the right.

During all of the sequence where the helicopter is visible, the load appears to be hooked to the sling.

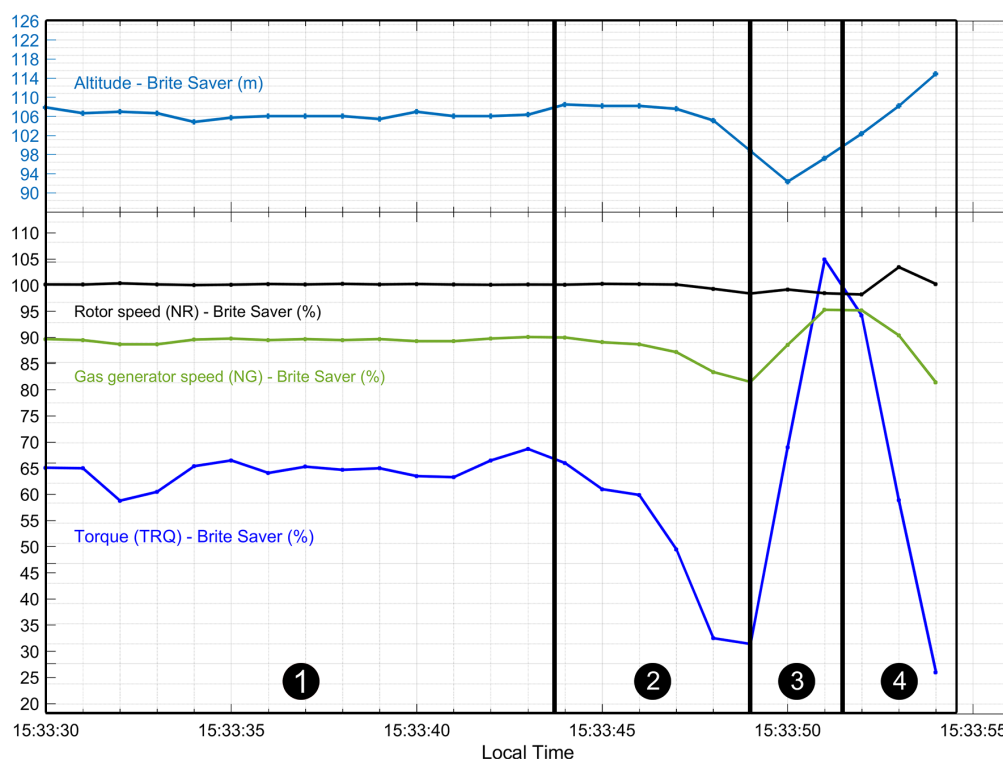
Figure 8: Evolution of certain parameters taken from the computers

The analysis of these parameters permits us to define four clear sequences during the accident flight:

- ☐ Sequence 1 corresponds to the nominal flight, during which the helicopter is in hover over the structure.
- ☐ Sequence 2 corresponds to a reduction in the engine rating during which a slight decrease in altitude is observed.
- ☐ Sequence 3 corresponds to an increase in the engine rating; the altitude progressively increases.
- ☐ Sequence 4 corresponds to a new reduction in the engine rating; it is during this phase that the helicopter has high and unusual variations in altitude.

These parameters were compared to those obtained in flight simulations and tests carried out by Airbus and Safran Helicopter Engines. This analysis showed that the helicopter and its systems were operating nominally at the time of the accident. Sequences 2 and 3 can thus very probably be explained by the collective pitch lever in the cockpit being progressively lowered (reduction in pitch) and then quickly raised (increase in pitch), which is consistent with the simulations carried out.
