## Accident to the AEROS SKYRANGER registered 13LZ

on 7 May 2019

at Saint-Antonin-sur-Bayon (Bouches-du-Rhône)

## Collision with the terrain

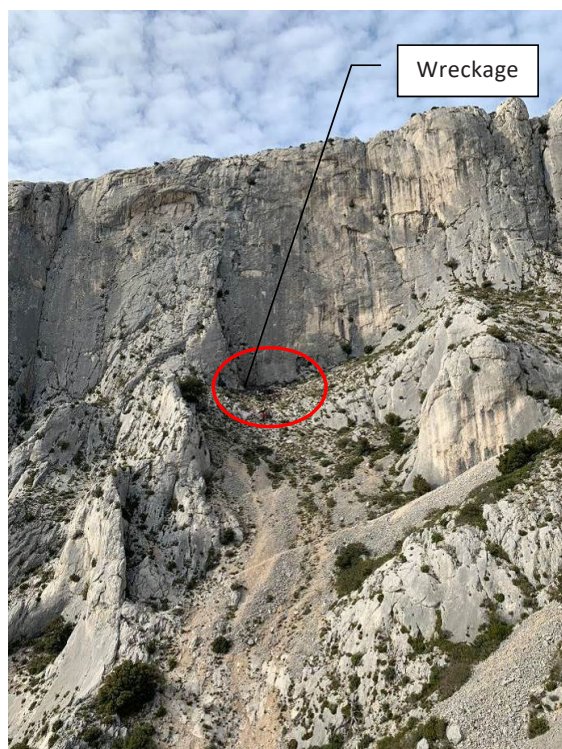
Figure 2: General view of the site and the wreckage

The wreckage was found at an altitude of 830 m, in a scree on the south slope of the mountain. Positioned 25 m below the peak, at the foot of the rocky face rising 855 m above the wreckage (see [Figure 2](#)), it was lying flat on the slope facing towards the mountain face. The microlight was completely burned except for all of the metal structures and some of the tailplane covering. The instrument panel was destroyed. The pilot's seat-belt buckle was found locked. The airframe parachute flare went off after collision with the ground<sup>(3)</sup>.

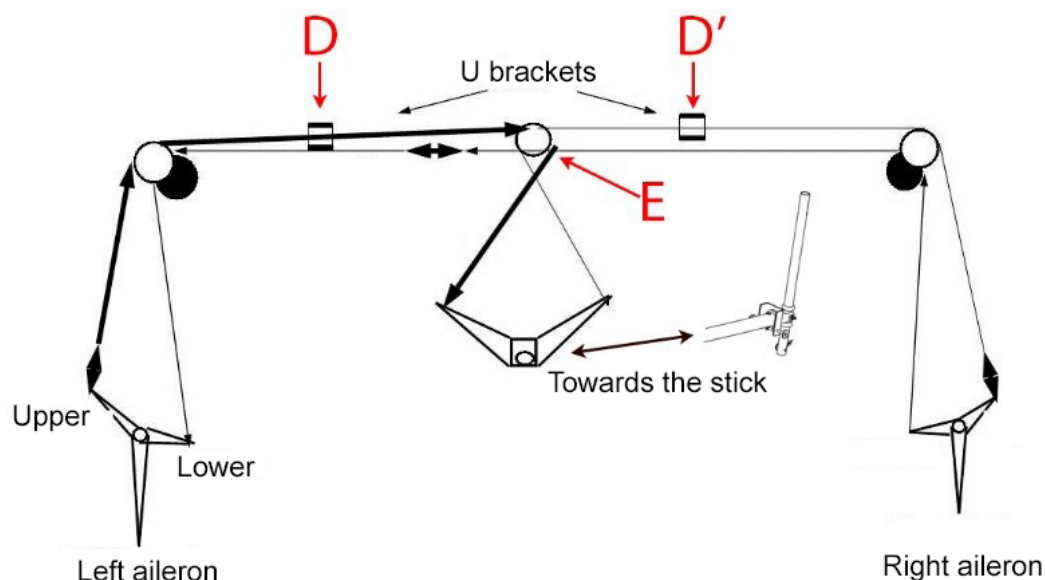
Figure 3: Functional diagram of the aileron control and areas of damage

- ☐ A breakage of all of the strands of the upper cable linked to the right aileron (zone E) located in line with the pulleys orienting the vertical cables to the wings (see [Figure 3](#)) and the presence of some wires with a morphology of fracture surfaces indicating friction wear (SEM<sup>(5)</sup> examination). However, it was not possible to determine if cable breakage had occurred before or during the accident.
- ☐ The presence of broken wires on both upper cables (zones D and D') at the U-brackets of each wing (see [Figures 3 and 4](#)). Nevertheless, this damage probably did not impact the manoeuvrability of the aileron control.

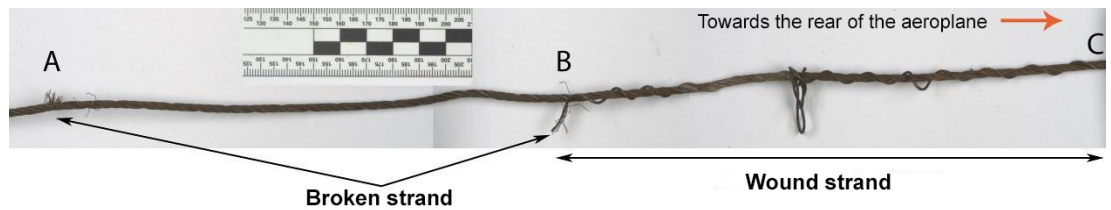
Figure 5: Damaged section of the LH cable of the rudder control

The visual examination of the LH cable on site showed that a section of the cable had a broken strand<sup>(6)</sup> which had wound around the cable over 20 centimetres (see [Figure 5](#)). The SEM examination of the broken strand showed that the fracture surfaces of some wires presented a morphology characteristic of friction wear. These observations indicate that the strand had probably broken before the impact with the ground, the breakage of just one strand at impact being highly unlikely.

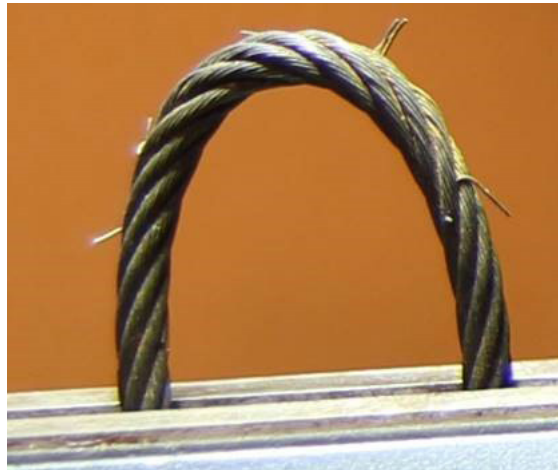
Figure 6: Position B of the RH cable with presence of broken wires upstream of pulleys, pedal in neutral (cable bent using a vice in the laboratory to provide a better view of the broken wires)

The laboratory examination of the RH cable using the rag method showed the presence of multiple broken wires at a position equivalent to position B on the LH cable (see Figure 6).

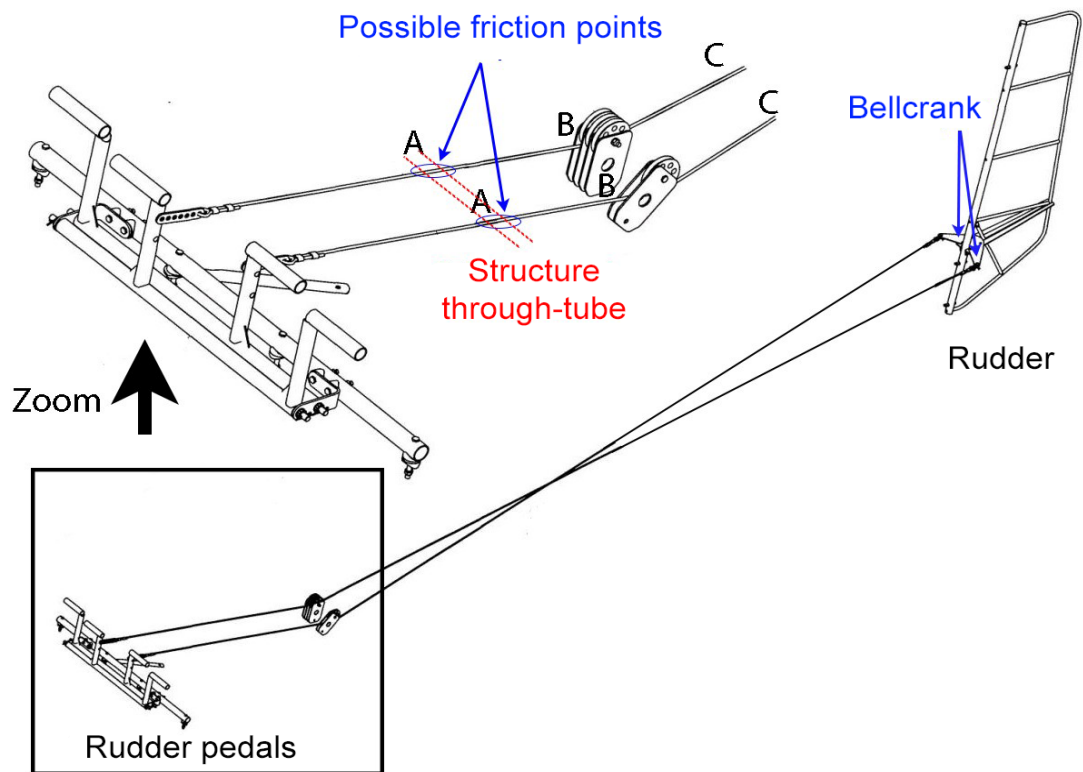
Figure 7: Functional diagram of the rudder control and positions of damage

- ☐ position A corresponds to an area of possible contact with a tube of the structure located under the seat;
- ☐ position B corresponds to a position just upstream of the pulleys;
- ☐ position C corresponds to a position downstream of the pulleys.

The presence or absence of a protection<sup>(10)</sup> between the metal tube of the airframe structure and the cable in position A was unable to be checked on the microlight involved in the accident due to the consequences of the fire. The pulleys were completely destroyed and it was not possible to examine them.

Taking into account the possible deflection of the cables, positions B of the RH and LH cables as well as a part of the winding of the LH cable are sections that pass through the pulleys.

- ☐ Revealed on the RH cable the presence of broken wires using the rag method on the section of the cable that passes through the pulley.
- ☐ Showed that a strand on the LH cable was probably broken before the impact with the mountain face. The winding of the strand around its cable may have restricted or even prevented the passing of the cable through the pulley. As the pulleys were unable to be examined, any blockage of the cable was unable to be confirmed.
