## Accident to the KUBICEK BB45Z registered F-HOAX

on 7 July 2019

at Puimoisson (Alpes-de-Haute-Provence)

## Emergency landing at high speed in a field, near a storm

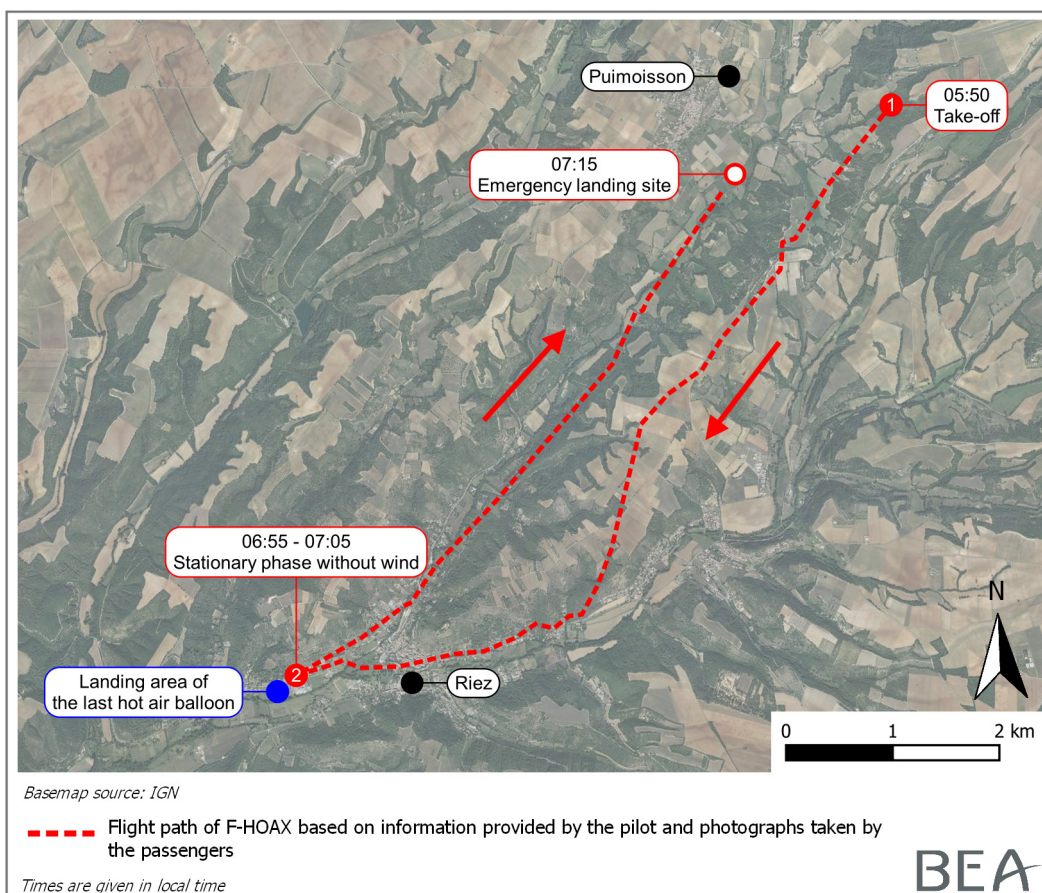
The hot air balloon then began to fly in a northeasterly direction and rapidly picked up speed to reach around 50 km/h. Observing that the balloon was travelling towards a dark and ominous-looking cloud mass located over Puimoisson, the pilot decided to abort the flight and look for a field to make an emergency landing.

Figure 1: Approximate flight path of the hot air balloon

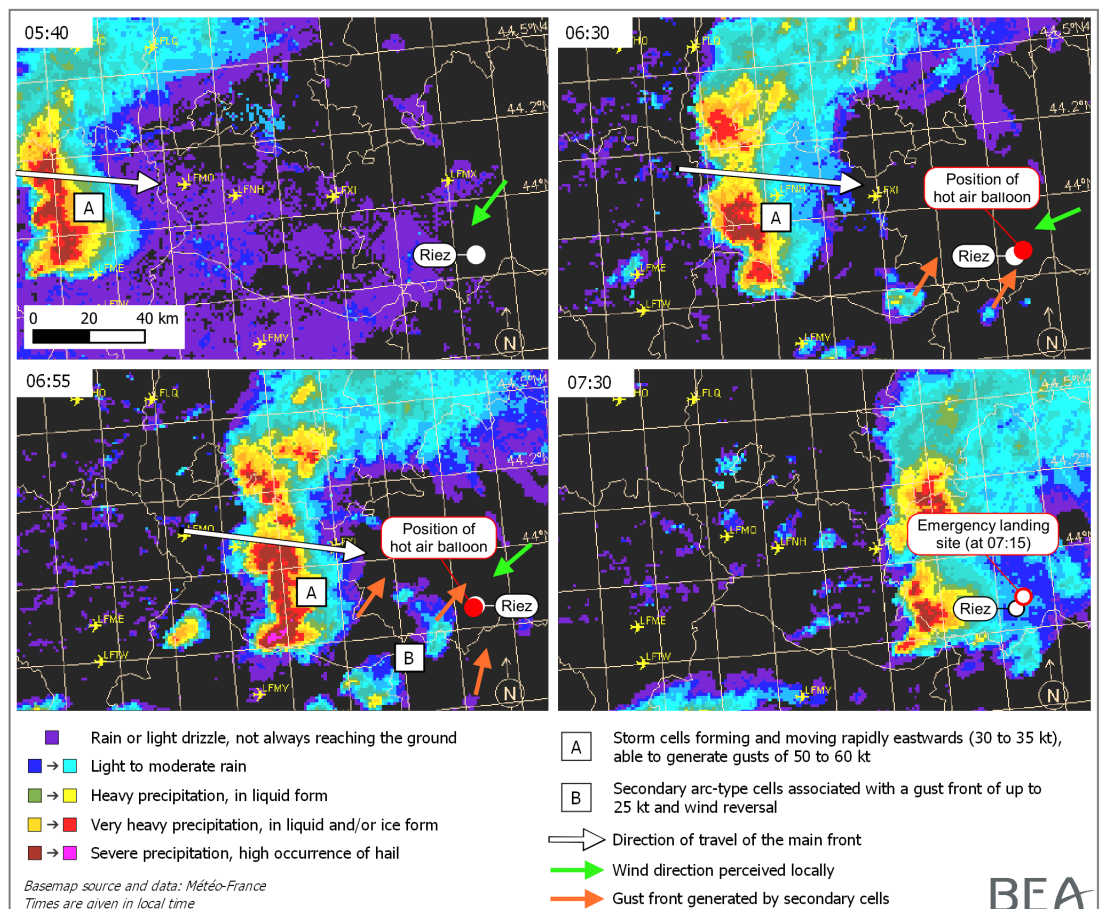
The conditions estimated after the accident by Météo-France on the hot air balloon's path up to the site of the accident were as follows (refer to [Figure 1](#)): at 05:40, 20 km visibility, clear skies between Puimoisson and Riez, wind from the north-east less than 10 kt in the area immediately around Puimoisson aerodrome. Intensifying storm cells were present to the north-east of Nîmes<sup>(17)</sup> and were moving eastwards. The main cell was moving at an average speed of around 25 kt. Around 06:30, the sky very quickly became overcast. An arcus<sup>(18)</sup> type cloud had reached Riez generating new storm cells on the hot air balloon's flight path and an air flow from the south-west of 30 to 35 kt. This altered the conditions, creating severe turbulence. Precipitation, initially moderate then becoming heavier, reached the location of the accident approximately ten minutes after the hot air balloon had landed.

Figure 2: Maps showing radar reflectivity during the hot air balloon's flight

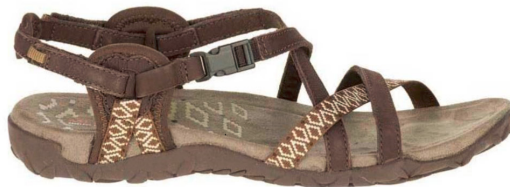
The passenger notably suffered a double ankle fracture due to a valgus collapse caused, at the joint, by the rapid shift of the body's weight sideways when the basket first made contact with the ground. The straps on her footwear (Figure 3) did not support her ankle when it was subject to a sudden load on impact.

Figure 3: Model of sandals worn by the passenger who was severely injured

- ☐ The wearing of sandals that failed to provide sufficient ankle support.
- ☐ The "facing the direction of travel" position that she adopted inside the basket at the time of the emergency landing.

Since the accident, the wording "*passengers wearing unsuitable footwear will not be permitted to fly*" has been added by the company to the safety instructions sent to passengers along with their flight invitation.
