## Accident to the COMCO IKARUS C42 identified 03AEN and the Schleicher ASK21 registered F-CITS on 11 September 2019 at Itxassou (Pyrénées-Atlantiques)

## Loss of control of tug microlight at take-off and collision with the ground; collision of towed glider with a tree, in instruction

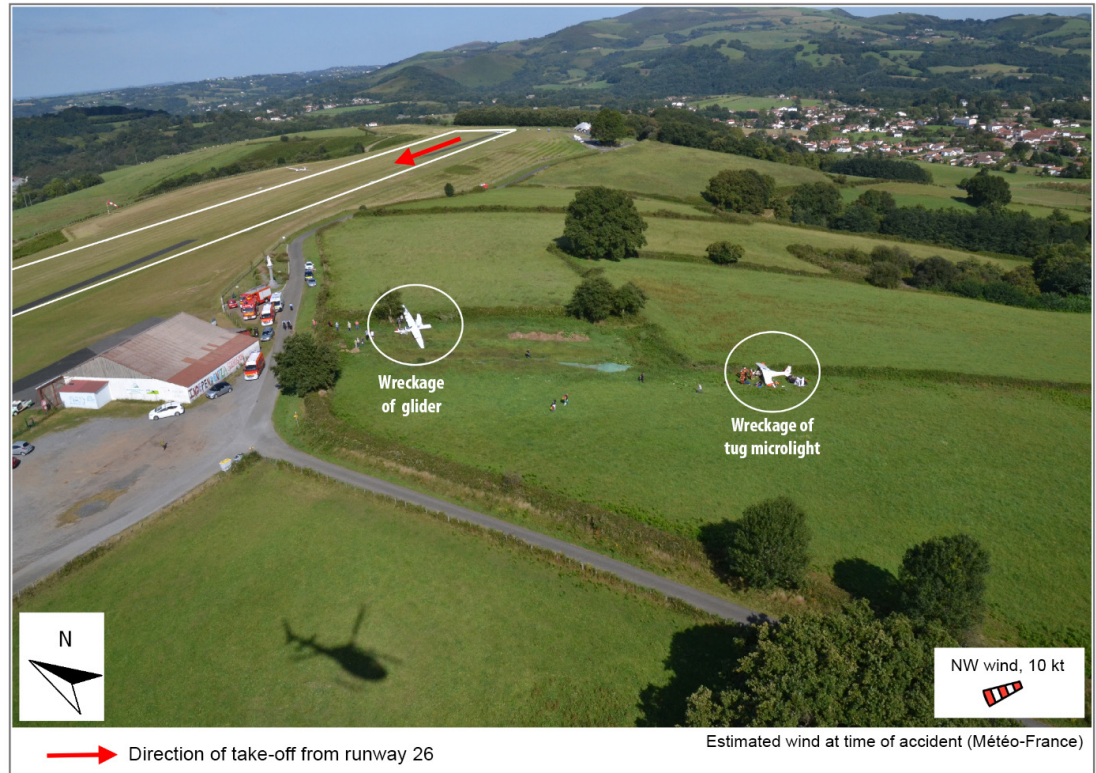
Position of the wreckages

Both wreckages were found to the south of the aerodrome runway. The glider wreckage was approximately 110 m south of the runway centreline, near a tree. The microlight wreckage was approximately 70 m further south (see illustration).

The microlight wreckage was complete and not dispersed. Observations of the wreckage found that the microlight had struck the ground with a nose-down attitude and a left bank angle. The position of the flaps when it collided with the ground could not be established with certainty. The examination of the microlight wreckage did not bring to light any anomaly likely to have contributed to the accident.

The glider presented damage consistent with the impact.
