Accident to the AIRBUS AS350 - B2 registered 3A-MLC

on 26 September 2019

at Col de Véry (Savoie)

Engine in-flight shut-down, autorotation, damage to the drive shaft by the main rotor when landing in a field

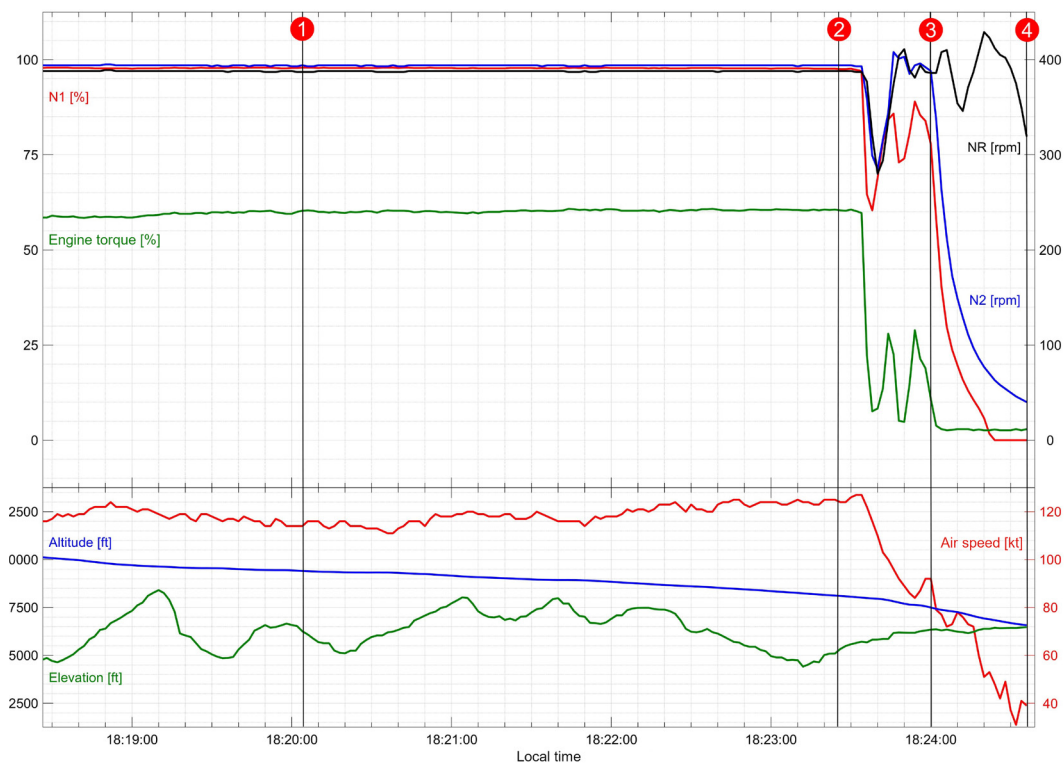
Figure 2: Flight parameters

Taking the pilot's statement into account, the **MOT.LIM** indicator light illuminated shortly before point ❶ which corresponds to the change of heading towards Megève mountain airfield.

Up to point ❷, i.e. for around four minutes, the engine parameters were nominal.

Between points ❷ and ❸, the fluctuations in engine parameters indicated a rapid deterioration of the engine and an abnormal operation.

From point ❸, the rapid decrease in free turbine rotation speed (N2) and gas generator speed (N1) indicated that the engine shut down. The engine torque of 0 showed that the engine was no longer transmitting power to the rotor. The rotor rotation speed (NR) was no longer synchronised with the free turbine speed (N2), which indicated the start of the autorotation.

A drop in rotor rotation speed in the nine seconds preceding contact with the ground was also visible and very likely corresponded to the flare made by the pilot to land.

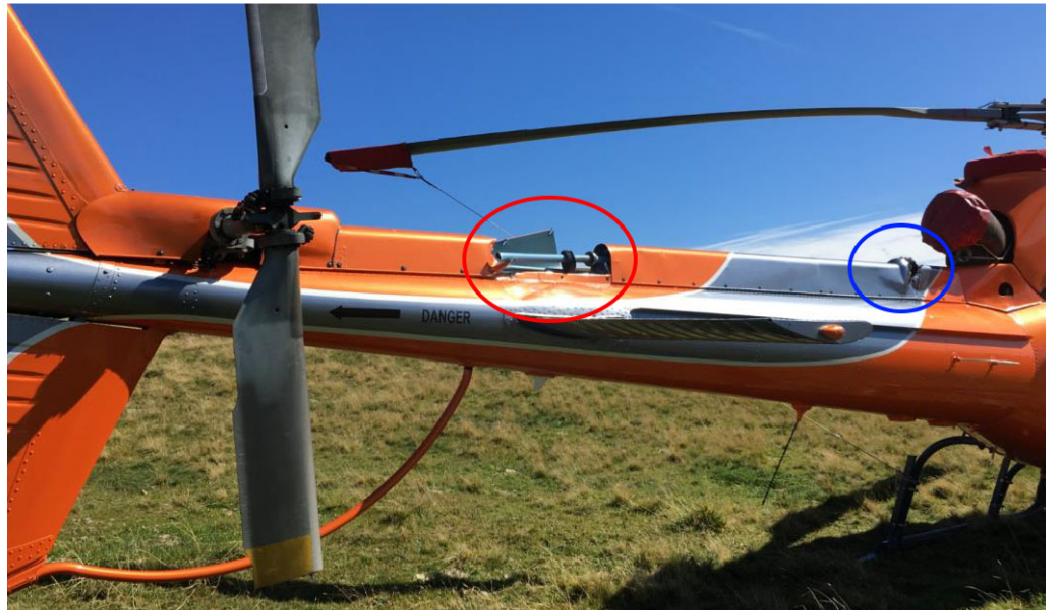
Figure 3: External damage on the tail boom

The helicopter had two areas of damage on the tail boom:

- ☐ The tail rotor drive cover was torn at its boss (Area 1).
- ☐ The tail rotor drive cover was partially torn off in the horizontal stabilizer area (Area 2). The tail drive shaft was cut. The tail rotor pitch-change rod was distorted.

Examinations conducted on site and in the workshop showed that one of the main rotor blades (yellow blade) had two contact marks on its lower surface, approximately 30 cm from the tip, as well as paint marks (of a colour identical to that of the tail drive shaft) at the blade tip leading edge.

This contact, which led to the fracture of the tail drive shaft, probably resulted from the combination of several factors, such as a slow rotation speed of the main rotor associated with a substantial movement of the cyclic pitch stick backwards and a tipping effect of the airframe associated with the contact of the tail boom skid with the ground.

When the tail rotor drive shaft broke, the tail rotor came into contact with the tail rotor pitch-change rod (yaw) thus causing its forced movement and its distortion, which almost certainly caused the jolt in yaw felt by the pilot.

The steel short shaft (engine side), still driven in rotation, was no longer coupled to the rear drive shaft. It then started to flutter, which caused the damage observed at the boss.

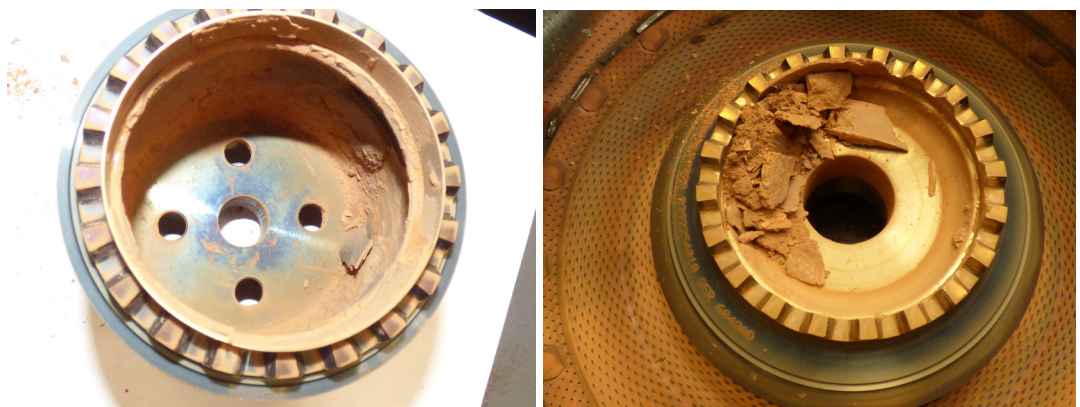
Figure 4: Presence of laterite inside the hollow shaft (on the left) and the injection wheel (on the right) coupling with the hollow shaft

- ❑ The presence of metallic particles on all of the magnetic plugs.
- ❑ A significant level of erosion (approximately 3 mm) on the leading edge of the blades of the axial compressor wheel (module 2).
- ❑ A significant level of erosion, greater than the tolerance values recommended by the manufacturer, of the leading edge of the centrifugal diffuser blades (module 3).
- ❑ Damage to the gas generator rear bearing presenting substantial wear of the rollers caused by friction with the internal track and an adhesive material due to seizure of the rollers.
- ❑ A large quantity of laterite on all module 3 components, and in particular the collection of 13.5 g of laterite from inside the hollow shaft⁽⁴⁾.
- ❑ Various damage on all of the rotating parts of the engine due to the failure of the gas generator rear bearing.

The damage to the gas generator rear bearing is characteristic of a deterioration due to the imbalance phenomenon. The imbalance was very probably caused by the partial detachment of the laterite present in the hollow shaft. The imbalance led to the damage of the rotating parts of the engine including the bearings, with the generation of chips which ended up in the engine oil system and caused the illumination of the warning indicator light during the flight.

The separation of some of the laterite that had built up in the hollow shaft of the engine's module 3 and that had not been detected during the previous years of engine operation, caused an imbalance on the engine's rotating parts. This imbalance caused damage to the gas generator rear bearing and the generation of chips, which triggered illumination of the **MOT.LIM** indicator light.
