## Accident to the PZL BIELSKO - SZD-51 registered F-CAJC on 3 October 2019 at Issoire Le Broc aerodrome (Puy-de-Dôme)

## Disconnection of elevator control, hard landing

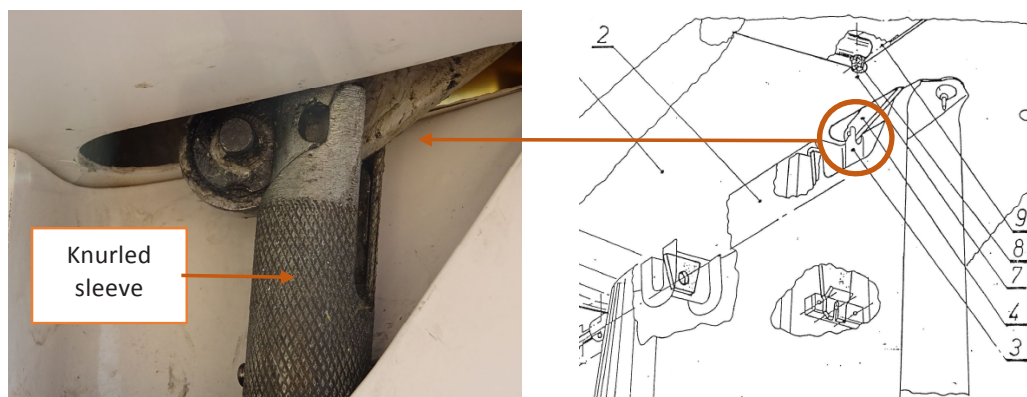
Figure 2: Disconnected elevator control

After the accident, the elevator control system was found to be disconnected between the quick-release end (3) and the elevator lever (4).

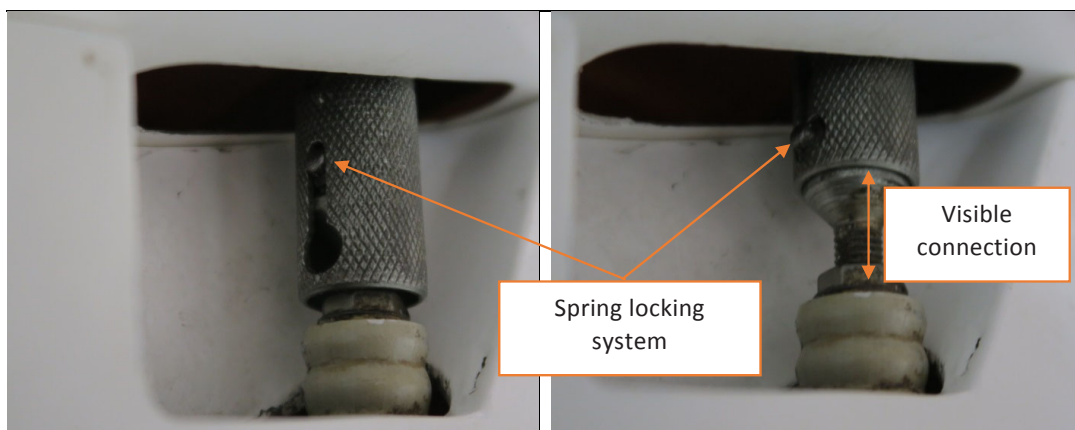
Figure 3: Sleeve slid to the bottom of the quick-release end (not locked)

Figure 4: Sleeve slid to the top of the quick-release end (locked), connection visible

The photos show that when the sleeve is correctly slid to the top and locked, the end piece to control tube connection is visible.

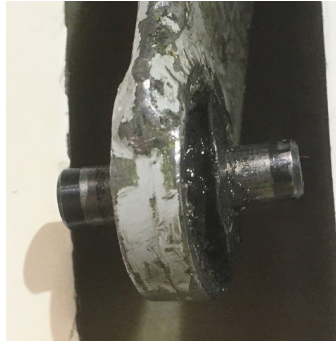
A detailed examination of the lever bolt found that the two washers on each side of the lever, which are integral to the bolt, were both distorted.

Figure 5: End of the left side of the lever

These distortions may prevent the sleeve from sliding up and down when the lever bolt is in place. The technical manager indicated that he had never had any particular difficulty sliding this sleeve. It is possible that the worst of the damage seen on the washers was caused by the interaction between the sleeve and the elevator lever during the hard landing.

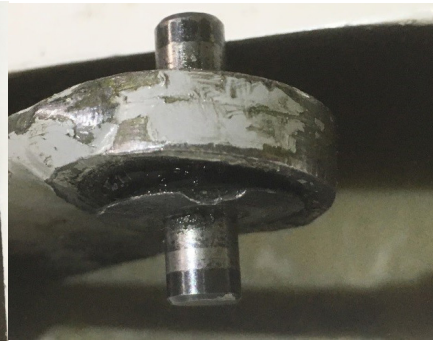
Figure 6: End of the right side of the lever

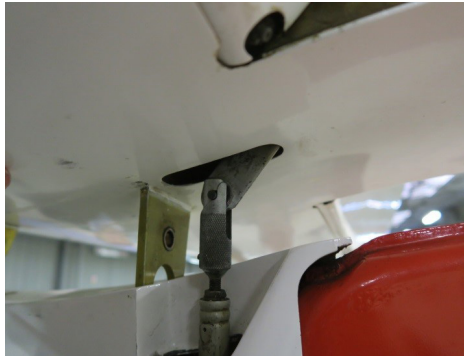
Figure 9: Connection made and sleeve locked with the spring system in its up position (secure connection)

If the sleeve is not fully slid to the top, it is not locked by the spring system and can slide down, thus disconnecting the connection between the quick-release end and the lever.
