Accident to the ROLLADEN SCHNEIDER LS7-WL registered F-CGYB

on 15 October 2019

at Pic Saint-Loup in the commune of Cazevieille (Hérault)

Collision with the terrain in slope soaring flight

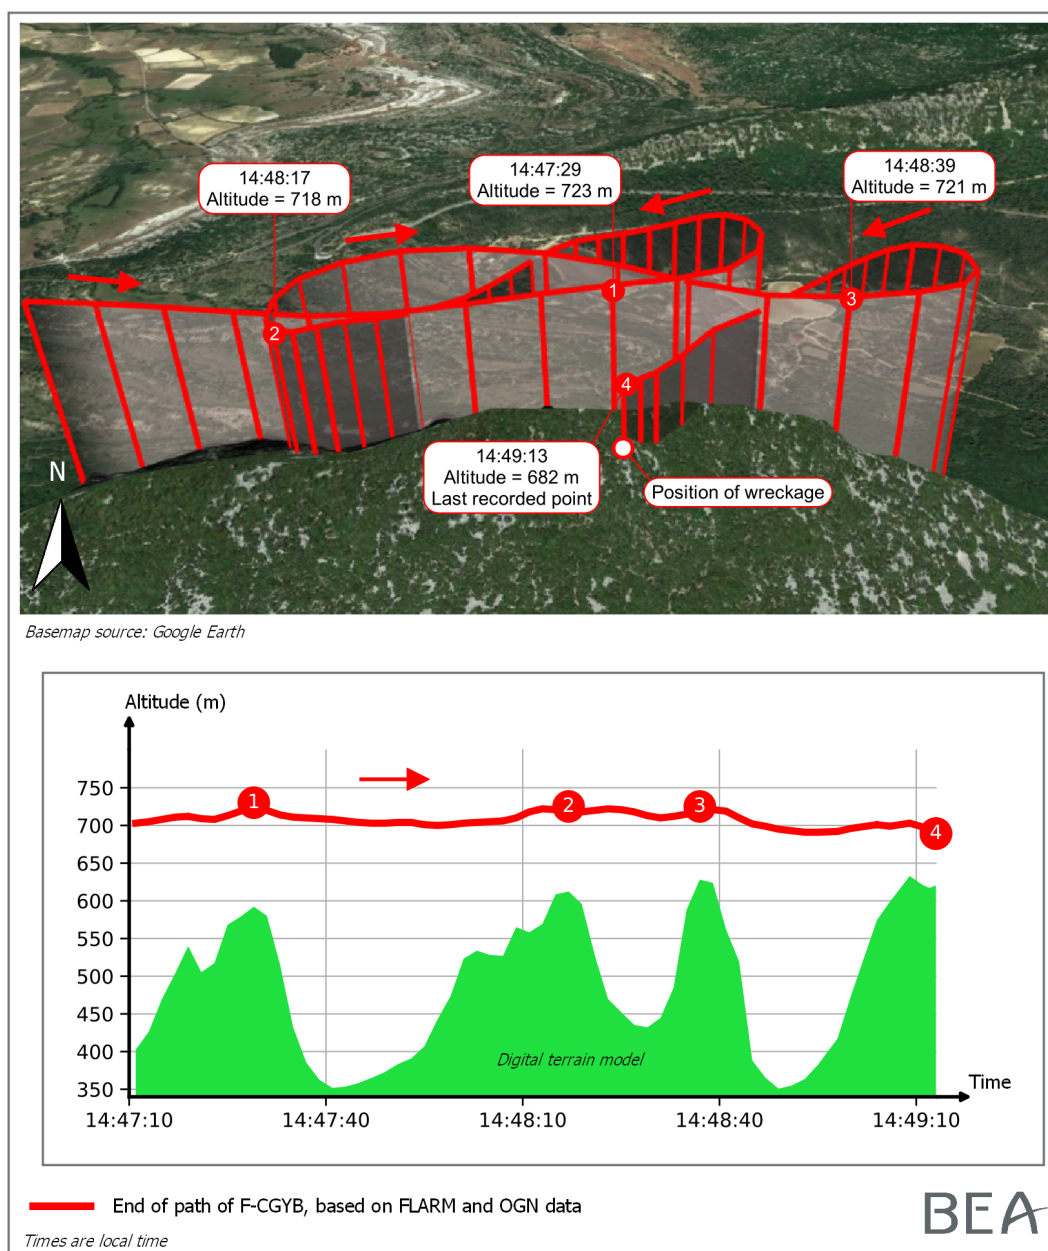
At around 14:50, during these manoeuvres, the glider flew past the peak at a height of around 70 m and found itself downwind of the terrain. The pilot lost control of the glider, which collided with the ground with a steep nose-down attitude.

Figure 1: End of the glider's path

The pilot took off a first time to carry out a wave soaring flight. Having failed to take up the wave, he returned to land at the aerodrome before taking off again to make the slope soaring flight at Pic Saint-Loup. Taking into consideration the direction of the wind (approximately 40° to the terrain) and its strong turbulent characteristics, the slope soaring flight at Pic Saint-Loup was possible but it was difficult to gain altitude. During his manoeuvres, the pilot found himself downwind of the terrain at low height. He probably flew into rotors and lost control of the glider. His proximity to the terrain did not allow him to quickly regain control to move away from the terrain before collision with the ground.

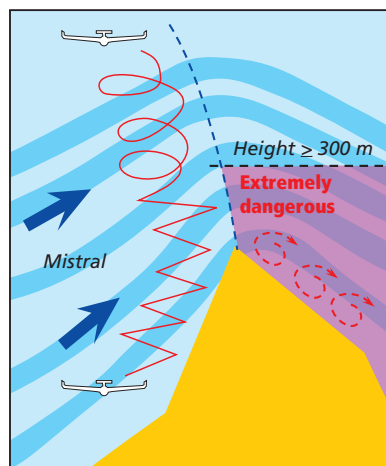
- ☐ The turbulence is extreme in the vicinity of the slope.
- ☐ Flying in the lee of crests is extremely dangerous.
- ☐ If, against your will, you find yourself in the lee of a crest, nearby its top or lower, the best solution is to flee tailwind, towards the valley, then reach a landable area, and eventually try to climb again.

Figure 2 below illustrates the flight zone to be avoided when flying the ridge in high winds.

Figure 2: Flight zone to be avoided in high winds

Flying the ridge in high winds comes with strong turbulence near the ground, as well as strong downdrafts and rotors on the downwind side of the terrain. In these conditions, it is extremely dangerous to penetrate the zone located downwind of the peak.
