Incident to the AIRBUS - A350 - 900 registered F-HREV

on 4 February 2020

at Paris-Orly (Val-de-Marne)

Predictive windshear warning on final, cognitive incapacitation of copilot during go-around, lateral and vertical flight path deviations, low energy alert, conflict with a departing aeroplane

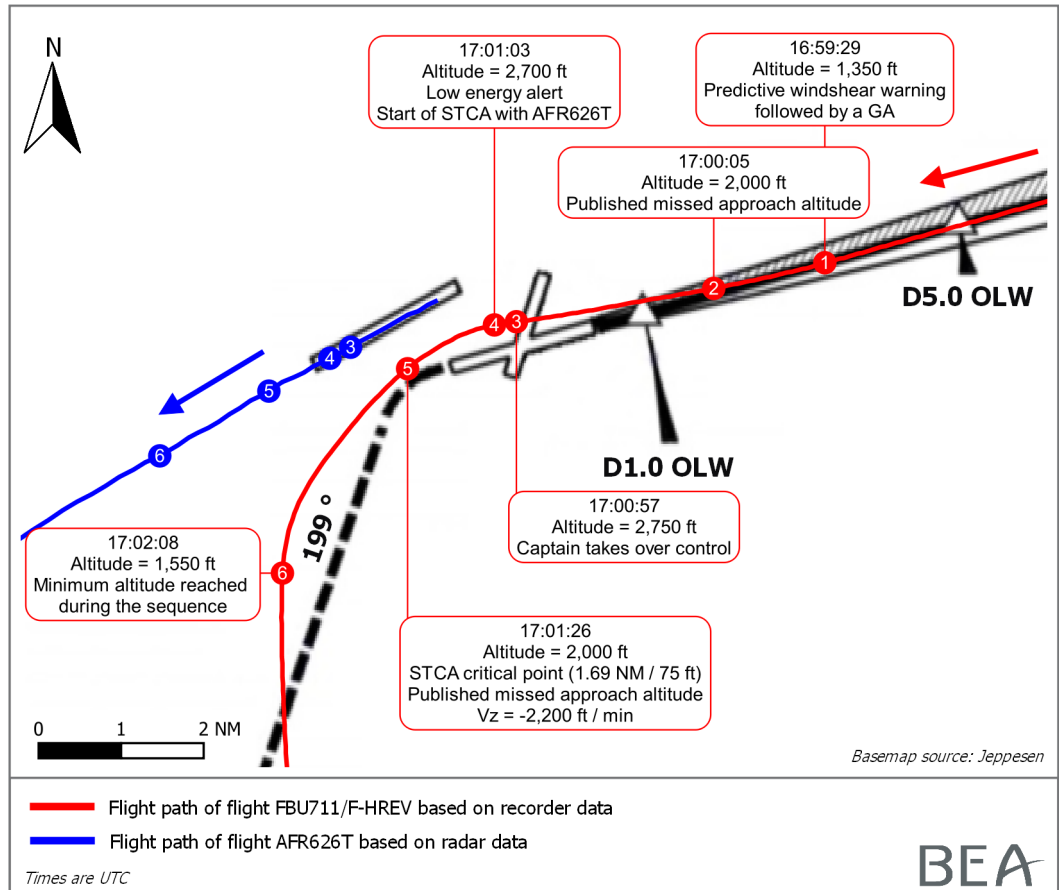
Figure 1: F-HREV's flight path

Phase 1: Predictive windshear warning, go-around, copilot cognitive incapacitation, exceedance of published missed approach altitude (points 1 to 3, Figure 1)

At 17:00:05, the plane bust the published missed approach altitude of 2,000 ft (point 2 [Figure 1](#)) with an indicated airspeed of 167 kt and a vertical speed of + 1,800 ft/min. Three seconds later, the crew retracted the flaps to CONF1. The FD command bars indicated a higher nose-down input. During this period, the aeroplane's pitch remained stable at around 8° nose-up and no movement was recorded on the sidesticks. Six seconds after flying through 2,000 ft, the altitude alert sounded continuously. The crew put the aeroplane into the clean configuration around 10 s later.

Phase 2: Captain takes over control, low energy alert, STCA⁽⁸⁾ and altitude undershoot (points 3 to 6, [Figure 1](#))

At 17:01:26, the aeroplane flew through the altitude of 2,000 ft with an increasing CAS of 235 kt and a vertical speed of - 2,200 ft/min (point 5 [Figure 1](#)). This time also coincided with the point where the distance was at its minimum between the two flights FBU711/AFR626T (critical point of STCA) with a separation of 1.69 NM for 75 ft. However, the flight paths of the two planes were not converging.

At 17:02:08, the aeroplane reached the minimum altitude of the sequence of around 1,550 ft (point 6 [Figure 1](#)). At the same time, the controller asked the crew to climb to 3,000 ft. There was no response but on board, the target altitude was changed from 2,000 ft to 3,000 ft.

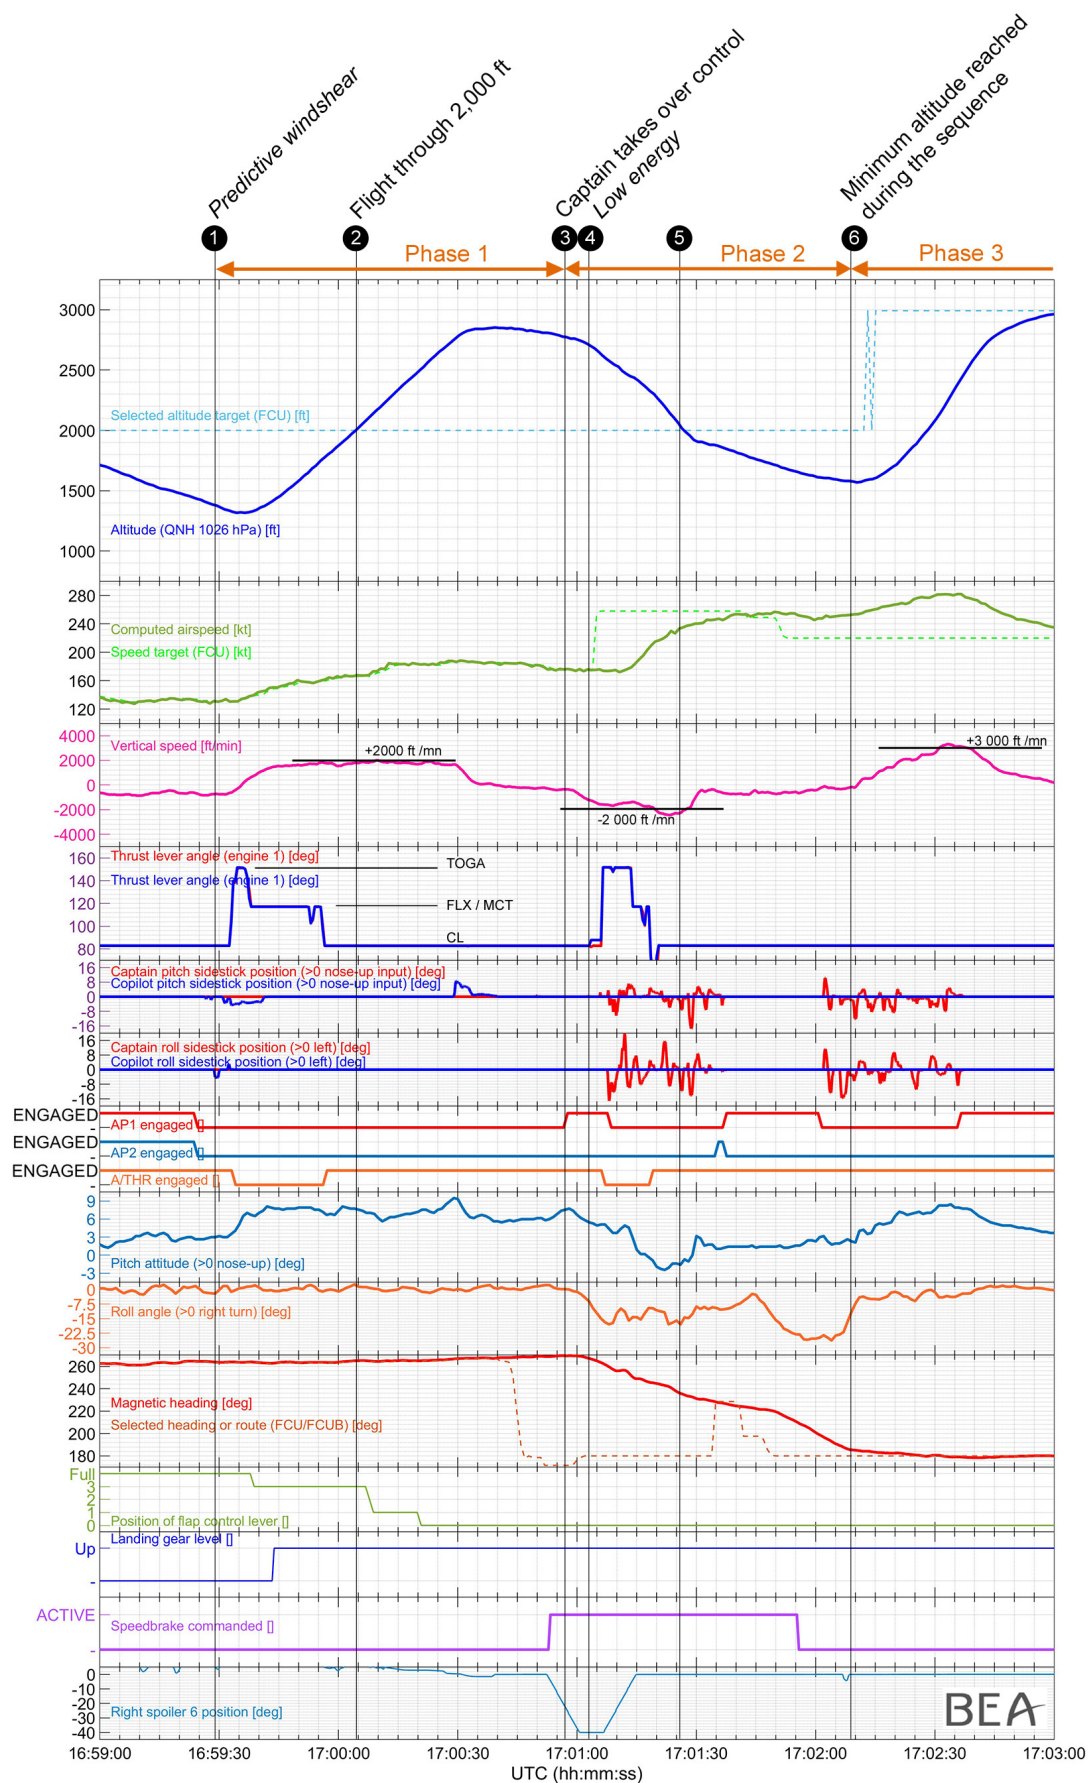
Figure 2: Main recorded flight parameters

[Figure 2](#) describes the main flight parameters during the occurrence sequence.
