Accident to the PIPER - PA32 - 300 registered F-OKGO

on 16 February 2020

in Fort-de-France bay (Martinique)

Reduction in engine power, ditching, during parachute drop flight

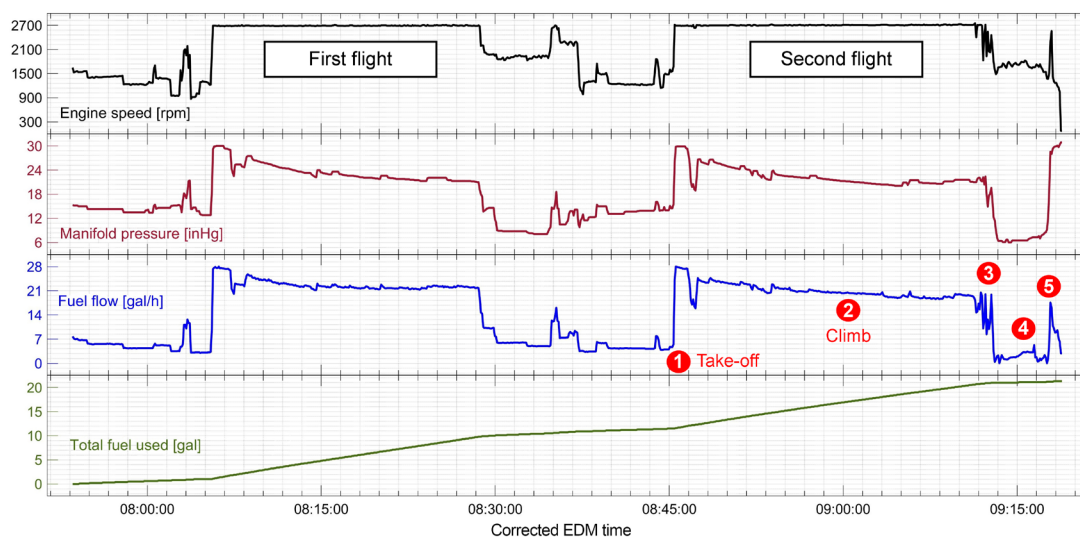
Figure 2: Engine data read out from EDM

Only the examination of the EDM computer provided usable data of interest to the investigation. An extract of the engine data for the two flights of the day is shown in Figure 2⁽⁸⁾.

The analysis of this data revealed nominal engine behaviour during the first flight of the day and at the beginning of the second flight. During this second flight, anomalies in the behaviour of the engine (manifold pressure, engine speed, fuel flow rate) are observed at the end of the climb (point ③ of [figure 2](#)). This malfunction, a series of quick variations in the measured value of the fuel flow rate is consistent with fuel starvation. This signature corresponds to the irregular drying up of the fuel at the engine intake causing the misfires observed.

The aeroplane then lost around 7,000 ft in less than five minutes with characteristics similar to an idle power descent with the propeller windmilling (④). The pilot may thus have had the sensation that the engine was operating normally although it was not possible to check this in this configuration.

At the very end of the recording, a sudden increase in the engine speed and fuel flow rate can be observed prior to the parameters dropping definitively (⑤). This increase is consistent with the inputs on the throttle control and the use of the remaining fuel in the pipes before the complete depletion of the fuel supply.
