Accident to the PIPER - PA28 - 161 registered F-OGKO

on 16 February 2020

near Dominica (Caribbean Island)

Collision with the surface of the water shortly after take-off at night

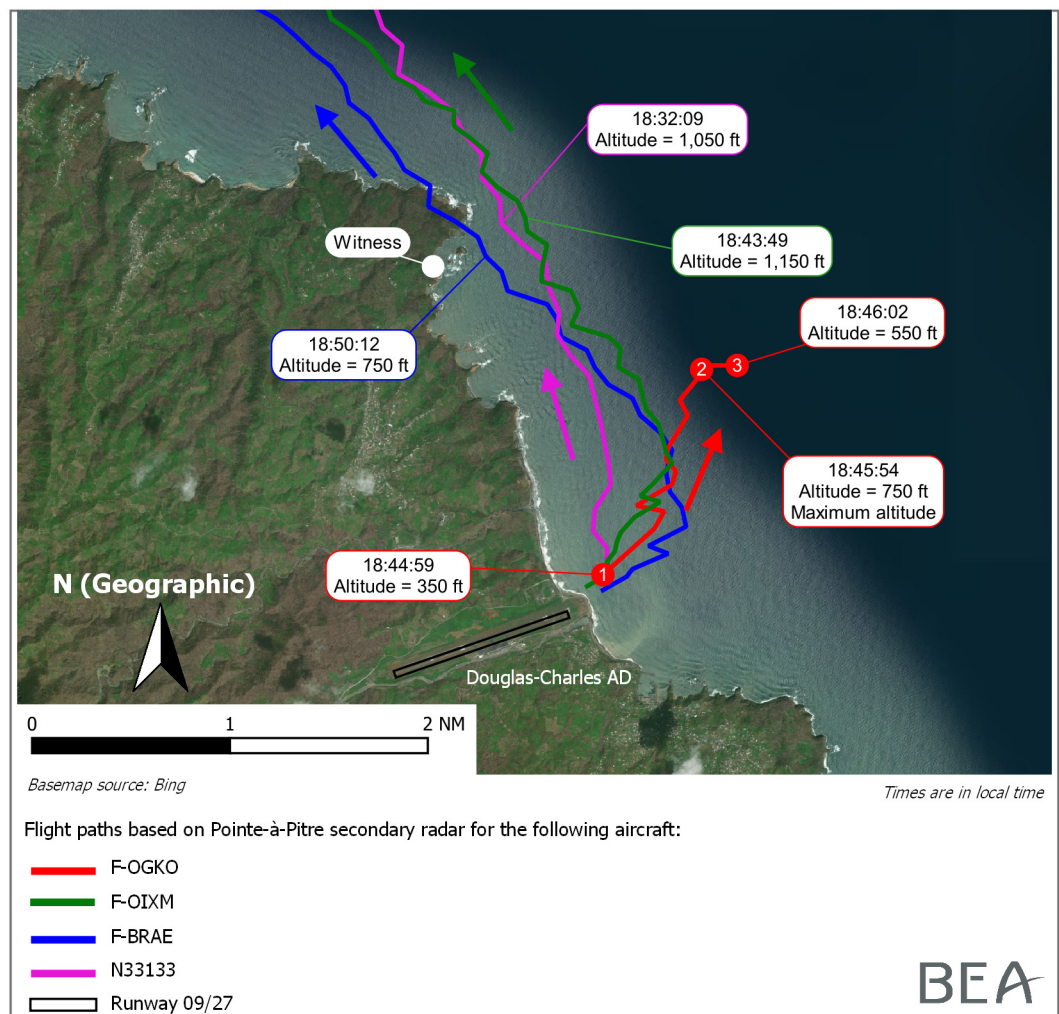
Figure 1: Accident flight path

The recording of the radar track showed that the aeroplane reached an altitude of around 750 ft. It stopped several seconds later, at 18:46 when the aeroplane was at an altitude of around 550 ft⁽³⁾, to the north-east and 1.6 NM from the threshold of runway 27 at Douglas-Charles airport.

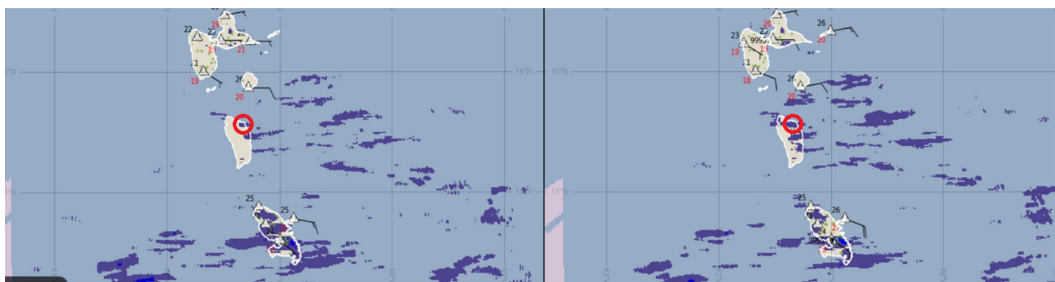
Figure 3: Satellite images from the Le Moule radar at 18:30 (on left) and 19:00 (on right)

The satellite images from the Le Moule radar between 18:30 and 19:00 confirmed the presence of rain on Dominica and notably around Douglas-Charles airport.
