Accident to the RYAN – PT-22

registered N53018

on 23 February 2020

Oil leak, in-flight engine shut-down, loss of control, collision with the ground

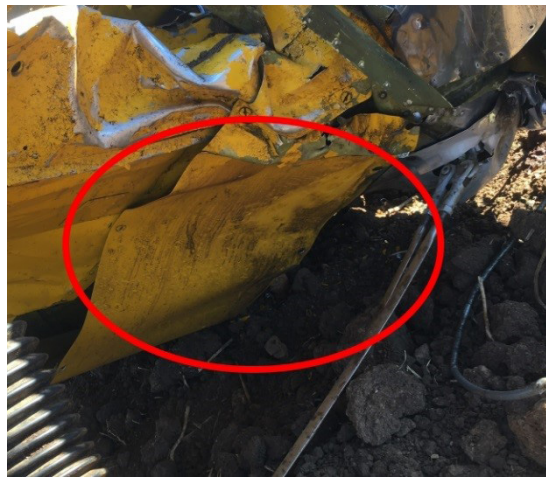
Black marks that could have been caused by the spraying of oil or smoke were found under the fuselage at the central fastening of the lower bracing wires towards the right main landing gear.

Figure 1: Marks under the fuselage

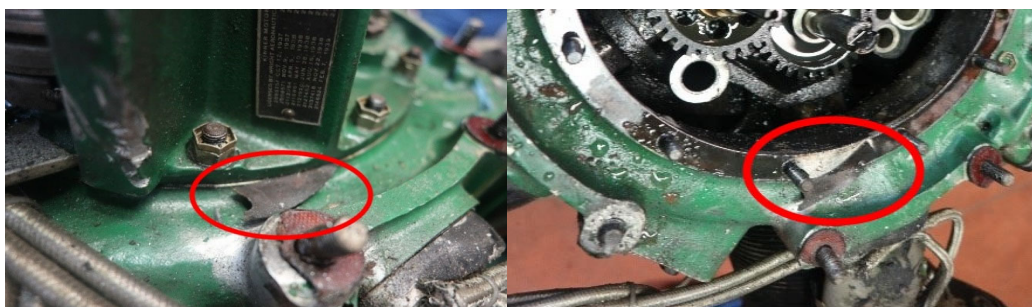
The seal between the accessory section and the engine casing was damaged on its lower part. The failed part of the seal was expelled from the joint face between the accessory section and the engine casing. A strong smell of burned oil was detected during removal of the accessory section.

Figure 2: Seal broken and expelled from its housing

Examination of the engine log book, the first entry of which dates back to 1977, indicates on this date that the engine had logged 110 operating hours since the last major engine check⁽⁸⁾. No major operation on the engine requiring removal of the accessory section had been carried out since 1977. The seal between the accessory section and the engine casing had therefore been installed since at least 1977. It is probable that the seal wore over time until it failed and became displaced during the accident flight.

During the flight, the seal failure between the accessory section and the engine casing caused a gradual oil leak that could not be detected by the pilot, along with the emission of black smoke. The lack of engine lubrication caused the engine to seize and shut down.
