## Accident to the BELL 47 G2 registered F-GBOO

on 26 April 2020

at Sète - Domaine Listel (Hérault)

## Loss of yaw control during a spraying flight, collision with ground and fire

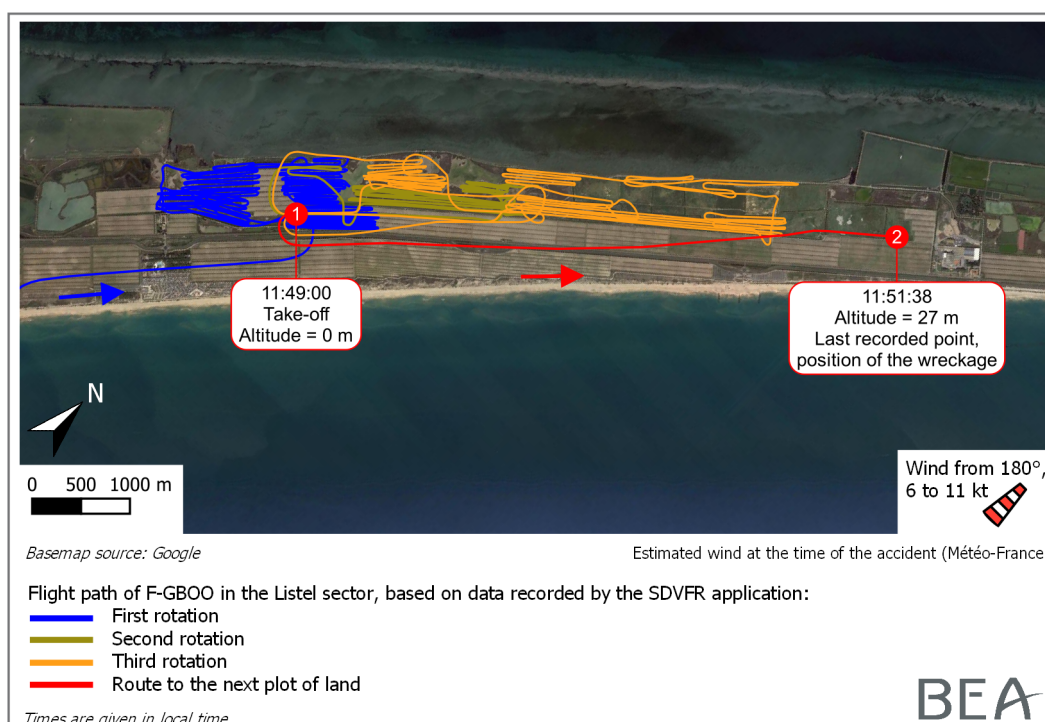
F-GBOO path

The data from the GNSS computer installed on board F-GBOO as well as those from the pilot's tablet (SDVFR application) was used to reconstruct the accident flight path almost up to the loss of control, without the yaw rotations being visible. The recorded track confirms the path described by the pilot.
