Accident to the CENTRAIR – 101A PEGASE registered F-CHDJ

on 21 May 2020

at Barcelonnette (Alpes-de-Haute-Provence)

Partial deployment of speed brakes following a confusion between controls during approach, collision with a tree in last turn, collision with the ground

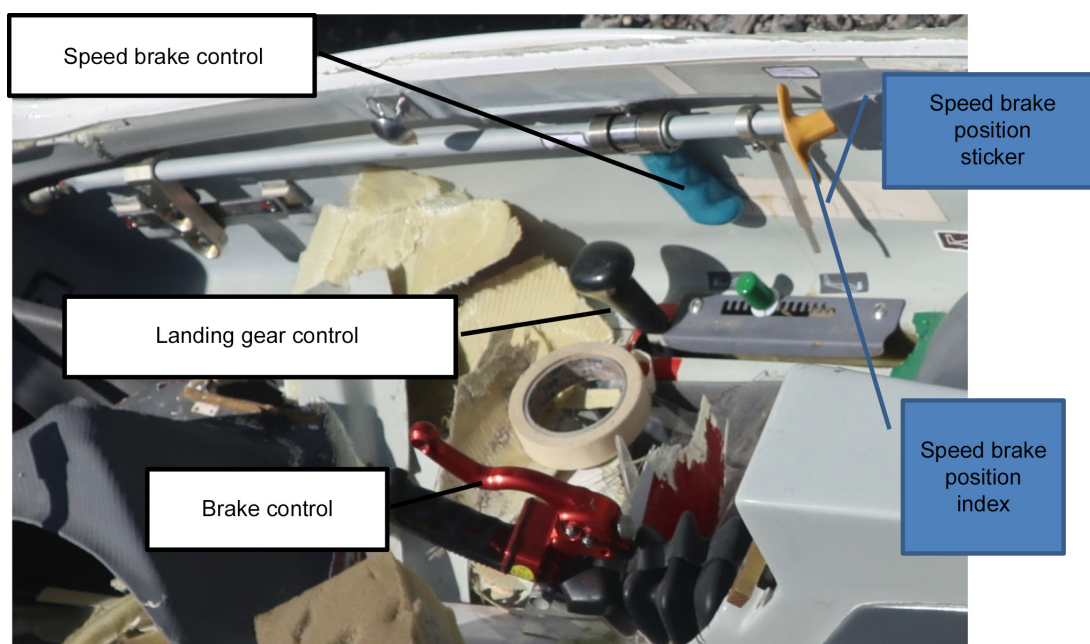
Figure 2: Positions of controls after the accident

Due to the wreckage partly lying on a public road, it had to be moved quickly after the initial observations were made by the air transport police and before the arrival of the BEA investigators. The former mechanic of the gliding centre present when the wreckage was turned up the right way stated that the speed brake control was locked in intermediate position, that the speed brakes were partially extended and that the landing gear was retracted.

- ☐ The damage was consistent with the accident.
- ☐ The flight control linkages were continuous and operational.
- ☐ The landing gear control was locked in retracted position ([Figure 2](#)).
- ☐ The speed brake control was notched in the first intermediate position ([Figure 2](#)).
- ☐ The speed brakes were operational. The different positions of the speed brakes were consistent with the positions of the control in the cockpit.
- ☐ The landing gear was retracted and operational; the extension/retraction sequences were nominal without friction points.

An index (vertical metal rod) and a sticker (not provided in the kit) with wording corresponding to the different positions must be added to show the positions in relation to the index as the lock notches are not visible to the pilot. The index and the sticker were present but the wording was partially faded ([Figure 2](#)).

However, it is very likely that when it came to configuring the glider for landing before joining the start of the downwind leg, the pilot inadvertently handled the speed brake control instead of the landing gear control. He then locked the speed brake control on the notch corresponding to the first position, "*speed brakes extended*".

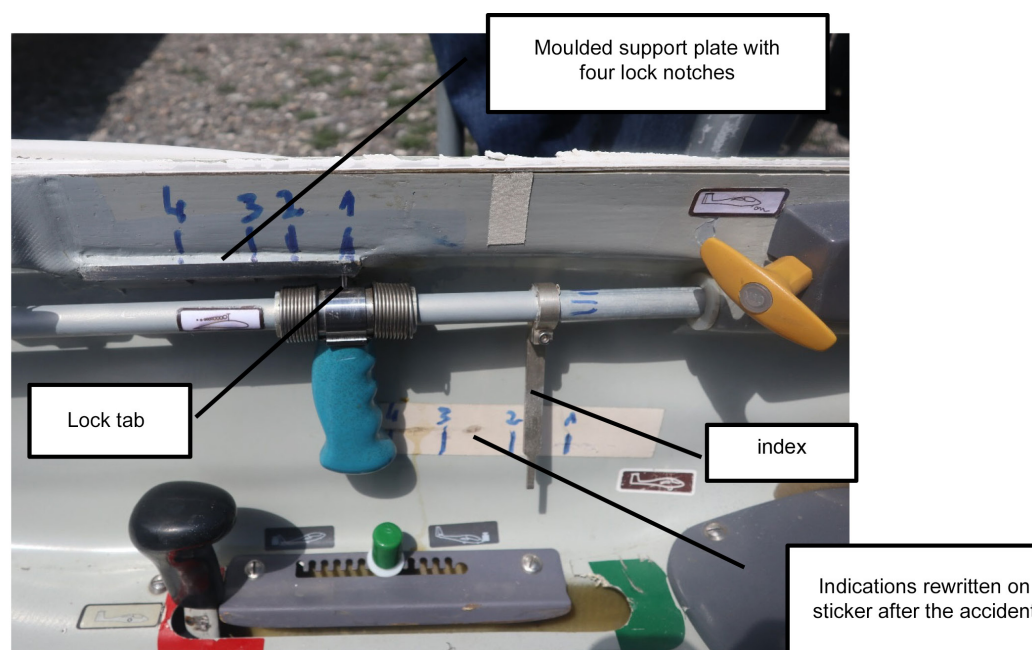
Figure 4: Flight controls and labels⁽⁵⁾ in F-CHDJ

Moreover, the hand rudder control installation kit specifies modification of the speed brake control ([Figure 4](#)) to enable the latter to be released in flight: in addition to the “*speed brakes retracted and locked*” position (in forward stop) that already exists on unmodified PEGASE gliders, four position notches are added corresponding to the varying degrees of extension of the speed brakes.

This modification notably consists in adding a metal plate including the lock notches and moulded inside the fuselage ([Figure 4](#)). Unlike the hand rudder control, this device cannot be removed. The speed brake control can be used exactly as it would be in an unmodified glider or using the lock notches.

To lock the speed brakes in a given position, the lever must be positioned vertically downwards so that the pin added to the lever goes into one of the notches of the plate located above the lever. To be able to change the position of the speed brakes, the lever must be positioned horizontally.

- ❑ The pilot's lack of knowledge of the characteristics of this glider, in particular the presence of lock notches in extended position on the speed brake control in F-CHDJ.
- ❑ The failure on the part of the CVVU to make pilots aware of these characteristics, notably with regards to the differences that exist between this glider and the second and unmodified PEGASE glider operated by the CCVU.
- ❑ The lack of a visual check by the pilot of the result of his actions on the flight controls, in particular the correct positioning of the landing gear control. In the absence of this systematic check being carried out, the simultaneity between the action carried out and the high rate of descent observed by the pilot should have alerted him.

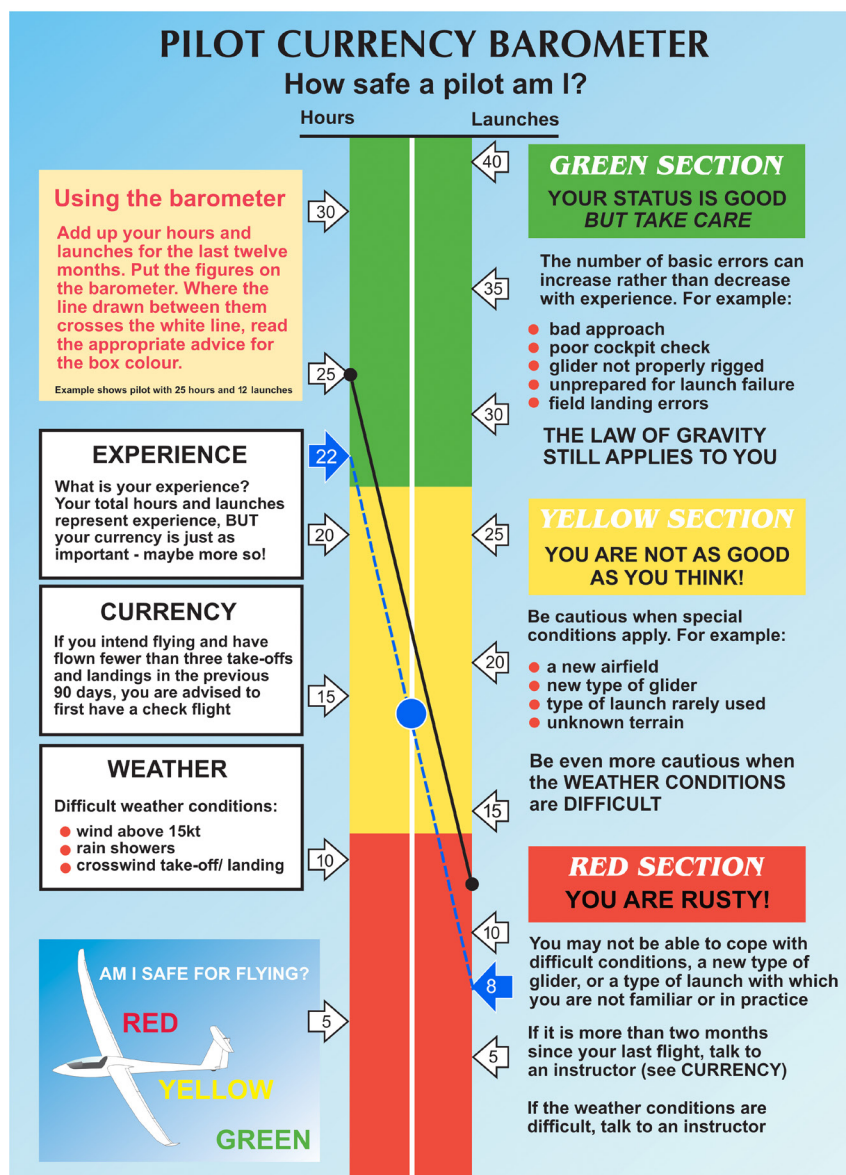
Figure 5: Self-assessment questionnaire used by FFVP (source: British Gliding Association)
(The values in blue correspond to the situation of the F-CHDJ pilot)

This recommendation was accompanied by advice for pilots to help them to self-assess their level of currency. According to the document published to this effect (Figure 5), with eight flights and 22 flight hours in the last 12 months, the pilot's level of safety was in the amber zone (blue point Figure 5). A check flight was therefore required.
