Accident to the AVEKO VL-3-A identified 59DAE

on 22 May 2020

at La Ferté-Bernard (Sarthe)

Increase in speed almost up to the VNE, in turn, mid-air rupture of the RH section of the horizontal tailplane and collision with the ground

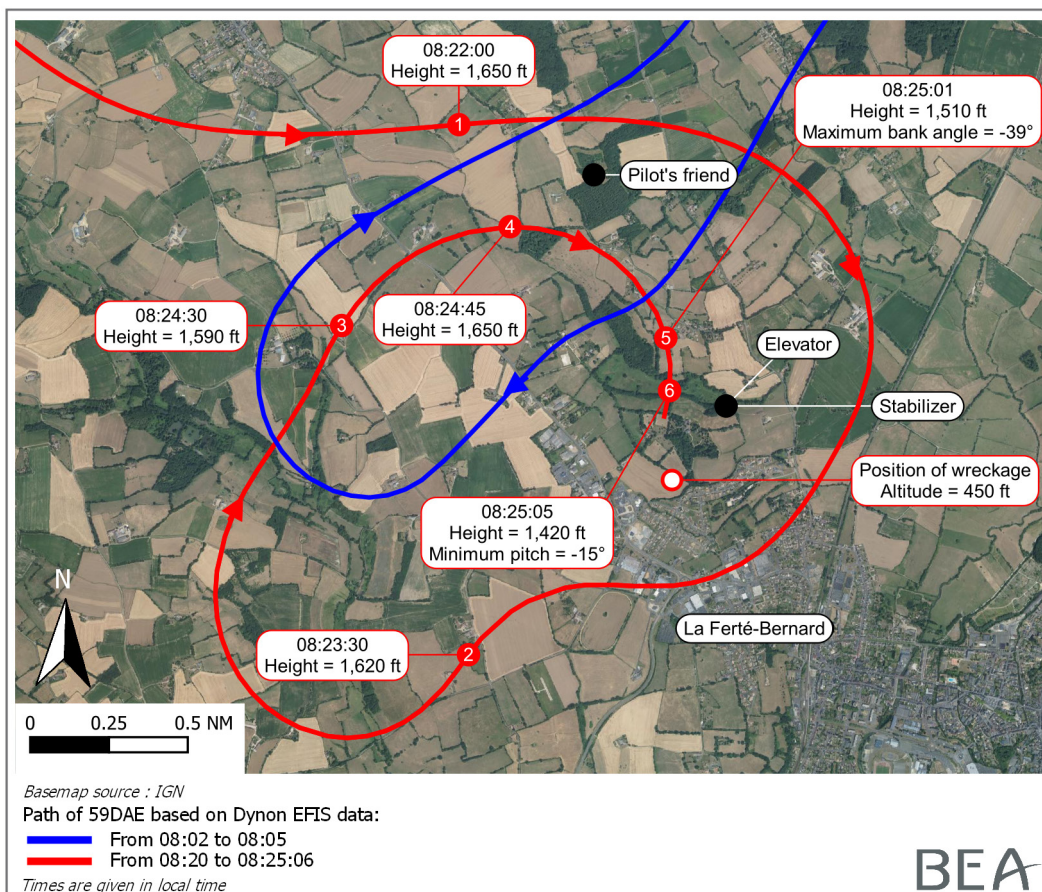
Figure 1: Partial path of 59DAE

At 08:22, at a height of around 1,650 ft (point ❶ in [Figure 1](#)), after approximately 25 minutes of flight northwards of his strip, the pilot initiated a turn-around to the right around the house of a friend who, seeing him, waved at him from her garden. During this turn, the microlight had a bank angle of around 20°. The pilot then initiated a second turn-around to the right (point ❷ in [Figure 1](#)), with a bank angle of around 25°.

The pilot initiated a third turn-around to the right (point ❸ in [Figure 1](#)) with a bank angle of around 25°. At 08:24:45 (point ❹ in [Figure 1](#)), the microlight's bank angle increased gradually and the pitch started to decrease. The air speed was approximately 240 km/h and increasing. Sixteen seconds later (point ❺ in [Figure 1](#)), the bank angle reached a maximum of 39° and the microlight had a nose-down attitude of 11°. Four seconds later (point ❻ in [Figure 1](#)), the microlight had a minimum nose-down attitude of 15° and the bank angle was 25°.

One second later, at a height of 1,200 ft, with an air speed of 295 km/h, the bank and pitch parameters varied between the minimum and maximum values that could be recorded. The microlight collided with the ground several seconds later.

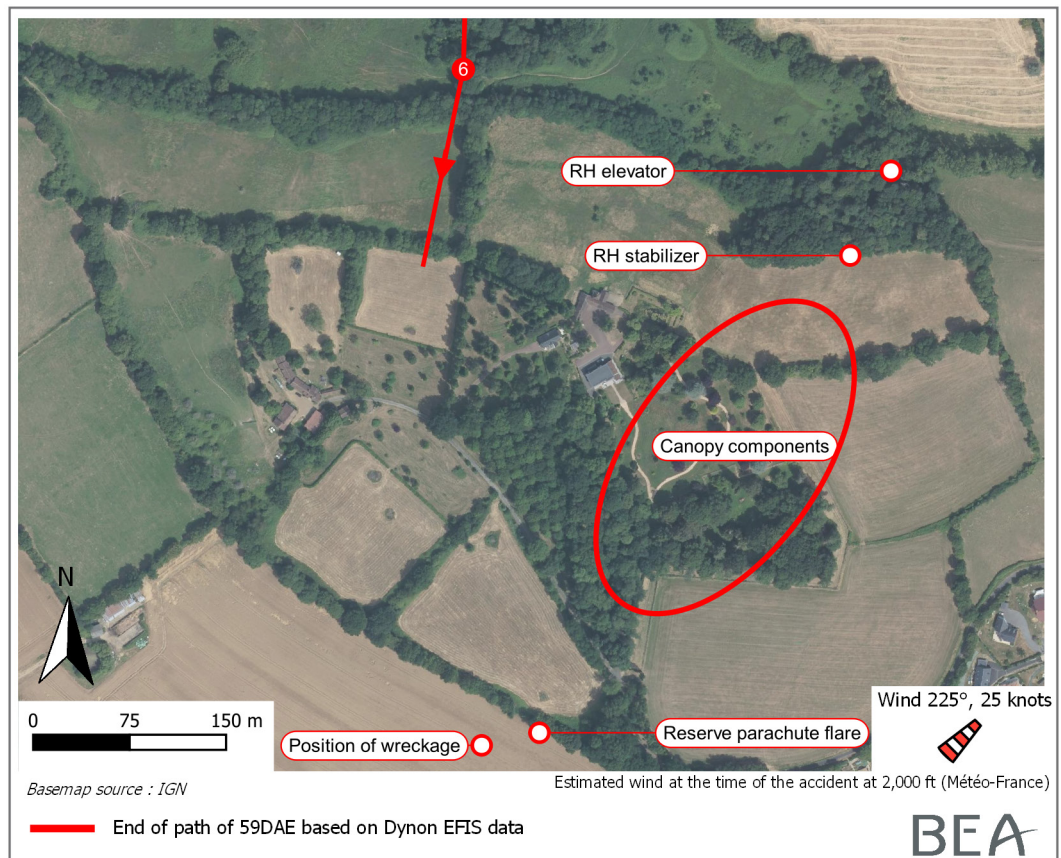
Figure 2: Distribution of 59DAE debris

The distance between the main wreckage and the debris of the RH section of the horizontal tailplane (stabilizer and elevator) indicated that the latter became detached in flight from the rest of the airframe, whilst the microlight was still fairly high. This was the same for the canopy elements. The deviation between the position of the debris and the path can be explained by the drift due to wind during the flight.

The short distance between the reserve parachute ejection flare and the main wreckage (approximately 50 m), combined with the fact that the deployment grip in the cabin was found out of its recess, indicate that the parachute was activated voluntarily by the pilot at a low height, shortly prior to the collision with the ground.

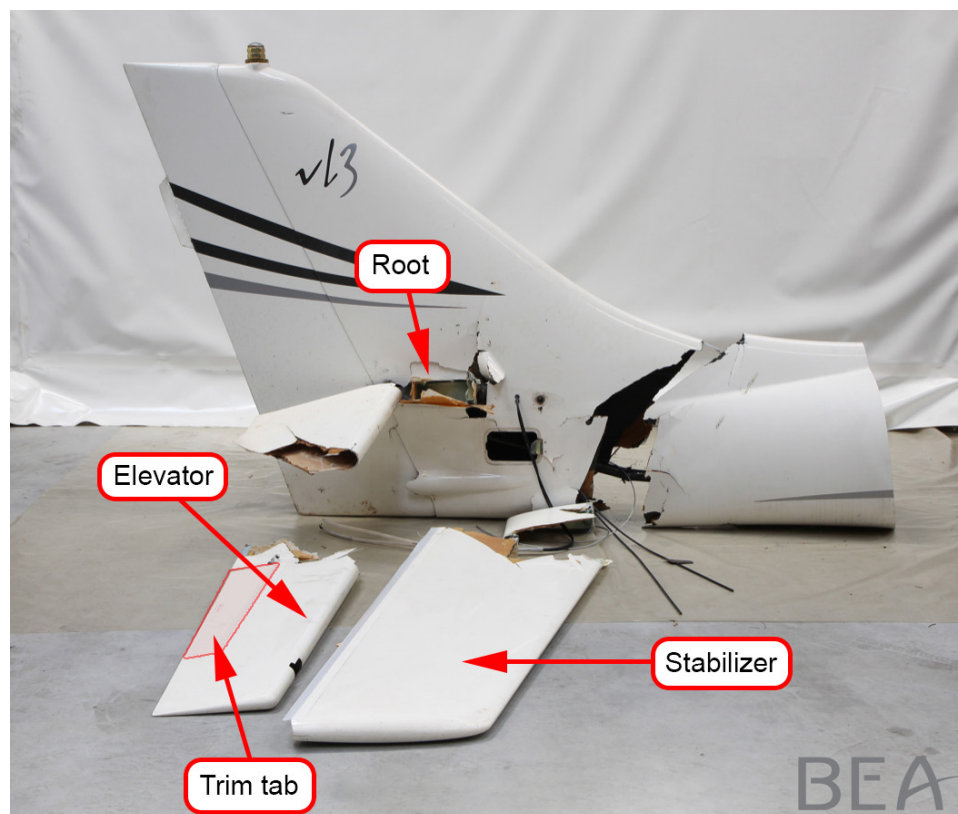
Figure 3: Reconstruction of tailplanes at BEA

The RH elevator and stabilizer became detached from the microlight in flight.

No signs of impact (bird, exterior element, parachute strap, etc.) were observed on these components.

The RH elevator ruptured in the first third of its length from the root. Various damage showed evidence of both upward bending and downward bending overloads. This flapping can be explained by the occurrence of a flutter phenomenon on the elevator. The elevator stops did not appear to have been overshoot. In addition, the elevator trim control cables were still integral with the elevator when it ruptured mid-air.

The rear spar of the stabilizer presented tears in line with the routing of these cables. The elevator then slipped sideways towards the exterior, relative to the stabilizer, the only movement enabled by the connecting hinges between the elevator and the stabilizer.

The damage observed on the RH side of the tail fin, at the stabilizer root, indicated that the stabilizer ruptured under upward bending and torsional load towards a reduction in incidence.

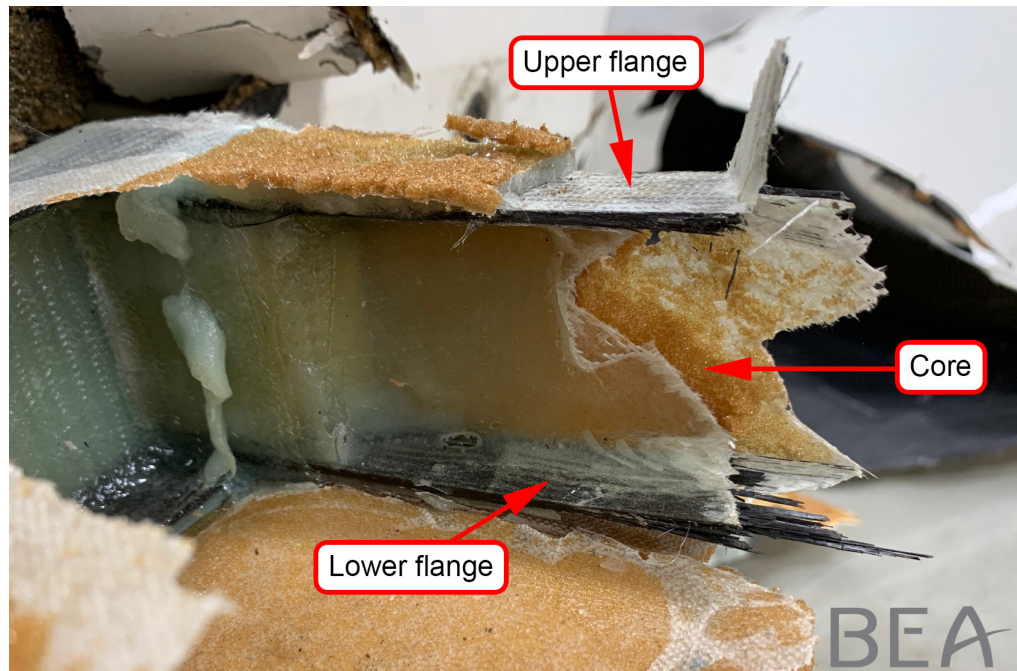
Figure 4: Broken spar of the RH stabilizer

The stabilizer spar comprises two carbon/epoxy composite flanges sandwiched between layers of glass fibre, and a core. This core comprises a high density glass fibre/foam sandwich (see Figure 4). The flanges are manufactured using carbon fibre unidirectional tape (interlinked strands) coated by hand with epoxy resin using a brush, before being cured in a vacuum bag.

- ☐ a rupture of the stabilizer due to overload, around 10 centimetres from the root, in line with a layer stop⁽⁵⁾ in the composite flanges;
- ☐ the lower flange broke under tensile load, the upper flange under compression (rupture of spar under upward bending load);
- ☐ the presence of dry zones (no resin) in the composite flanges;
- ☐ the presence of many inter- and intra-strand voids in the flanges, with a mean overall void ratio of around 8 %. These ratios are consistent with the manufacturing process used.

It was not possible to rule out the possibility that the perfectible quality of the stabilizer spar could have contributed to its premature rupture.

On 8 February 2021, JMB Aircraft published a *Safety Alert* to reduce the VNE from 305 km/h to 260 km/h for VL-3s with a serial number between 1 and 99, therefore applicable to all VL-3s produced by Aveko. This document was shared with the FFPLUM and the DSAC. The FFPLUM then circulated a Safety Flash to its subscribers.
