Accident to the PITTS S2-A registered F-GIIZ

on 30 May 2020

at Carcassonne (Aude)

Loss of control after take-off during an aerobatic figure, collision with the ground, fire

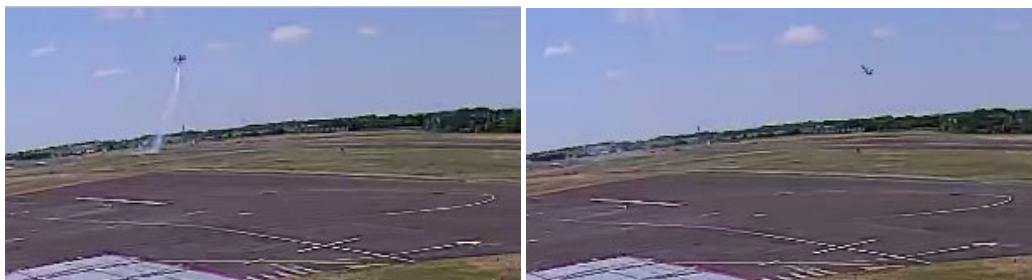
Figures 3 and 4: Take-off and collision with the ground

Carcassonne aerodrome is equipped with surveillance cameras. One of these, located on the roof of the control tower, filmed the accident. The recording showed that the pilot immediately adopted a vertical flight path before it was out of the camera's range. Around 20 seconds later, the plane reappeared with a steep nose-down attitude, a few dozen metres from the climb path. It exploded when it collided with the ground and immediately caught fire. The Aircraft Rescue and Fire Fighting Service vehicle was putting out the fire less than one minute later.

Careful observation of the footage did not identify any component that could have detached in flight, both during the take-off and during the fall and collision with the ground.

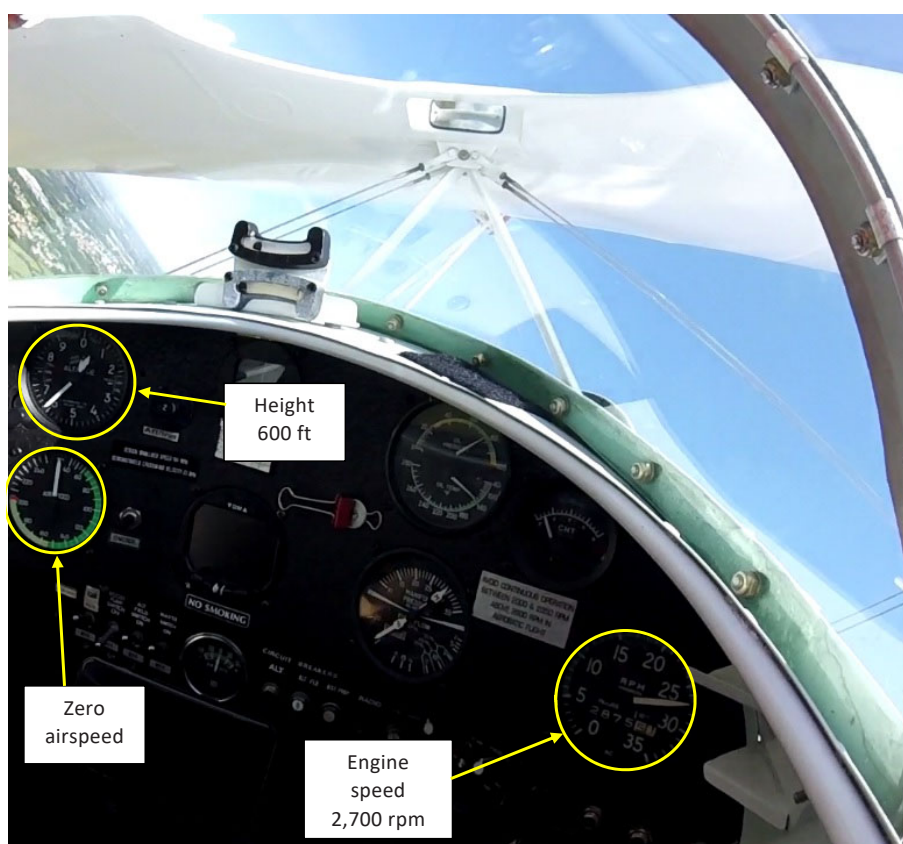
Figure 5: Loss of control

The pilot had installed a camera on board his plane that filmed the instrument panel. The recording showed that the pilot accelerated up to approximately 100 kt⁽²⁾ before performing the pull-up manoeuvre. Throughout the take-off phase and at the start of the chandelle climb, the engine rating was maintained at 2,750 rpm. During the climb, the speed gradually decreased to below the lowest level marked on the airspeed indicator (40 kt) whilst the engine rating remained at 2,700 rpm, without variation or abnormal noise. At around 600 ft in height, the plane tilted left then nose-down before descending in a spin for approximately six seconds. The pilot attempted several actions on the throttle control and on the ailerons⁽³⁾ without managing to regain control of the plane before it collided with the ground.
