Accident to the DTA Dynamic – 15/430 identified 67BLZ

on 7 June 2020

at Sarrebourg-Buhl (Moselle)

Loss of control in turn during approach, collision with the ground

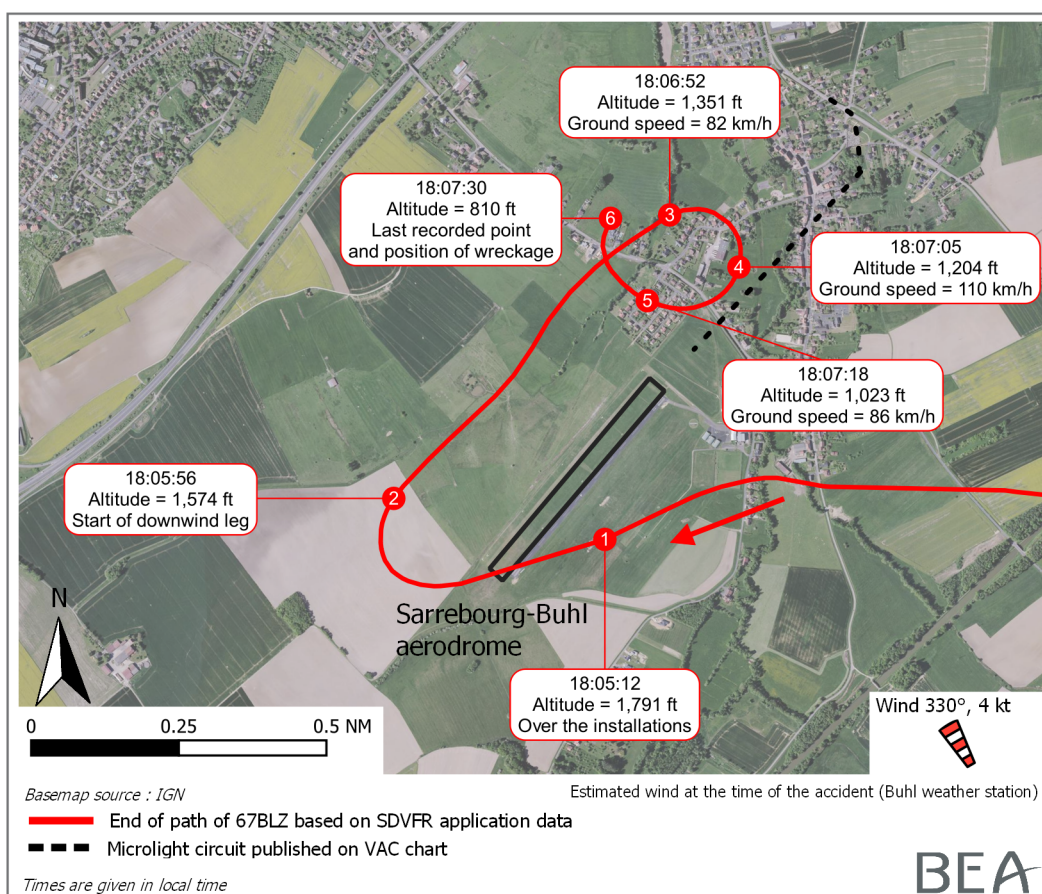
Figure 1: Path of end of accident flight

The pilot took off at 17:25 from the microlight strip at Batzendorf (Bas-Rhin), where he was based, bound for Sarrebourg-Buhl aerodrome (Moselle). As part of a group excursion organised by the flying club, seven other microlights were making the same flight. After 40 minutes of flight, the pilot flew over the aerodrome at an altitude of nearly 1,800 ft to conduct a reconnaissance of its installations ❶, before joining the start of downwind leg for a right-hand circuit at approximately 1,600 ft ❷ to land on unpaved runway 22. The microlight's path during downwind leg was downward to reach the published aerodrome circuit height. At an altitude of approximately 1,350 ft and a distance of approximately 700 m from the threshold of runway 22, the pilot initiated a turn with an estimated right bank angle of approximately 30° in descent ❸. The turn was pursued in continuous descent to the ground (❹ and ❺). The microlight collided with the ground (❻).

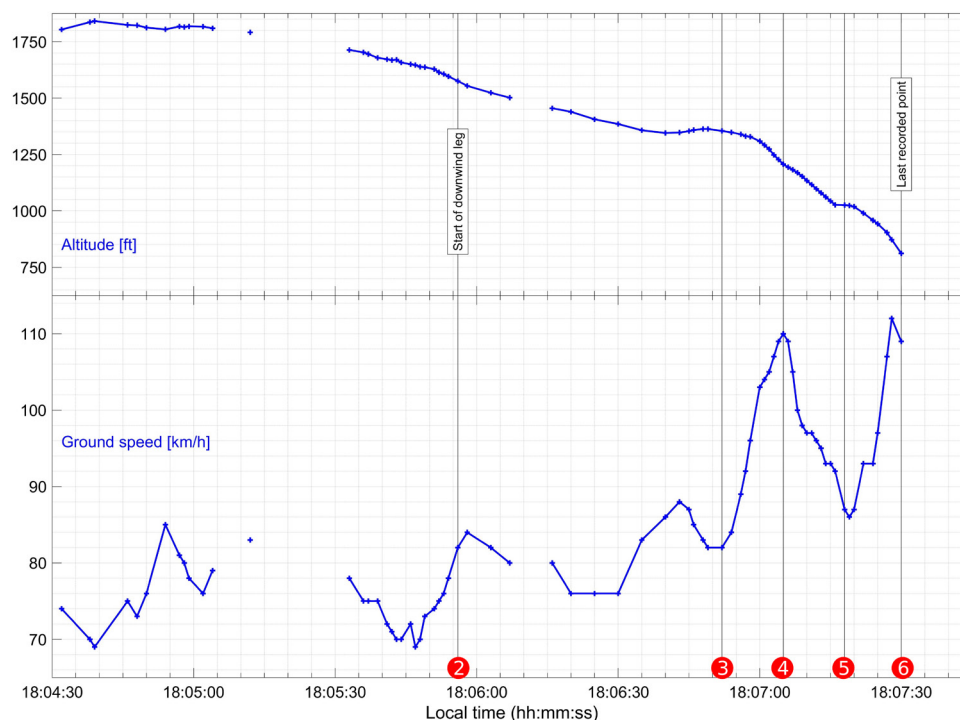
Figure 3: Change in parameters of the accident flight

- ❑ **2** Downwind, the path of the microlight was descending, from 1,600 to 1,350 ft⁽³⁾. The microlight's ground speed varied between 75 km/h and 88 km/h.

- ❑ The pilot initiated his right turn 700 m from the threshold of unpaved runway 22 **3**; after 180° performed in 14 s, corresponding to a turn with an estimated bank angle of approximately 30°, he reached an estimated descent rate of approximately 7 m/s (nearly 1,400 ft/min).

- ❑ When it was in the runway centreline during the turn, the microlight was at an altitude of 1,190 ft and 430 m from the threshold of runway 22 **4**, putting it in a steep final approach path (around 20% to land at the threshold of the runway and 12% to land halfway along the runway); the turn was pursued.

- ❑ Around 100 metres from the ground, the descent rate decreased during the turn and the ground speed decreased to 86 km/h **5**.
- ❑ The ground speed rapidly increased up to the last point recorded **6**.
