Accident to the SCHLEICHER - ASK13 registered F-CDYD

on 25 June 2020

at Montagnole, locality of Pas de la Fosse (Savoie)

Collision with trees in slope soaring flight

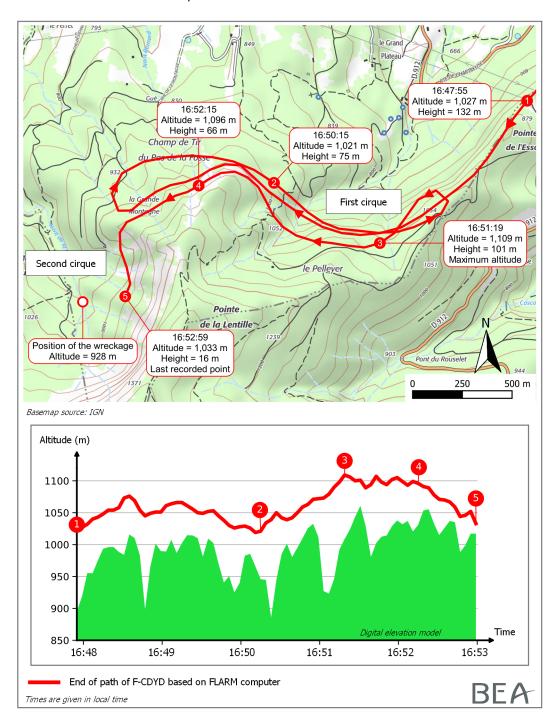
The glider was equipped with a FLARM computer. Reconstruction of its path was possible based on data from the computer read-out.

End of the path
