Accident to the AIR COPTER - DJP 2000 identified 31LI

on 05 July 2020

at Sos (Lot-et-Garonne)

Rudder struck by main rotor, loss of control in flight, collision with the ground

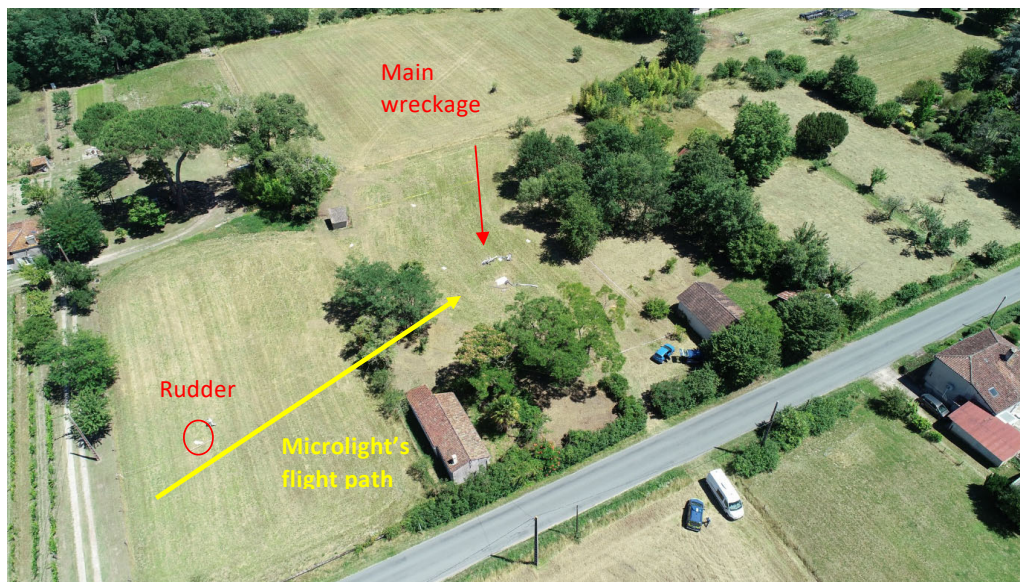
Figure 4: Accident site

The gyroplane was in several pieces spread over a radius of around 50 m around the main part of the wreckage, essentially on the axis of the path. Components of the rear section were found further back from the wreckage on the gyroplane's final flight path.

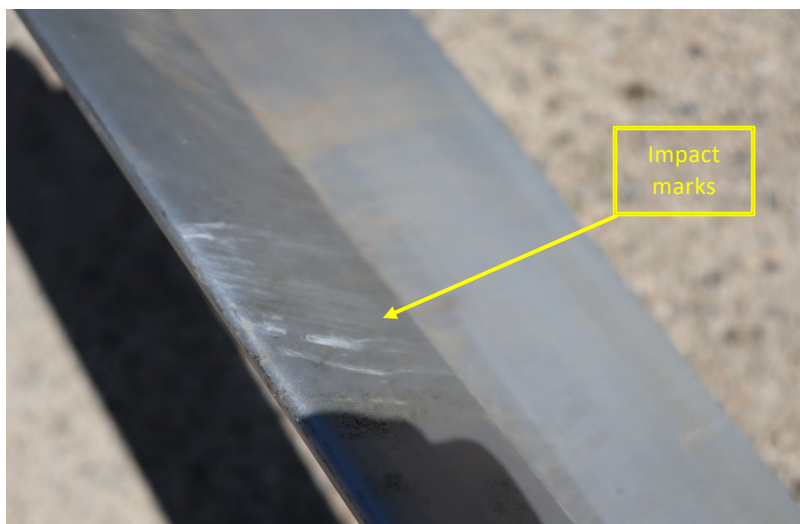
Figure 5: Marks observed on the main rotor blades

The rotor was in position on the mast, the leading edges of both blades had white marks due to contact with exterior elements.

The marks observed on the rotor blades (see [Figure 5](#)) coincide with deformations observed on the tail fin and the rudder, both in terms of deposited colour and position.

These observations showed that the main rotor entered into contact with the rudder in flight. The rudder then separated from the airframe. The control cables and the rudder probably struck the blades of the unfaired pusher propeller, which caused an engine oil leak, the reduction in rotor rotation speed then the fall of the aircraft.

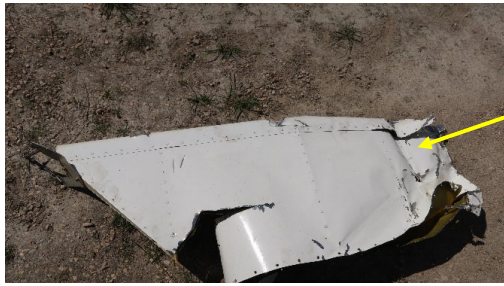
Figure 6: Rudder

The tail fin and the rudder each had contact marks and were deformed at mid-height approximately.

The two control cables connecting the pedals to the rudder were broken perpendicular to the propeller. Damage observed on the other flight controls was consistent with the impact with the ground.

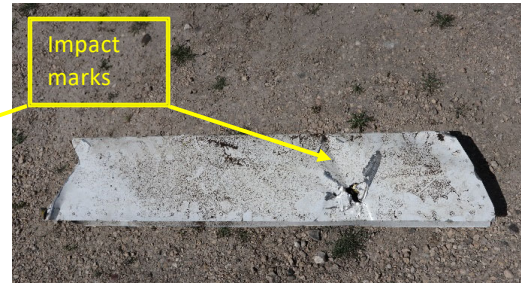
Figure 7: Tail fin covered with oil

With the exception of the rudder, the tailplane components had traces of sprayed oil.

The white smoke visible on the video is consistent with oil being sprayed onto the engine's hot parts. The two components falling towards the ground were very likely pieces of the rudder separated from the gyroplane after the control cables broke.
