Accident to the PIPER – PA-28-181 Archer II registered N5352F

on 4 July 2020

off the coast of the isle of Guadeloupe (Guadeloupe)

Decrease in engine power en route, ditching, ferry flight

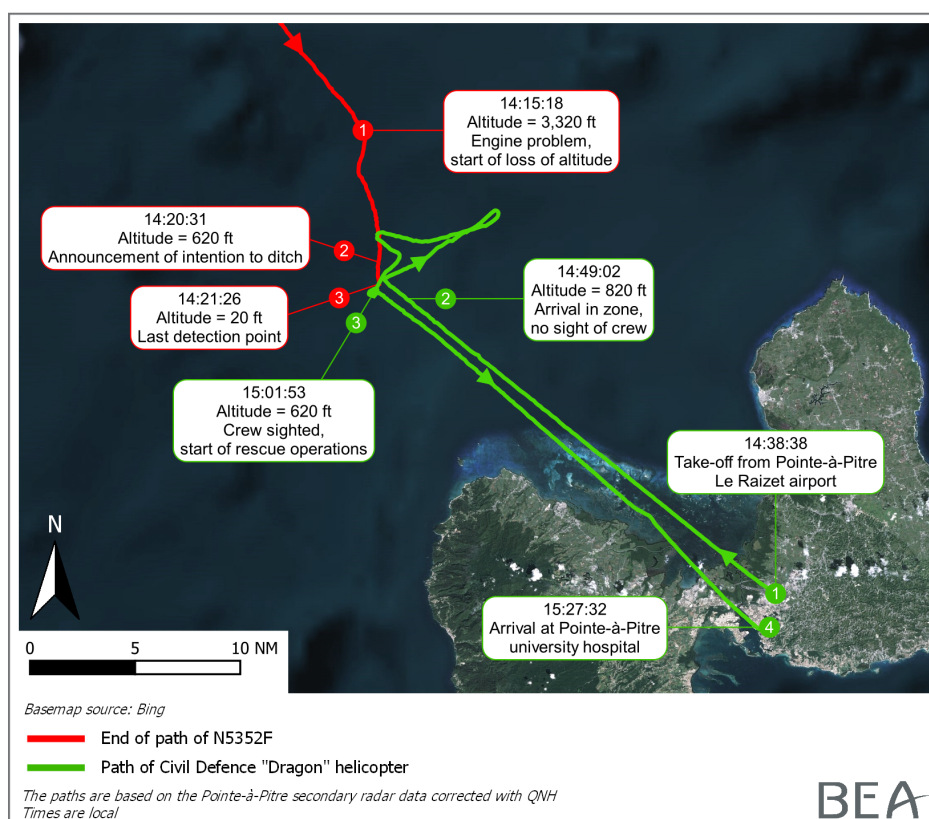
At about 14:15, at approximately 30 NM from Pointe-à-Pitre - Le Raizet airport, the pilot and his passenger observed, without there being any particular noise, a reduction in engine speed (see illustration [Point 1](#)) which prevented them from holding the flight level. The pilot adopted a speed of around 75 kt, corresponding to the plane's best glide speed. The passenger, who also held a pilot licence, carried out the actions of the inflight power loss procedure (changing fuel tank, switching on electric pump, switching off and on the magnetos) without any notable effect on the power.

At a height of around 1,000 ft, the passenger opened the lifejackets, donned one of them and equipped the pilot with the second one. He then prepared the liferaft⁽²⁾. At around 600 ft, the pilot informed the controller that he was going to ditch (see illustration Point 2). It was 14:20. The latter immediately contacted the rescue services to launch the search and rescue operations. At around 200 ft, the pilot and his passenger shut down the engine and powered off the electricity, and the passenger unlocked the door.

End of accident flight and flight of search and rescue helicopter
