Accident to the GLASFLUGEL 304 CZ registered D-5304

on 09 July 2020

at Saint-Pons (Alpes-de-Haute-Provence)

Collision with trees in the mountains

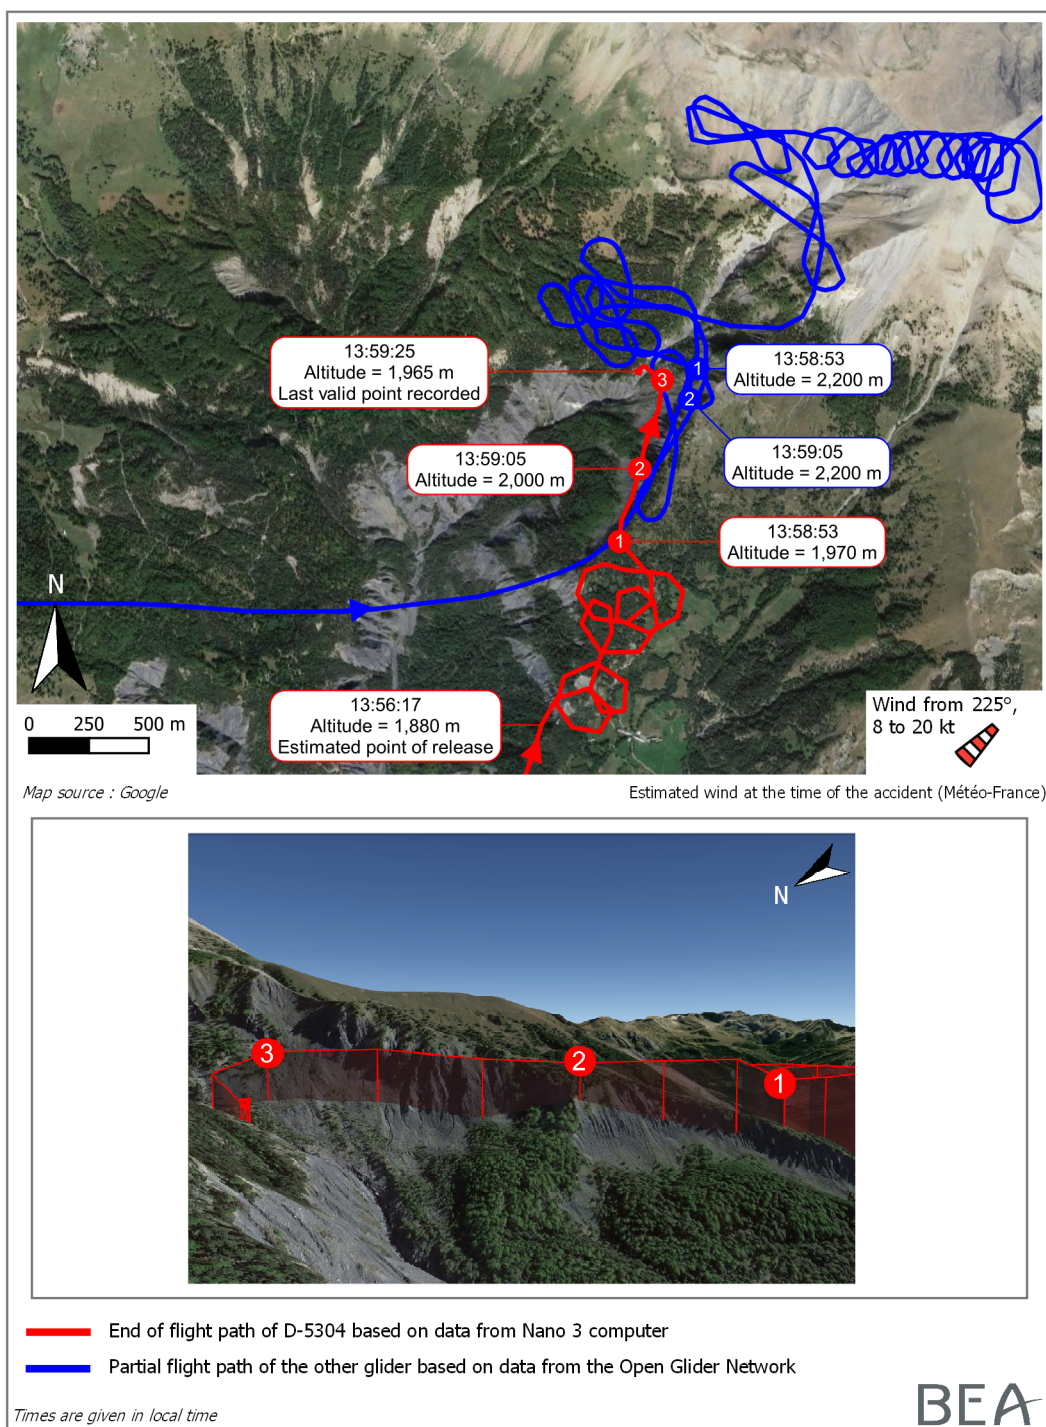
He released the tug cable at an altitude of around 1,900 m north of the aerodrome and used the uplifts making spirals. He then saw another glider that was making spirals, more or less at the same altitude and closer to the Parpaillon massif. As the other glider seemed to climb quicker, the pilot decided to move closer to it to attempt to use better uplifts (see [illustration](#), point ❶). He headed towards the other glider, facing the terrain.

Considering himself to be too close to the terrain, the pilot turned around to the left (see [illustration](#), point ❸). The glider then lost altitude and the pilot was unable to avoid collision with the vegetation.

Path of end of flight
