## Serious incident between the Boeing 787-10 registered N16009 and the Airbus A320-214 registered OE-IJF on 20 July 2020 at Paris-Charles de Gaulle airport (Val-d'Oise)

## Lapsus by a controller when giving a landing clearance, read back not checked, missed approach on short final on request from aeroplane lining up on runway

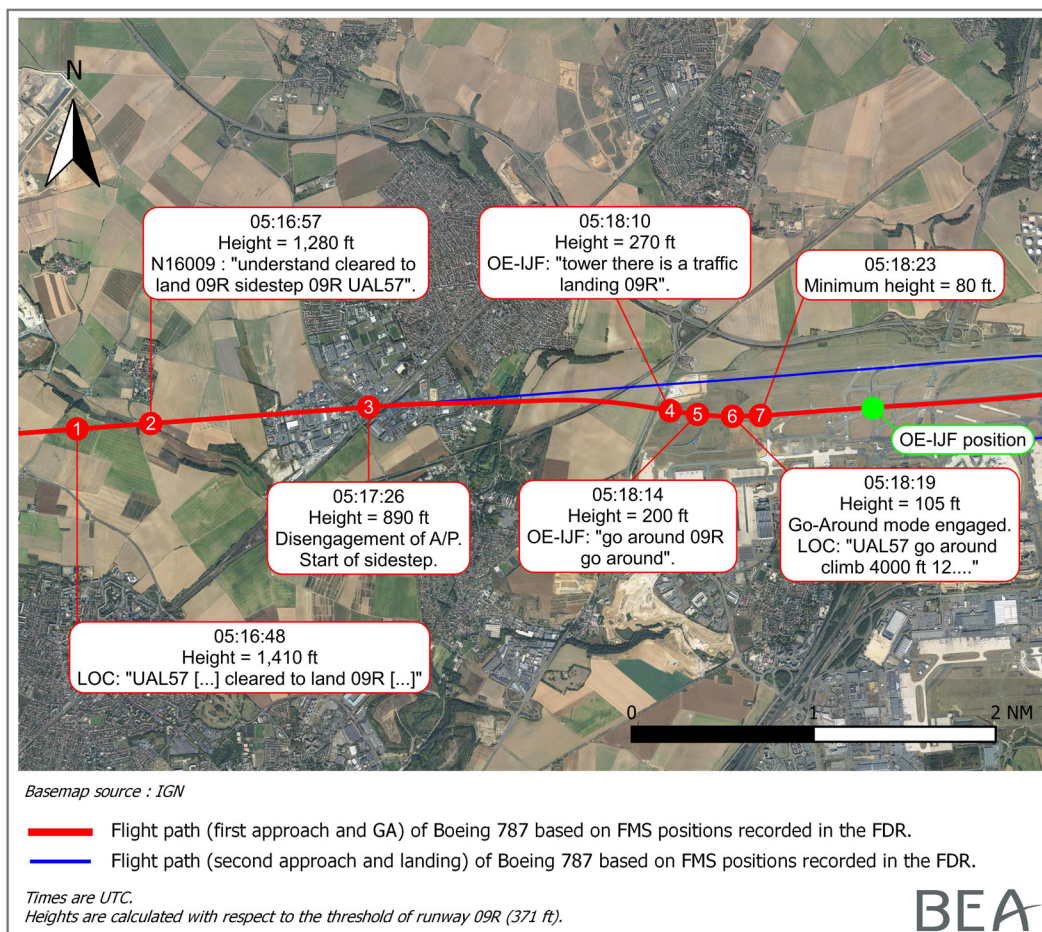
Figure 1: Path of Boeing 787 based on FDR

At 05:17:23, the controller cleared an EasyJet Airbus A320 to line up and hold on runway 09R at holding point D5<sup>(5)</sup>. At the same moment, the captain of the United Airlines Boeing 787 disengaged the autopilot (AP) and started a sidestep for runway 09R at a height of around 900 ft and at 2.2 NM from the threshold of runway 09R (point ❸ of [Figure 1](#)).

The captain of the Airbus A320 announced over the radio, at 05:18:10, *"Tower, there is a traffic landing 09R"* (point ❹ of [Figure 1](#)), then, *"Go around 09R, go around"* (point ❺ of [Figure 1](#)). The crew of the Boeing 787, who had seen the Airbus A320 on the runway and were getting ready to fly a missed approach replied that they were going around (point ❻ of [Figure 1](#)). Just after this message, the controller confirmed the go-around order by asking the crew of the Boeing 787 to climb to 4,000 ft. At the same time, the controllers' RIMCAS (Runway Incursion Monitoring and Collision Avoidance System) emitted warnings.

The Boeing 787 descended to a minimum height of 80 ft at 250 m before the runway threshold before climbing (point ❼ of [Figure 1](#)). It flew over the Airbus A320 at a height of just over 300 ft and continued the go-around followed by a new approach to runway 09L without any further incident.

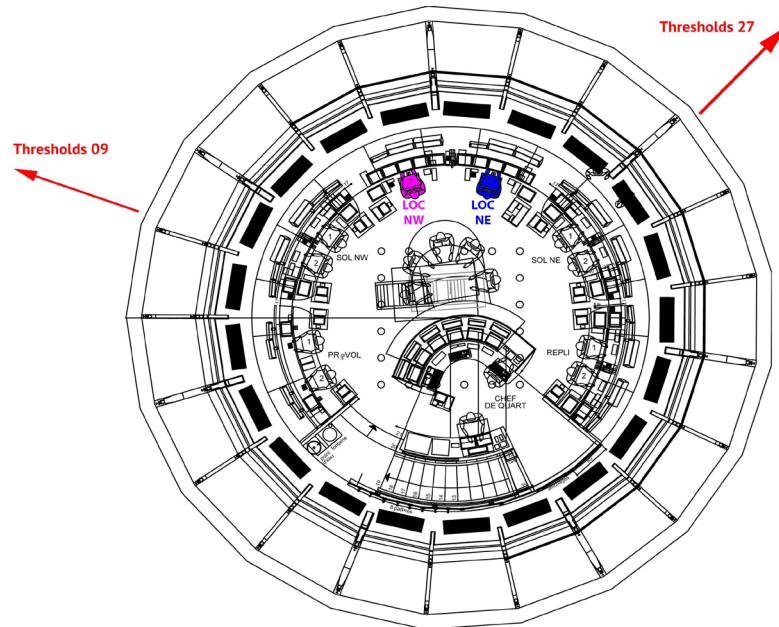
Figure 3: NE and NW LOC positions in north control tower

From the NE position, the controller faced the holding points of runway 27L, she did not have direct sight of the thresholds of runways 09 from her position in the control tower.
