## Accident to the STEMME S-10V registered F-CAOT

on 5 August 2020

at Dingy-Saint-Clair (Haute-Savoie)

### In-flight collision with a cable

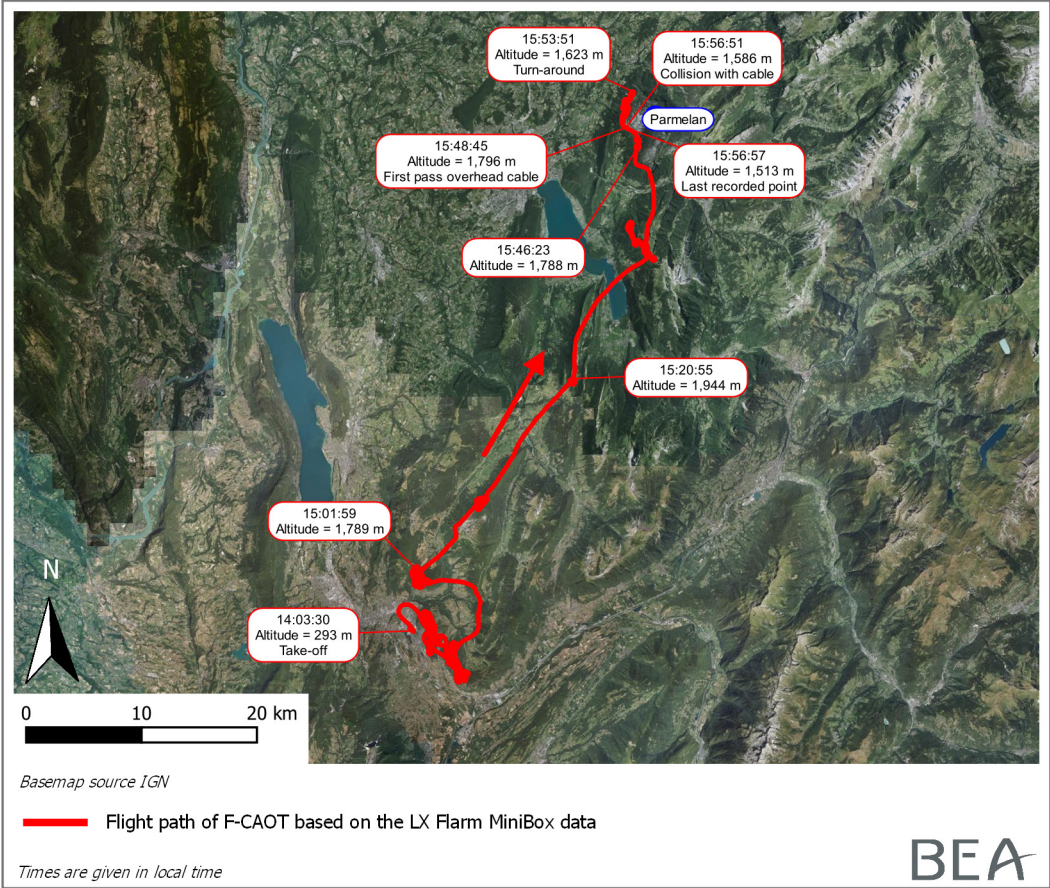
Figure 1: Path

The pilot, in the left seat, accompanied by a passenger, took off without assistance from Chambéry - Challes-les-Eaux aerodrome (Savoie) at around 14:00. He used the uplifts around the aerodrome for about an hour, then flew north towards Lake Annecy and on to Lachat mountain, flying along the rock face on the south side of Parmelan mountain. He flew close to the Parmelan refuge at around 15:48. He turned around after Lachat mountain. While flying back along the rock face on the south side of Parmelan summit, the left wing of the glider struck the cable of the lift<sup>(2)</sup>. The glider became unstable and entered a flat spin, colliding with the tree-covered mountain slope below the rock face.

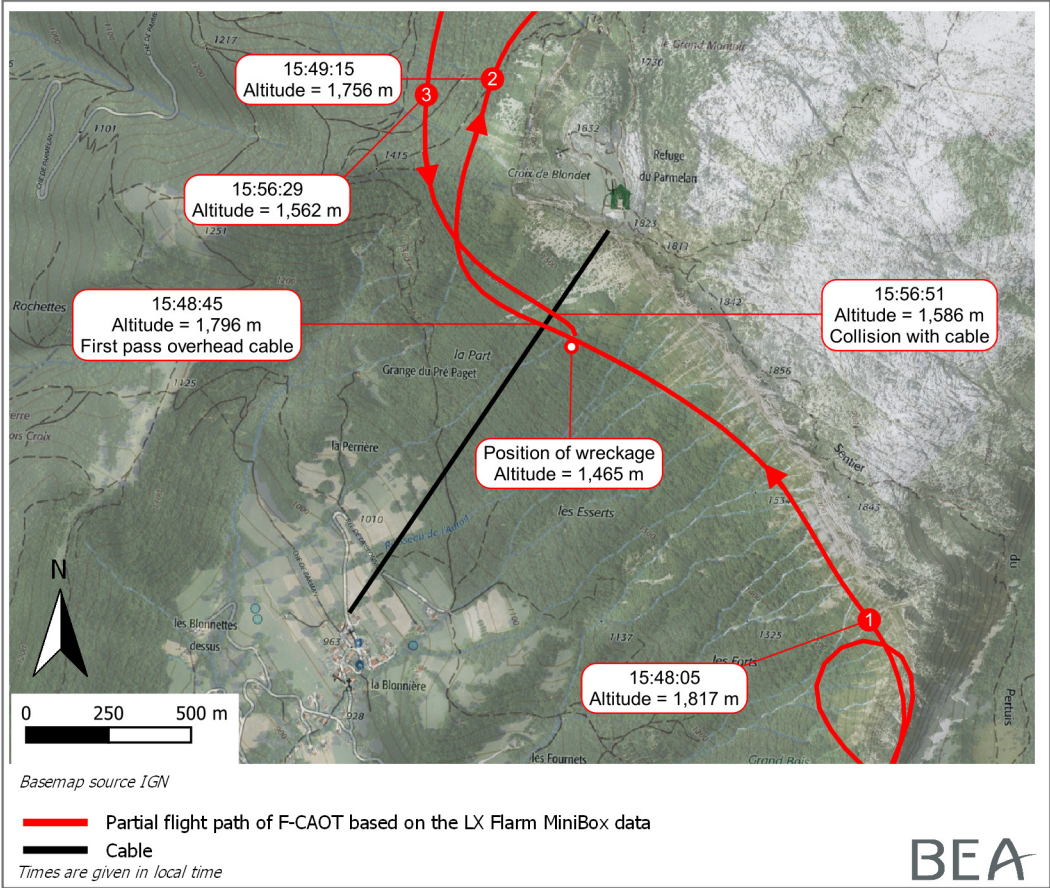
Figure 2: Detail of the path near the cable

<sup>(2)</sup> The height of the  
cable from the ground  
is approximately  
120 m at this point.

While flying along the rock face of Parmelan mountain, the pilot passed close to the cable for the first time without seeing it. On the return leg, the glider was lower, below the ridge line and closer to the cliff wall. It is likely that the pilot could not see either the refuge or the pylon and was therefore not alerted to the presence of the cable.

The collision of the left wing with the cable destabilised the glider and led to the in-flight loss of control.

The lack of a cable marking system may have contributed to the pilot's failure to detect the cable.

The DSAC-CE re-examined the Parmelan cable case and contacted the owner in order to define the requirements for installing markings in accordance with the regulations in force.

The manager has arranged to have new cable markings installed in conjunction with maintenance operations scheduled for the first half of 2021.
