Accident to the Schroeder Fire Balloons G30/24 registered F-GLAU

on 20 September 2020

at Jouaville (Meurthe-et-Moselle)

Collision with power line during landing

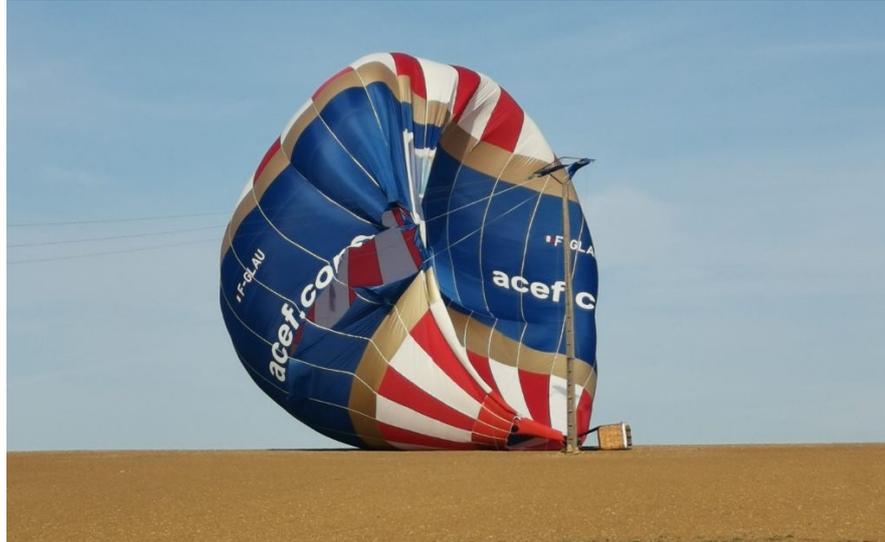
Accident site

At the end of the safety briefing, the pilot observed that the risers of the balloon's basket were at the same height as a medium-voltage power line that he had identified earlier. With the balloon a few dozen metres from this power line, in descent, the pilot decided to land before the line and pulled on the valve line ⁽³⁾. He landed around 15 metres from the power line with the basket upright. Pushed by the wind, the balloon moved closer to the power line and its envelope touched the cables that broke and partially tore the envelope. Electric arcs burned some of the envelope's panels.

A 20,000 V power line at a height of approximately six metres, comprising three cables, crosses the uncultivated field practically perpendicularly to the balloon's path. The poles are spaced around one hundred metres apart. This power line is located approximately 500 m from the area flown over at low height two minutes earlier.

The balloon envelope came into contact with the power line after the basket had touched down.

The safety instructions for landing must be presented before take-off then repeated during the flight when preparing for landing, at a height that is sufficient enough to enable the balloon to clear any obstacles.

The pilot's decision to pull on the valve line instead of attempting to fly over the obstacle, in this case the power line, lessened the consequences of the collision. Indeed, clearance of the obstacle was not guaranteed given the inertia of the balloon with a descent path.
