Accident to the Airbus AS350-B3e registered F-HLXO

on 30 October 2020

at Thiézac (Cantal)

Interference of the sling with the tail boom and the tail rotor, emergency landing

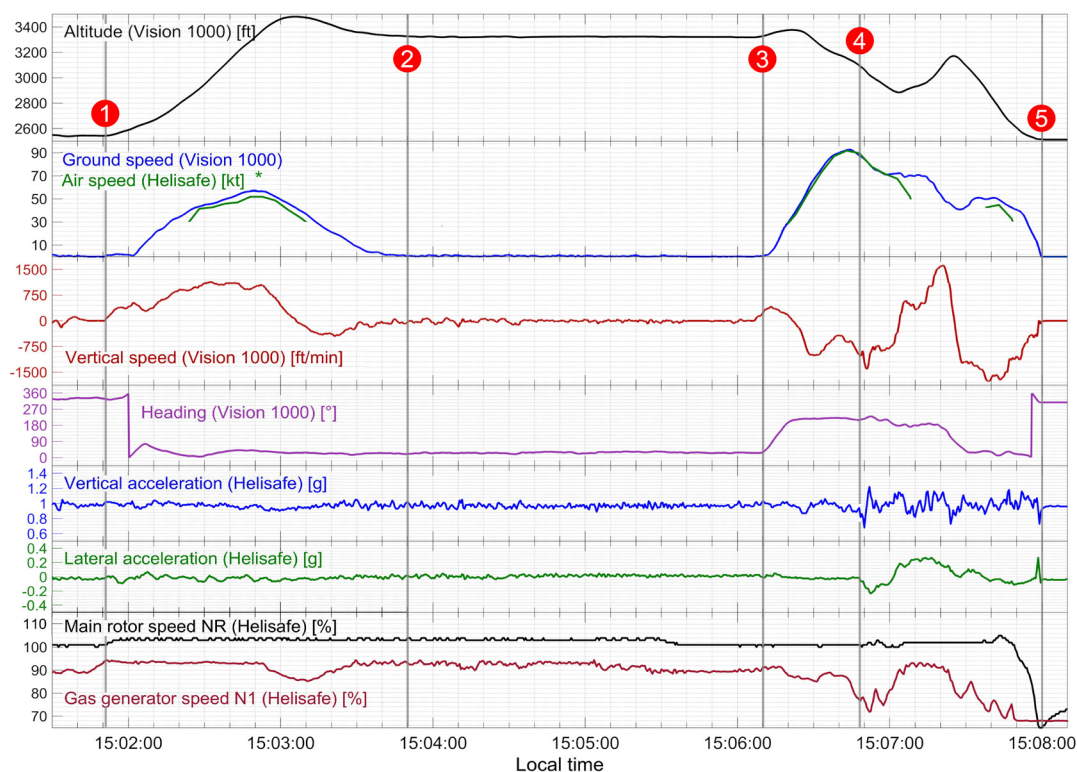
Figure 2: Extract of saved parameters

The parameters extracted from the Helisafe and Vision 1000 computers showed that at the time of the sling interference (point ④), the helicopter was flying at an indicated airspeed of 87 kt for a vertical speed of -1,030 ft/min.
