## Accident to the MAGNI - M16 identified 48BU

on 18 January 2021  
at Valmeinier (Savoie)

### Interference of rotor with tailplane, loss of control, collision with ground

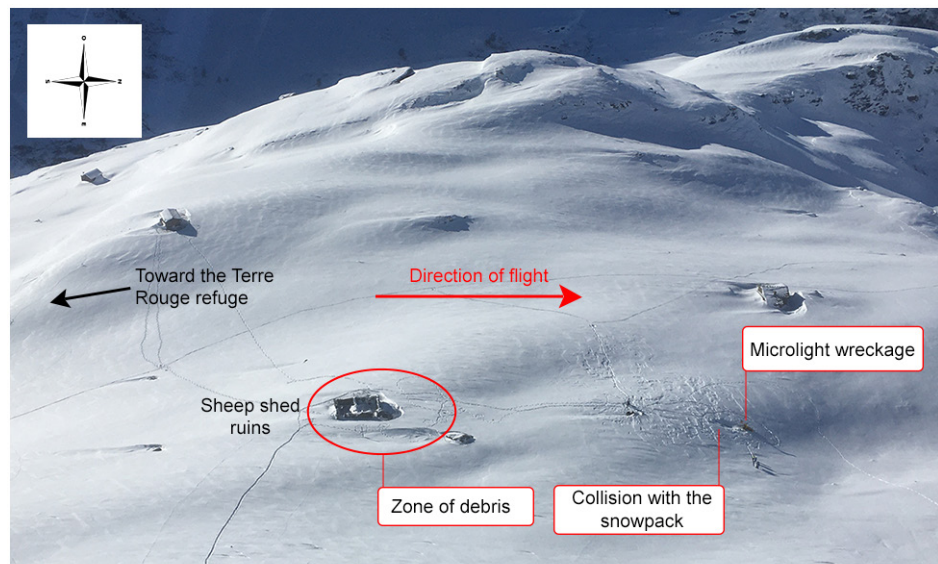
Figure 2: Aerial view of the accident site

The accident site was located at an altitude of around 2,190 m on a snowy plateau. The wreckage was found around 100 metres north of a dilapidated former sheep shed. The Terre Rouge refuge is located south of the sheep shed. The terrain slopes steeply from the refuge up to the accident site (average slope of around 16%).

Some debris from the gyroplane was found around this sheep shed, within a 20-metre radius. The debris corresponded to the vertical and upper sections of the tailplane, as well as glass fibre fragments from the pusher-propeller blades. The propeller cone was also found in this zone with the lightest debris found after the sheep shed.

The small spread of debris around the sheep shed would indicate a separation in flight at low height when flying over the sheep shed.

No sign of contact of the gyroplane with the sheep shed was detected and no debris was found between this zone and the wreckage.

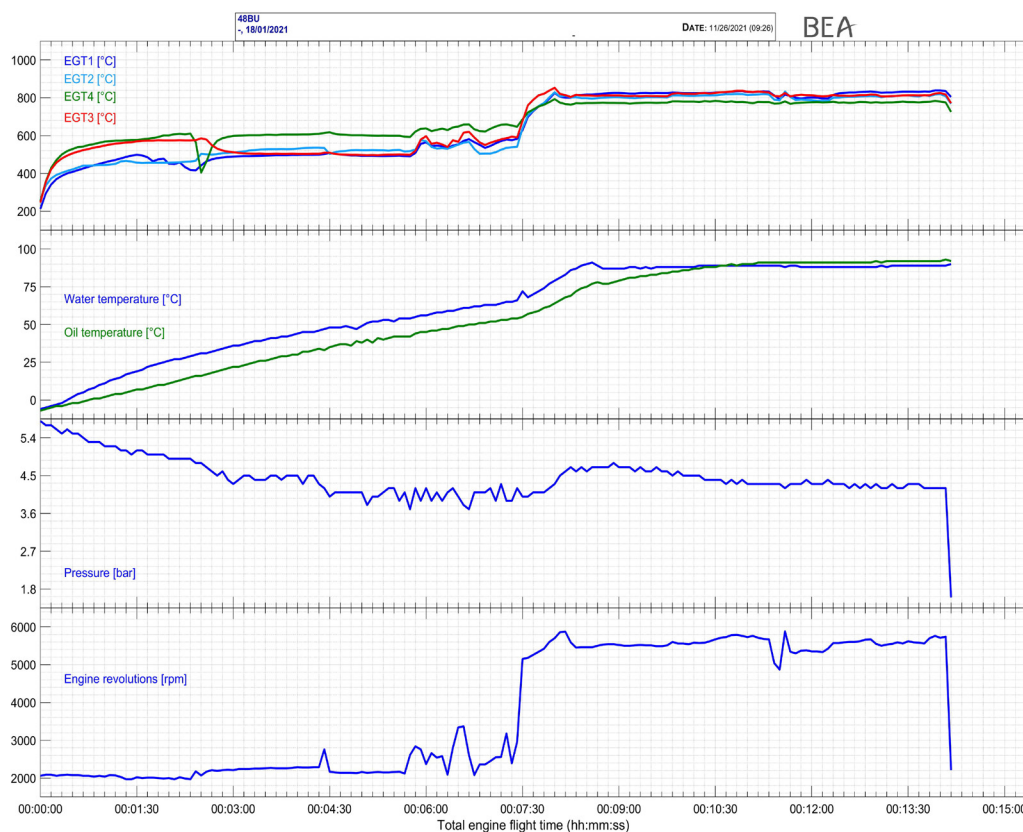
Figure 3: Accident flight engine parameters

The analysis of these parameters showed that:

- ☐ the engine had operated for 22 minutes from start-up;
- ☐ 5 mins 40 seconds after engine start-up, a period during which the engine warmed up, the pilot performed engine tests (lasting one minute);
- ☐ take-off took place 7 mins 20 seconds after start-up;
- ☐ the duration of the flight up to the accident was 6 mins 40 seconds;
- ☐ during the flight, no anomaly on the parameters that could indicate an engine failure was visible;
- ☐ at the time of the accident, the engine speed was close to its maximum.
