Accident to the SOCATA TB10
registered **F-GJXO**
on 4 March 2024
at Béziers-Vias (Hérault)

Time	Around 14:30 ¹
Operator	ENAC
Type of flight	Instruction
Persons on board	Instructor, student pilot, passenger
Consequences and damage	Student pilot injured, aeroplane substantially damaged
This is a courtesy translation by the BEA of the Final Report on the Safety Investigation. As accurate as the translation may be, the original text in French is the work of reference.

Bird strike while in holding pattern, in instruction

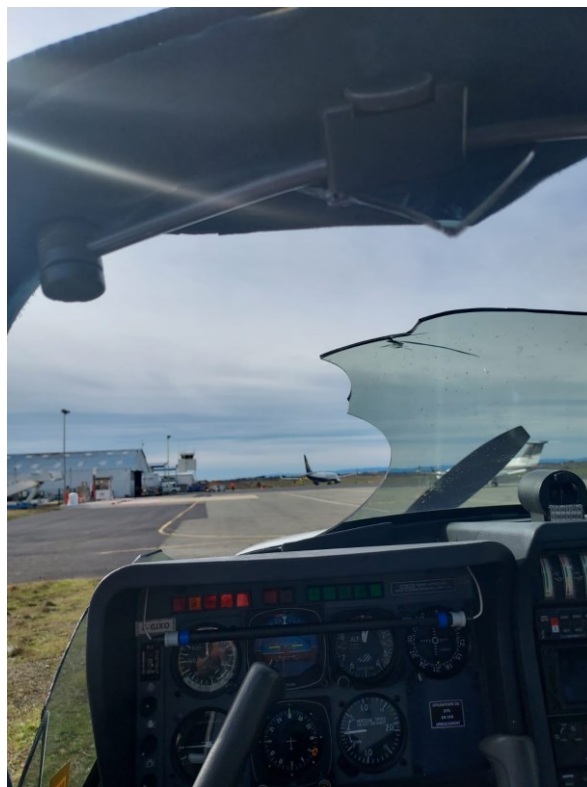
At the end of the turn, when the student pilot levelled the wings, a group of storks could be seen ahead of them. The instructor called out that she was taking the controls and tried to avoid the birds. A stork struck the windshield, which broke under the impact, and the bird penetrated into the cabin, finishing its path on the LH rear seat. The student pilot was injured by the bird and fragments of windshield. The instructor observed that the aircraft was controllable and that the engine was operating normally. She reported the collision and windshield damage to the controller and asked to join the circuit for a full stop landing. The landing took place without further incident. The instructor asked for medical assistance for the student pilot.

The windshield of F-GJXO was damaged on the LH side (see **Figure 1**).

An impact mark on the elevator was visible without structural damage.

Figure 1: photo of damage (source: ENAC)
