Serious incident to the AIRBUS - AS 365 - N3 "Dauphin" registered F-GYLH

on 11 February 2021

off the coast of Le Havre (Seine-Maritime)

Near-collision with the water surface, during a night flight

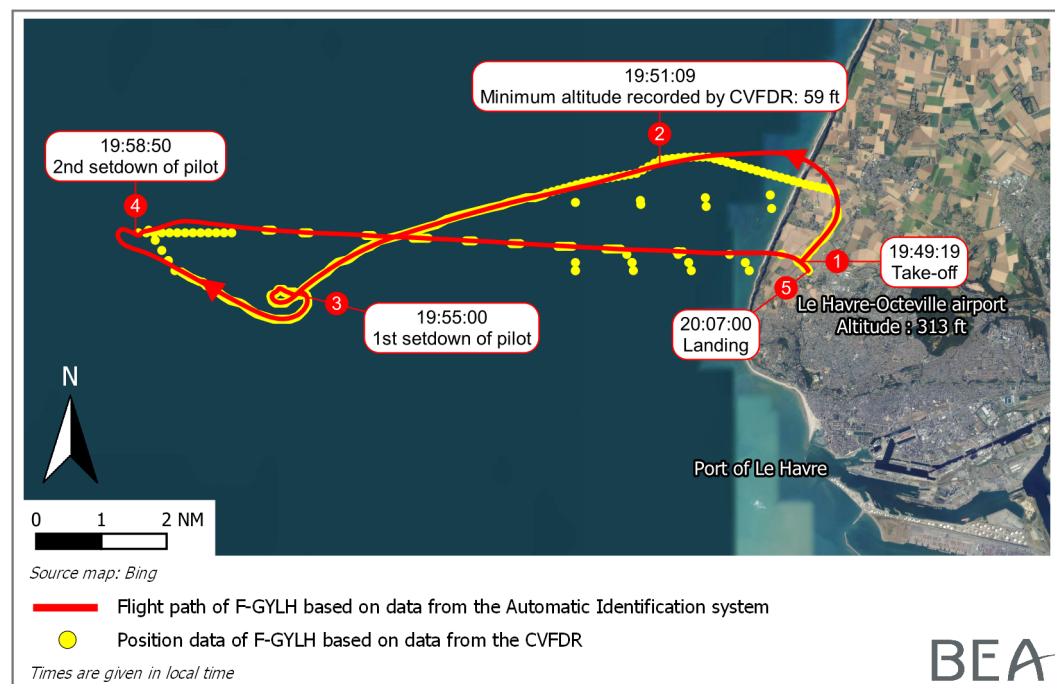
The minimum recorded altitude was 59 ft. During the descent, the speed reached 158 kt and thus exceeded the maximum never-exceed speed (VNE) by 8 kt (see [paragraph 2.3.4](#)).

Figure 1: F-GYLH flight path and partially invalid CVFDR position data

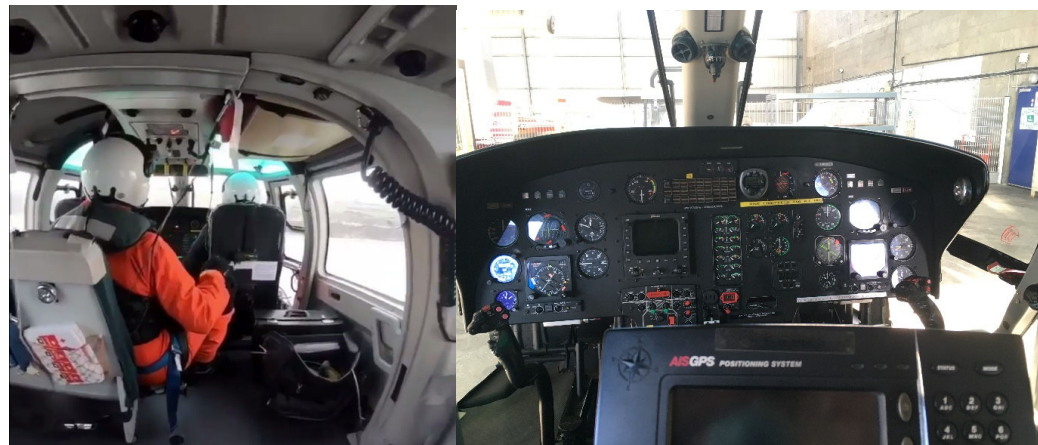
The passenger cabin has a two-place central bench seat, one place is reserved for the hoist operator, and a four-place rear bench seat. From his position, the hoist operator can see the instruments on the instrument panel.

Figure 2: cabin configuration and view from the hoist operator's place

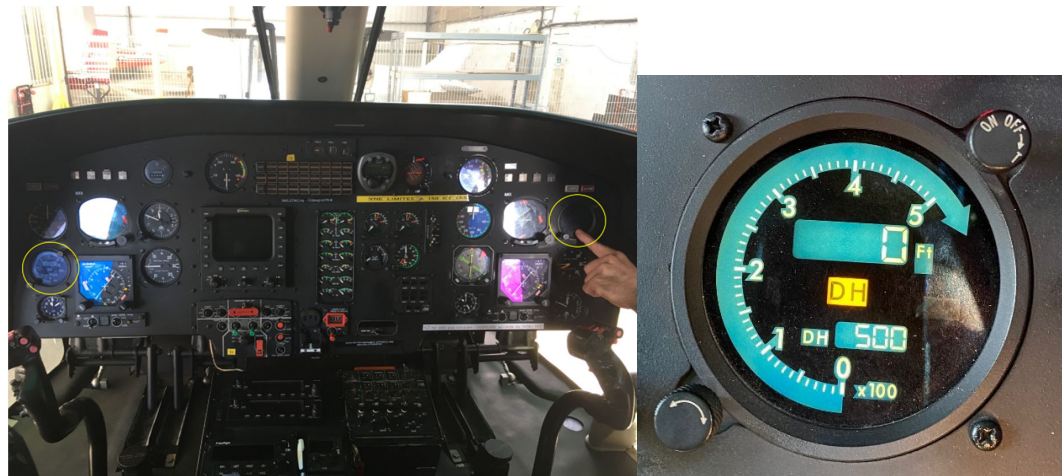
A decision height (DH) can be set for each instrument. During a descent and when passing the set DH, a non-persistent aural warning sounds. A "DH" yellow light remains illuminated for the time the value of the radio altimeter is below the DH (see [Figure 3](#)).

For the pilot in the right seat, the radio altimeter on the opposite side is not clearly visible.

Figure 3: LH and RH radio altimeters circled in yellow; radio altimeter set with DH of 500 ft for a height of 0 ft

- ❑ The fact that the pilot and hoist operator did not notice the aural and visual warnings of the radio altimeters signalling that the aircraft was getting closer to the ground, which can particularly be explained by the low aural and visual salience of the radio altimeter warnings when passing the decision height (DH).

- ☐ Implementation of new initial training for hoist operators:
 - Technical Crew Member initial training outsourced to a specialised organisation;
 - initial training in hoist operations outsourced to a specialised organisation;
 - recruitment of a new hoist operator with proven flight and hoist operation experience.
- ☐ Search for a solution to make the aural warning of the radio altimeters more obvious or to add an acknowledgement system.
